COLORADO CULTURAL RESOURCE SURVEY

Architectural Inventory Form

1. Resource number: 5PE.5957

Historic building name: 1712 Craig Street
 Current building name: 1712 Craig Street
 Building address: 1712 Craig Street

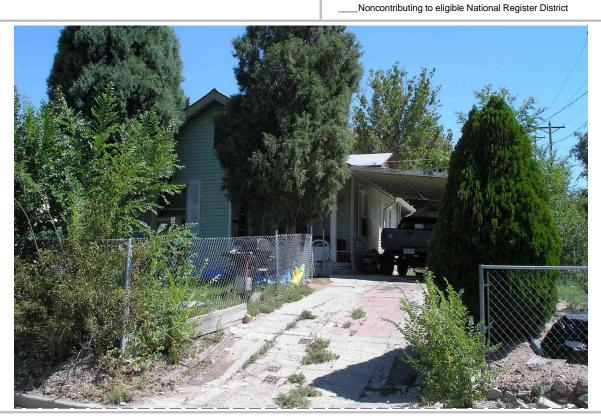
Constructed in 1928, this house exhibits a low level of physical integrity relative to the seven aspects of integrity as defined by the National Park Service and the Colorado Historical Society: location, setting, design, materials, workmanship, feeling, and association. This house appears to have been moved, compromising its integrity of location. Thus, this property does not retain sufficient physical integrity to convey its architectural and historical significance.
