COLORADO CULTURAL RESOURCE SURVEY

Architectural Inventory Form

Historic building name: **Lousteau-Langley House** Current building name: Wilson, Bryon R., House

Building address: 507 W 12th Street

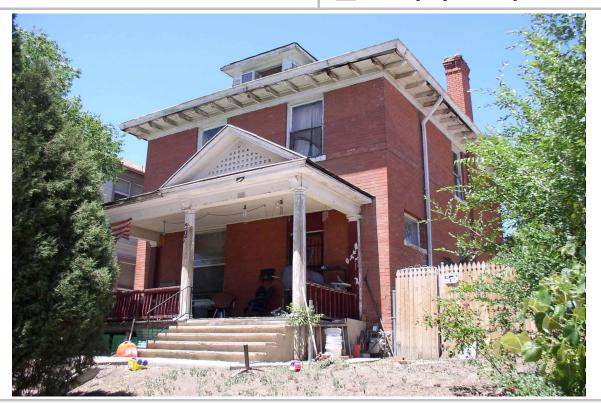
Oriented to the south, this house rests on a pink-colored, rock-faced sandstone, coursed ashlar foundation. The walls consist of red, pressed brick, with thin, pink mortar. A protruding watertable marks the junction of the foundation and exterior walls. Another belt course corresponds to the sills of the second-story windows. Most windows are 1-over-1-light, double-hung sash, with white-painted wood frames, white-painted, rock-faced, sandstone sills, and flat arches. Awning or hopper windows, with diamond-shaped glazing, appear in the south ends of the first story of both the east and west elevations. A hipped-roof porch extends across the entire principal (south) façade. The porch has a wood floor and beadboard ceiling. A red-painted wood balustrade, with curved balusters, surrounds the porch. The porch supports are white-painted, wood, Tuscan columns. Offset to the east half of the porch are 4 concrete steps. Above these steps is a pediment with latticework frieze. Scroll brackets mark the junction of the pediment with its corresponding porch supports. The porch provides access to the principal doorway, which opens east of center on the otherwise symmetrical facade. It hosts a wood slab door, opening behind a black, security-type storm door. The transom above the door has been boarded shut. A small, hipped-roof porch protrudes from the center of the rear (north) elevation. It is entered on the east side and is enclosed with a combination of latticework and translucent sheets of plastic. Green, interlocking asphalt shingles cover the centrally hipped roof. A hipped-roof dormer protrudes from the roof's

south-facing slope. It is faced in white-painted, square-cut wood shingles. A red-brick, engaged chimney protrudes above the roof, north of center on the east elevation. White-painted beadboard boxes the eaves, and white-painted, evenly spaced, shaped modillions appear beneath the soffit.
