COLORADO CULTURAL RESOURCE SURVEY

Architectural Inventory Form

- 1. Resource number: **5PE.517.24** Parcel number(s):
- 2. Temporary resource number: **036** **525419007**
- 3. County: **Pueblo**
- 4. City: **Pueblo**
- 5. Historic building name: **Lewis, James A., House**
- 6. Current building name: **MJC Consulting Offices**
- 7. Building address: **517 W 12th Street**
- 8. Owner name: **MJC Consulting, LLC**
- Owner organization:
- Owner address: **517 W 12th St**  
**Pueblo, CO 81003**

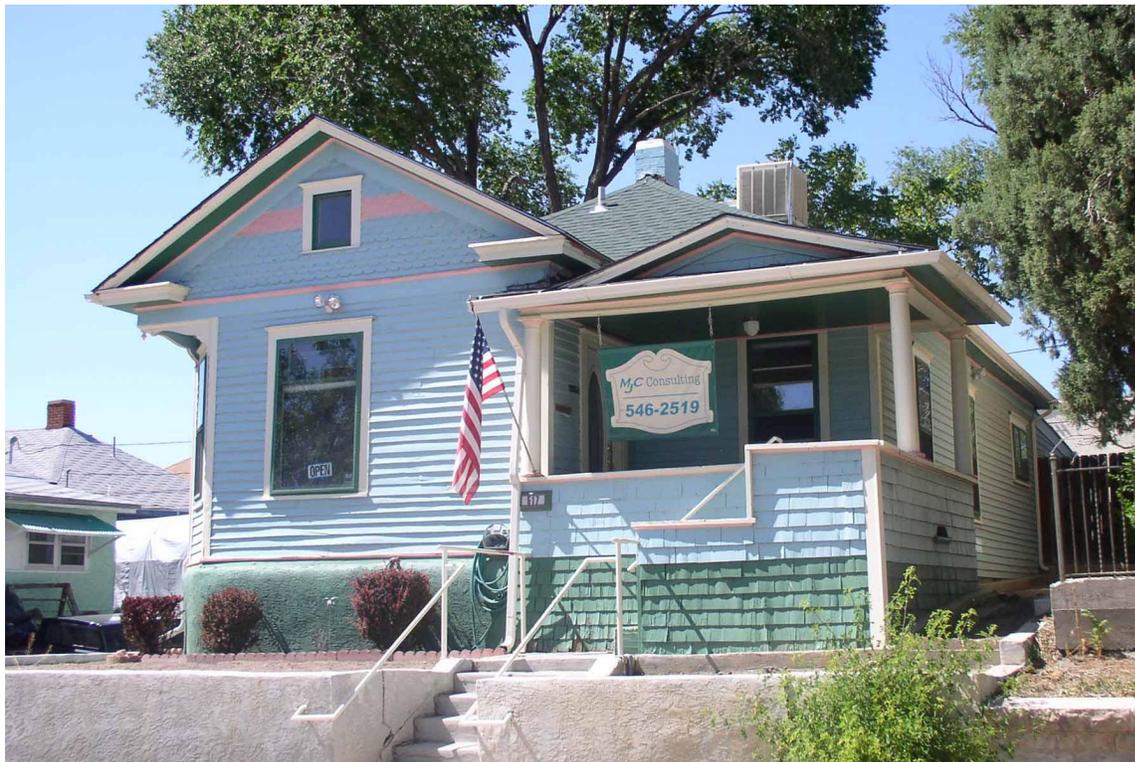
**Ornamentation/Decorative Shingles**  
**Window/Stained Glass**
21. General architectural description:  
**Oriented to the south, this house rests on a green-painted, stucco-covered foundation. Blue-painted, horizontal wood siding, with cream-painted, 1-by-4-inch cornerboards, clads the exterior walls. Octagon shingles, painted blue, with a band of pink, cover the front- (south-) facing gable. Windows are generally 1-over-1-light, double-hung sash, with green-painted wood frames and cream-painted wood surrounds. These surrounds have projecting cornices. The only window facing fully south has a narrow upper sash with stained glass. Paired, single-light casement windows pierce the north end of the east elevation. Single-light, awning, hopper, or casement windows open in the gables. The southwest corner is canted beneath the roof, and features scrolled brackets and a finial at the corner itself. A front-gabled porch is located off the southeast corner. It has a kneewall covered in square-cut wood shingles. The porch supports are cream-painted, wood, Tuscan columns, resting on the kneewall. Because of the severe slope from street level to the house, a series of concrete steps approach the porch. The principal doorway opens in the east face of the southeast-facing inside corner. It hosts a metal door featuring a large, oval light, with leaded glass. A shed-roofed addition is attached to the eastern two-thirds of the rear (north) elevation. It is clad in blue-painted, horizontal wooden composition siding. It has a combination of 12-light, sliding-sash and fixed-frame windows. Opening near**

the center of the addition's west elevation are 10-light French doors. The doors provide access to a concrete patio off the northwest corner of the house. The roof of the northernmost portion of the addition is covered in sheets of plexiglass, to create a solarium. Green asphalt shingles cover the gable-on-hip roof, and the eaves are boxed, with white-painted wood fascia and blue-painted wood soffit. A pair of blue-painted brick chimneys protrudes from either end of the main hipped roof's north-south ridge.

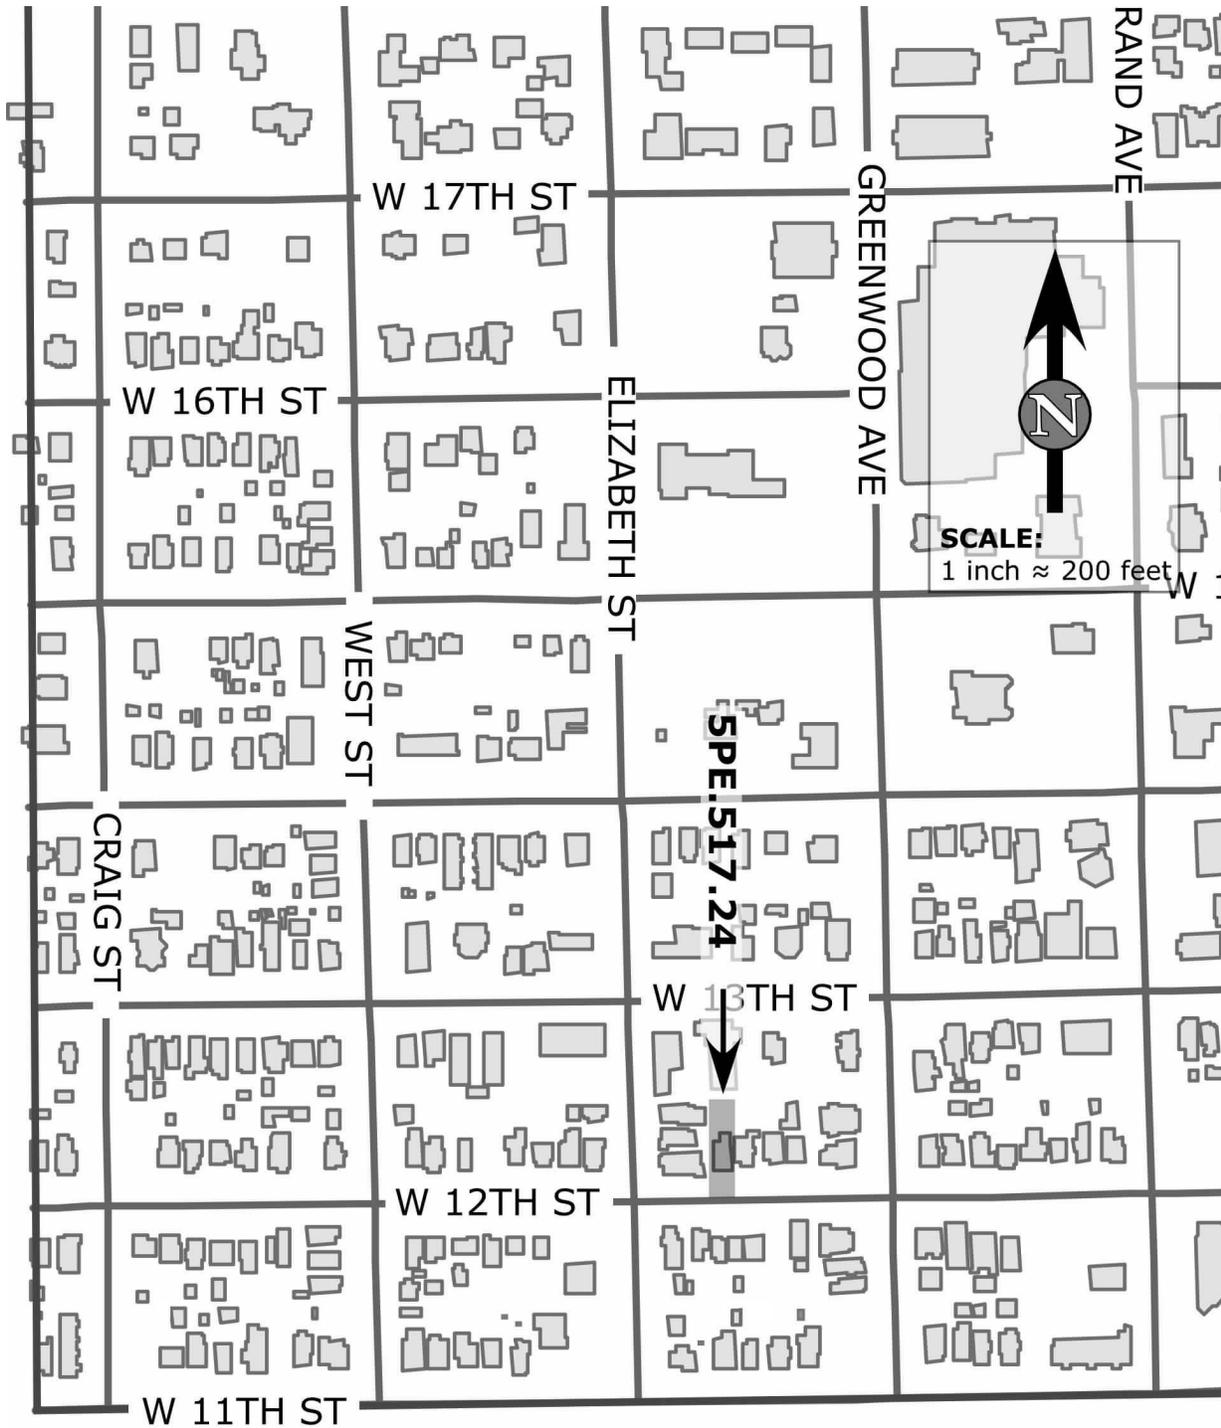
#### SITE SKETCH MAP

**This property is located on terrain sloping steeply downward from north to south, with an elevation of around 4,700 feet above mean sea level. The neighborhood features modest, one- and two-story houses. This property is located on the north side of West 12th Street, an east-west-oriented thoroughfare. It is situated between 515 West 12th Street, to the east, and 1202 North Elizabeth Street/519 West 12th Street, to the west. A gravel-covered strip, with oval-shaped, rock-line planters, separates the sidewalk from the street. High, concrete retaining walls divides the sidewalk from the front yard. A wood privacy fence surrounds the terraced backyard, which concrete block walls retain. Workers were installing new landscaping at the time of this survey.**

Describe: **A shed is located at the northeast corner of the property. Oriented to the south, the building appears to lack a formal foundation. Blue-painted sheets of plywood, with 1-inch, cream-painted cornerboards, clad the exterior walls. Opening in the center of the front (south) elevation is a plywood door, on metal strap hinges. Green, asphalt shingles cover the double-pitched shed roof, which has broadly overhanging but asymmetrical eaves. Boxing the eaves is green-painted wood soffit and white-painted fascia.**
