COLORADO CULTURAL RESOURCE SURVEY

Architectural Inventory Form

- 1. Resource number: **5PE.517.46**
- 2. Temporary resource number:
- 3. County: **Pueblo**
- 4. City: **Pueblo**
- 5. Historic building name: **Mooney-Marmaduke House**
- 6. Current building name: **Tsuyama, Jill, House**
- 7. Building address: **624 W 14th Street**
- 8. Owner name: **Jill Tsuyama**
- Owner organization:
- Owner address: **624 W 14th St**
Pueblo, CO 81003

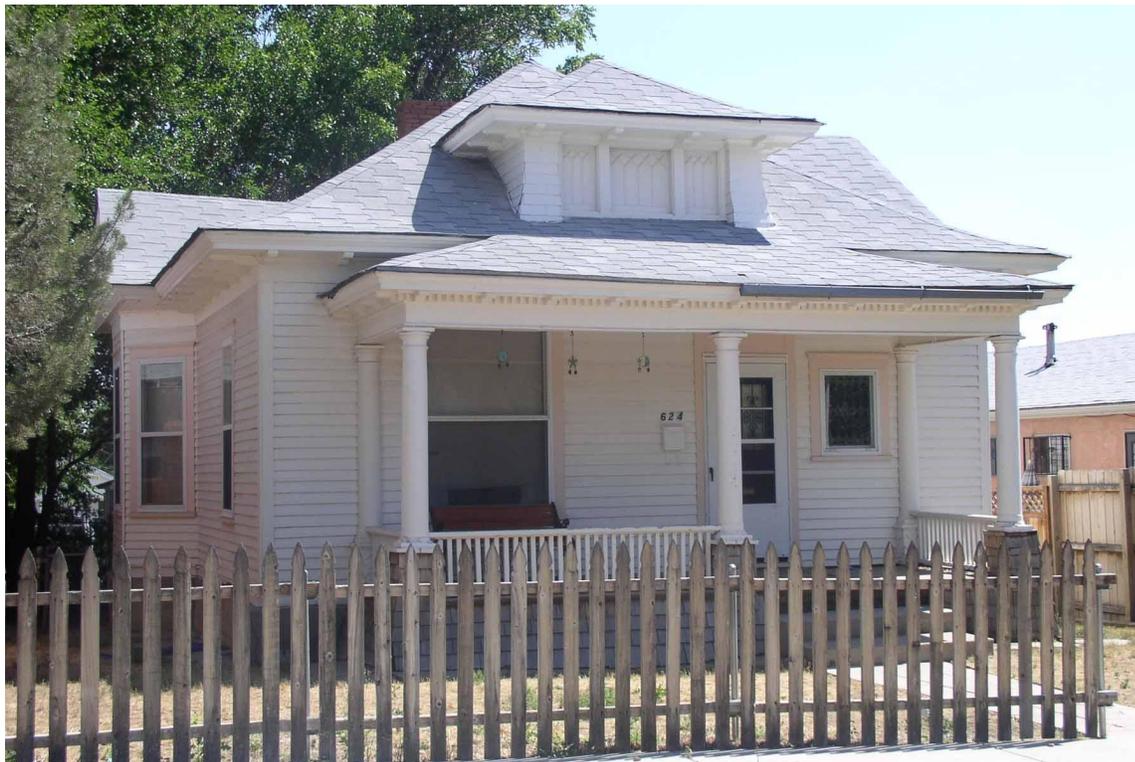
21. General architectural description:
Oriented to the north, this house rests on a random-laid sandstone foundation, encased in concrete. White-painted, horizontal wood siding, with 1-by-4-inch cornerboards, clads the exterior walls. Windows are 1-over-1-light, double-hung sash, with white-painted wood frames, aluminum-frame storm windows, and pink-painted wood surrounds. A 3-sided, canted bay protrudes from the center of the east elevation; above it is a large pediment. A larger, rectangular, front-gabled bay protrudes from the center of the west elevation. A stained-glass hopper or awning window opens just west of the principal doorway. A hipped-roof porch spans most of the front (north) façade. Square-cut wood shingles cover the portion of the porch below the floor and the column pedestals. The balustrade features closely spaced, square balusters. White-painted, round, Doric columns support the porch roof. Beneath the porch roof is a dentiled cornice, with evenly spaced modillions. Two concrete steps approach the porch west of center. The principal doorway also opens west of center. It hosts a 4-panel, 1-light, glass-in-wood-frame door, with a wrought-iron grille over the light. It is protected behind a white vinyl-frame storm door. Another doorway, hosting a 5-
