COLORADO CULTURAL RESOURCE SURVEY

Architectural Inventory Form

- 1. Resource number: **5WL.5602** Parcel number: **080721204019**
- 2. Temporary resource number: **Not Applicable**
- 3. County: **Weld**
- 4. City: **Windsor**
- 5. Historic building name: **Windsor Public Library**
- 6. Current building name: **Pat Weakland DDS**
- 7. Building address: **214 5th Street**
- 8. Owner name: **Patrick G. and Amanda J. Weakland**
- Owner organization:
- Owner address: **214 5th St
Windsor, CO 80550**

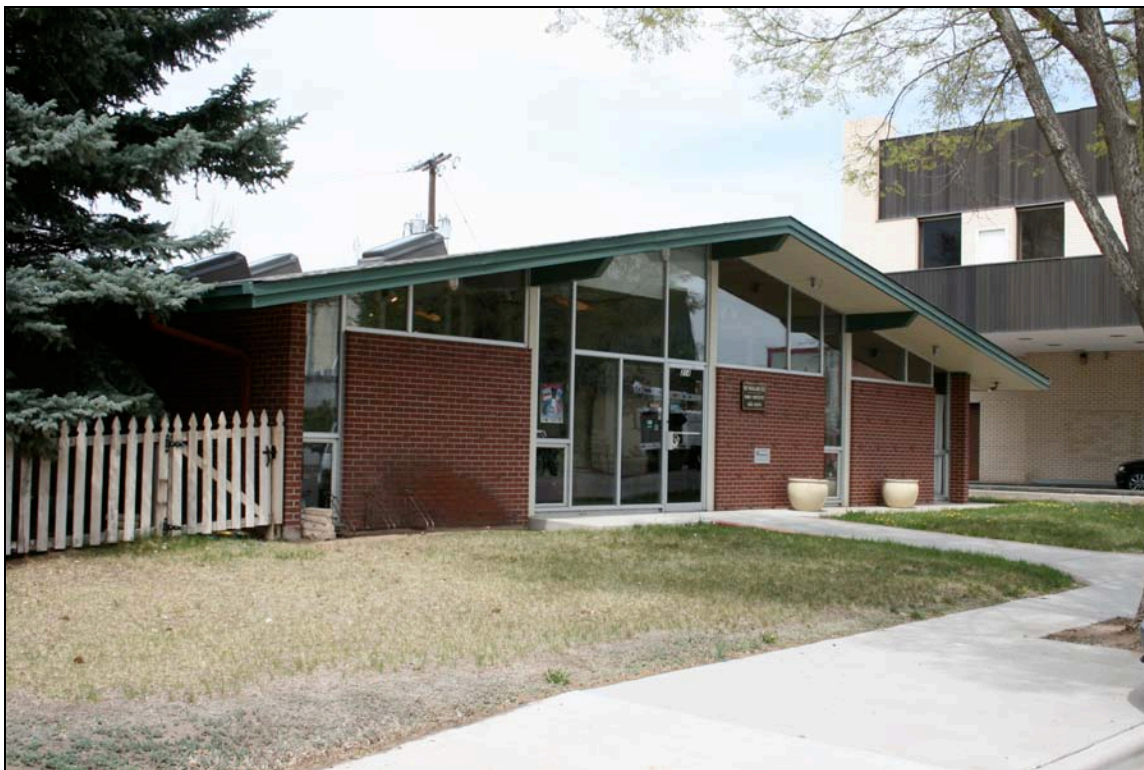
19. Primary external roof material: **Asphalt Roof/Composition Roof**
Other roof materials:
20. Special features: **Fence**
21. General architectural description:
Oriented to the east, this building rests on a concrete foundation. A red, pressed-brick veneer clads most of the exterior walls. The brickwork features alternating, raised squares across the front (east) façade. Covering the rear (west) elevation are sheets of white-painted plywood. Four, tall and narrow window openings extend from the foundation to the eaves at either end of the façade and divide each half of this elevation. They consist of an awning window at the bottom and a single, fixed-frame light extending upward. The principal doorway opens just south of center. It hosts a plate-glass door. South of them are two, plate-glass windows of nearly identical size as the door. Clerestory windows extend from the level of the front door lintel to the bottom of the eave. All of the doors and windows in the façade have aluminum frames. Opening in the west end of the south elevation and south of center in the rear elevation are 1-beside-1-light, sliding sash windows, with white vinyl frames. A pair of single-light clerestory windows pierce the rear-facing gable, south of center. Doorways open in the extreme west end of the north elevation and in the north end of the rear elevation. The northern doorway hosts a white-painted, 6-panel steel door. A white-painted wood slab door opens in the southern doorway. Gray-green asphalt shingles, punctuated by skylights, cover the front-gabled main roof. Large, green-painted, glue-lam perkins extend beneath the very broadly overhanging eaves, which are boxed in green-painted wood fascia and cream-colored aluminum or vinyl soffit.
