COLORADO CULTURAL RESOURCE SURVEY

**Architectural Inventory Form**

- 1. Resource number: **5WL.3172** Parcel number: **080721204009**
- 2. Temporary resource number: **Not Applicable**
- 3. County: **Weld**
- 4. City: **Windsor**
- 5. Historic building name: **Dr. Thomas B. and Cora Gormly House**
- 6. Current building name: **Elizabeth S. Meyer House**
- 7. Building address: **230 5th Street**
- 8. Owner name: **Elizabeth S. Meyer**
- Owner organization:
- Owner address: **230 5th St  
Windsor, CO 80550**

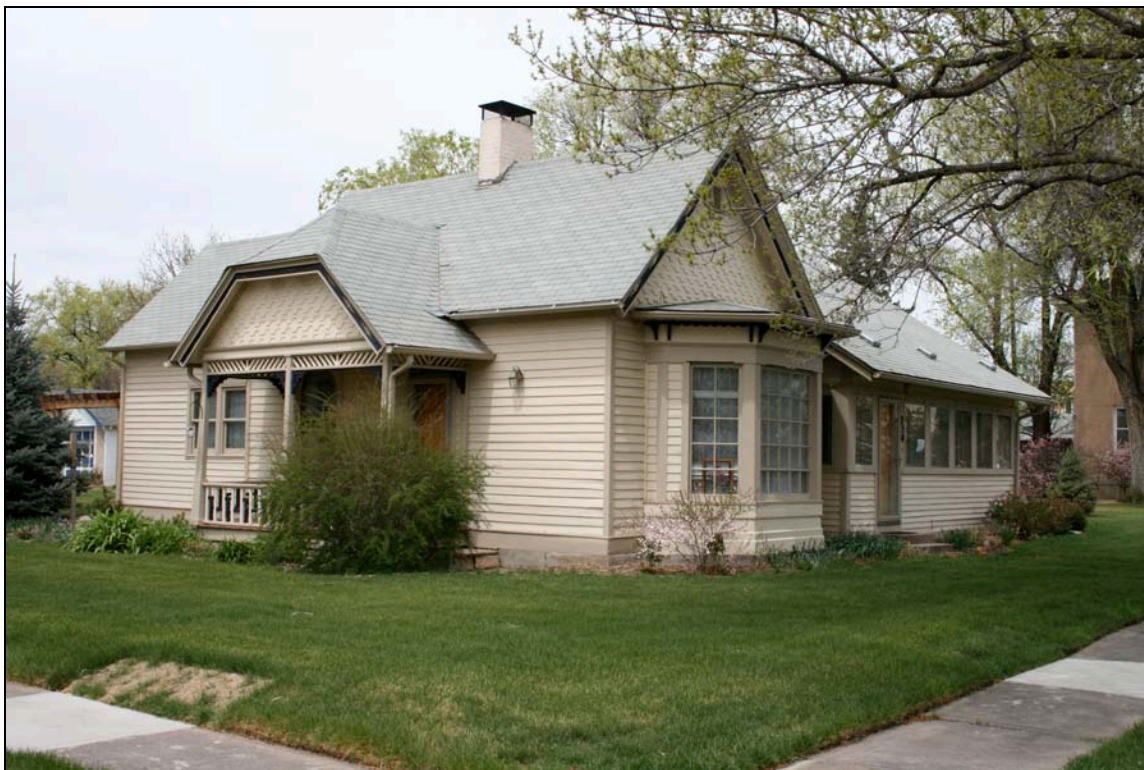
20. Special features: **Car Port**  
**Porch**  
**Ornamentation/Decorative Shingles**  
**Window/Stained Glass**
21. General architectural description:  
**Oriented to the east, this house rests on a sandstone foundation, largely concealed behind cream-colored stucco. Cream-painted wood siding, with tan-painted wood cornerboards, clads the exterior walls. Decorative wood shingles cover the gables. Windows are generally 1-over-1-light, double-hung sash, with tan-painted wood frames and surrounds. Spanning the northern two-thirds of the asymmetrical front (east) façade, beneath a pent roof, is a band of paired, 12-light casement windows, with tan painted wood frames and surrounds. The casement window opening just south of the principal doorway has 24 lights. Protruding from the southern third of the façade, centered beneath a gable, is a canted, three-sided bay window. It consists of a 25-light window flanked by 10-light windows. Beneath the bay window's shallowly pitched roof a paired, scroll-cut brackets. Opening beneath a front, clipped-gabled porch protruding from the south elevation is a window with a round-arch upper sash of stained glass. The principal doorway opens south of center in the front façade. It hosts a 6-panel wood door, opening behind an aluminum-frame storm door. Approaching the doorway is a 2-step concrete stoop. An identical doorway opens beneath the south porch, which is approached from the east. The porch features a decorative wood balustrade and friezes. A third doorway, nearly identical to the other two, opens in the north end of the rear (west) elevation. Decorative vergeboards appear in the east-, south-, and west-facing gables. The north-facing gables have knee brackets. Gray asphalt shingles cover the cross-gabled main roof and all other roof surfaces. A tan-brick chimney protrudes near the center of the east-west roof ridge.**
