COLORADO CULTURAL RESOURCE SURVEY

Architectural Inventory Form

1. Resource number: **5LR.2252**
2. Temporary resource number: **SHF-5**
3. County: **Larimer**
4. City: **Fort Collins**
5. Historic building name: **Keith D. Lee Residence**
6. Current building name: **Kayla Crowe and Ryan Stover House**
7. Building address: **330 Circle Drive**
8. Owner name: **Kayla R. Crowe and Ryan S. Stover**
- Owner organization:
- Owner address: **330 Circle Drive**
Fort Collins, CO 80524

Fort Collins Post-World War II Survey

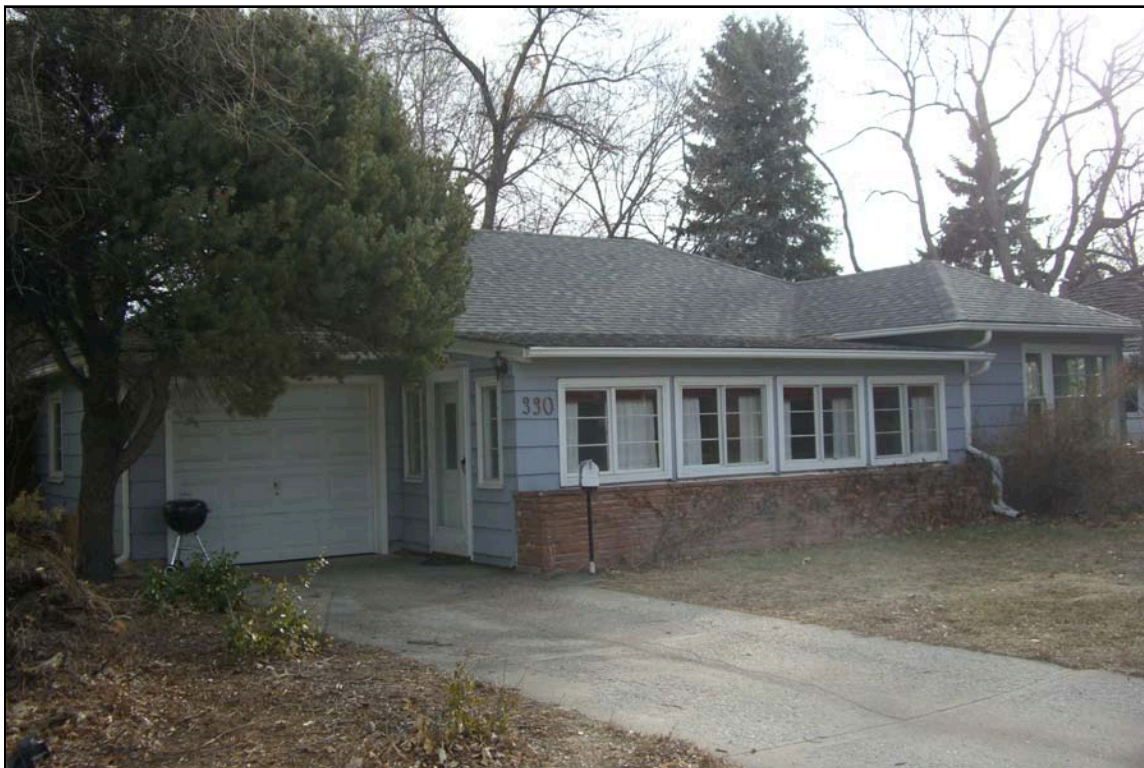
20. Special features: **Garage/Attached Garage**
Fence
21. General architectural description:
Oriented to the west, this early Ranch type home rests on a concrete foundation. The rectangular-shaped house features blue-gray asbestos siding, a stone covering over the foundation and bottom half of the facade, and a hipped asphalt shingle roof. There is a non-original enclosed porch with a nearly flat roof centered on the front of the home. This portion of the home features four six-lite windows with white trim. The primary entry, a wooden door painted white with a large rectangular window and glass storm door, faces north. Three-lite, vertically oriented windows with white trim appear on either side of this door. The northern corner of the façade features a one-car attached garage. At the opposite (southern) corner there is a front-gabled roof bay with a large multi-lite window with white trim. At least two windows, one a near-corner window similar to the one on the façade and the other (perhaps fixed pane) closer to the rear of the home, are visible on the southern elevation. There is a single three-lite, vertically oriented window similar to those which are located near the primary entry located on the northern elevation/ in the wall of the garage. The east (rear) elevation was not visible from the public right of way. According to Larimer County Assessor

Records, the home has three bedrooms and one bathroom. Character-defining features of this property type evident at 330 Circle Drive include: horizontal orientation, hipped roof, and a single-car attached garage.

According to Larimer County assessor records, this building was constructed in 1948. An analysis of the style, building materials, and other historical records corroborate a 1948 date of construction, although there appear to have been a number of alterations. From field observation, it seems likely the home originally possessed an L-shaped footprint with an integrated stone planter to form an open porch; other houses along Circle Drive possess such planters. At an undetermined date (no building permits or historic images have been located) it looks like an enclosed front porch, incorporating the planter and featuring a side entry, was created.
