## COLORADO CULTURAL RESOURCE SURVEY

**Architectural Inventory Form**

Fort Collins Post-World War II Survey

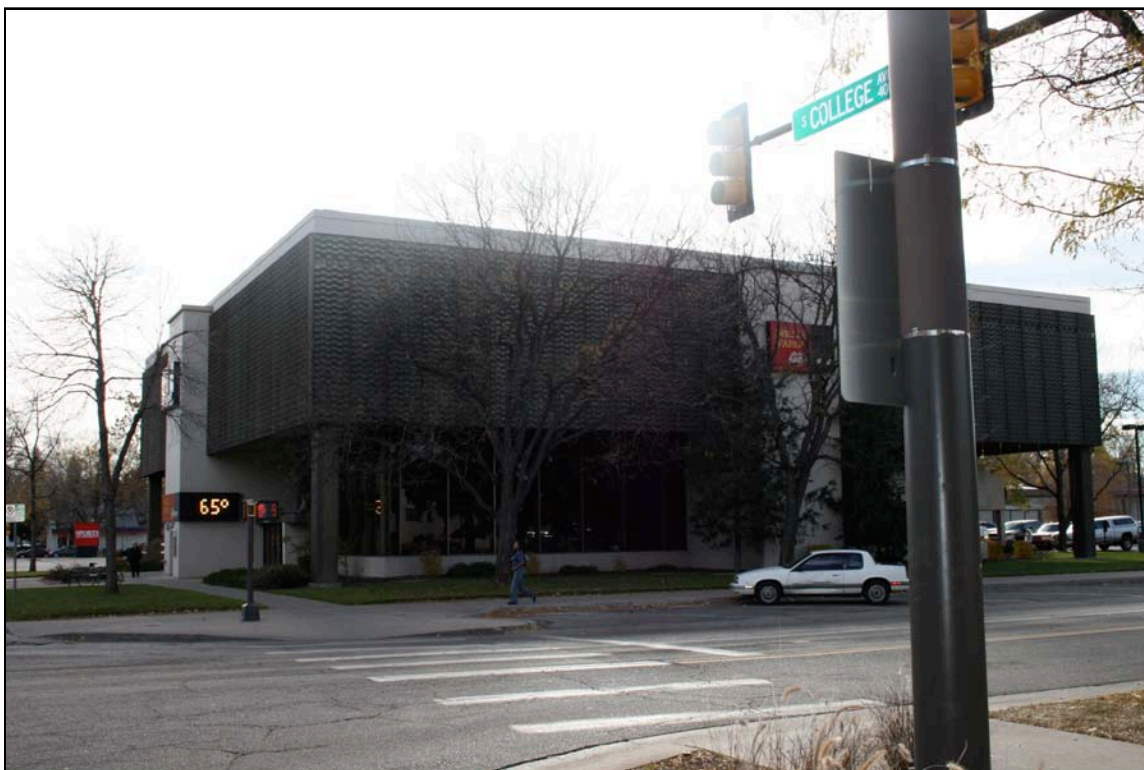
**Oriented to the east, this Modern Movement bank building rests on a concrete foundation. The square-shaped building features concrete siding, tinted window walls, and a bronze decorative sunscreen. This screen is composed of mostly rectangles with a cornice-like line of circles near the top of this distinctive design element. The three-story building also has a flat roof. Four large concrete towers provide the main support for the building and the individual floors are suspended from these towers with a system of cables running through the concrete. The third floor is cantilevered out beyond the lower floors. There are two glass double-door entries on the façade, one on each side of the central tower. These entry vestibules feature tinted glass and are adjacent to the window walls along the façade. The towers around the building feature illuminated signage; the front tower has a centered metal door. There is a time and temperature clock near the southern primary entrance. It is affixed to the south-facing portion of the central concrete tower. Square supports, grooved concrete or metal, at the front corners both make the body of the building appear recessed and give this bank an appearance of floating. The north and south elevations show a continuation of the tinted window walls and the bronze screen; each features a central concrete tower. There is a secondary entry and ATM lobby, of either concrete or stucco, which**

projects from the west (rear) elevation and is closest to the adjacent parking lot behind the building. This part of the building appears to be an addition or alteration from the original design. Character-defining features of the Modern Movement style evident at 401 South College Avenue include: flat roof, integrated window walls, cantilevered design, and distinctive bronze sunscreen.

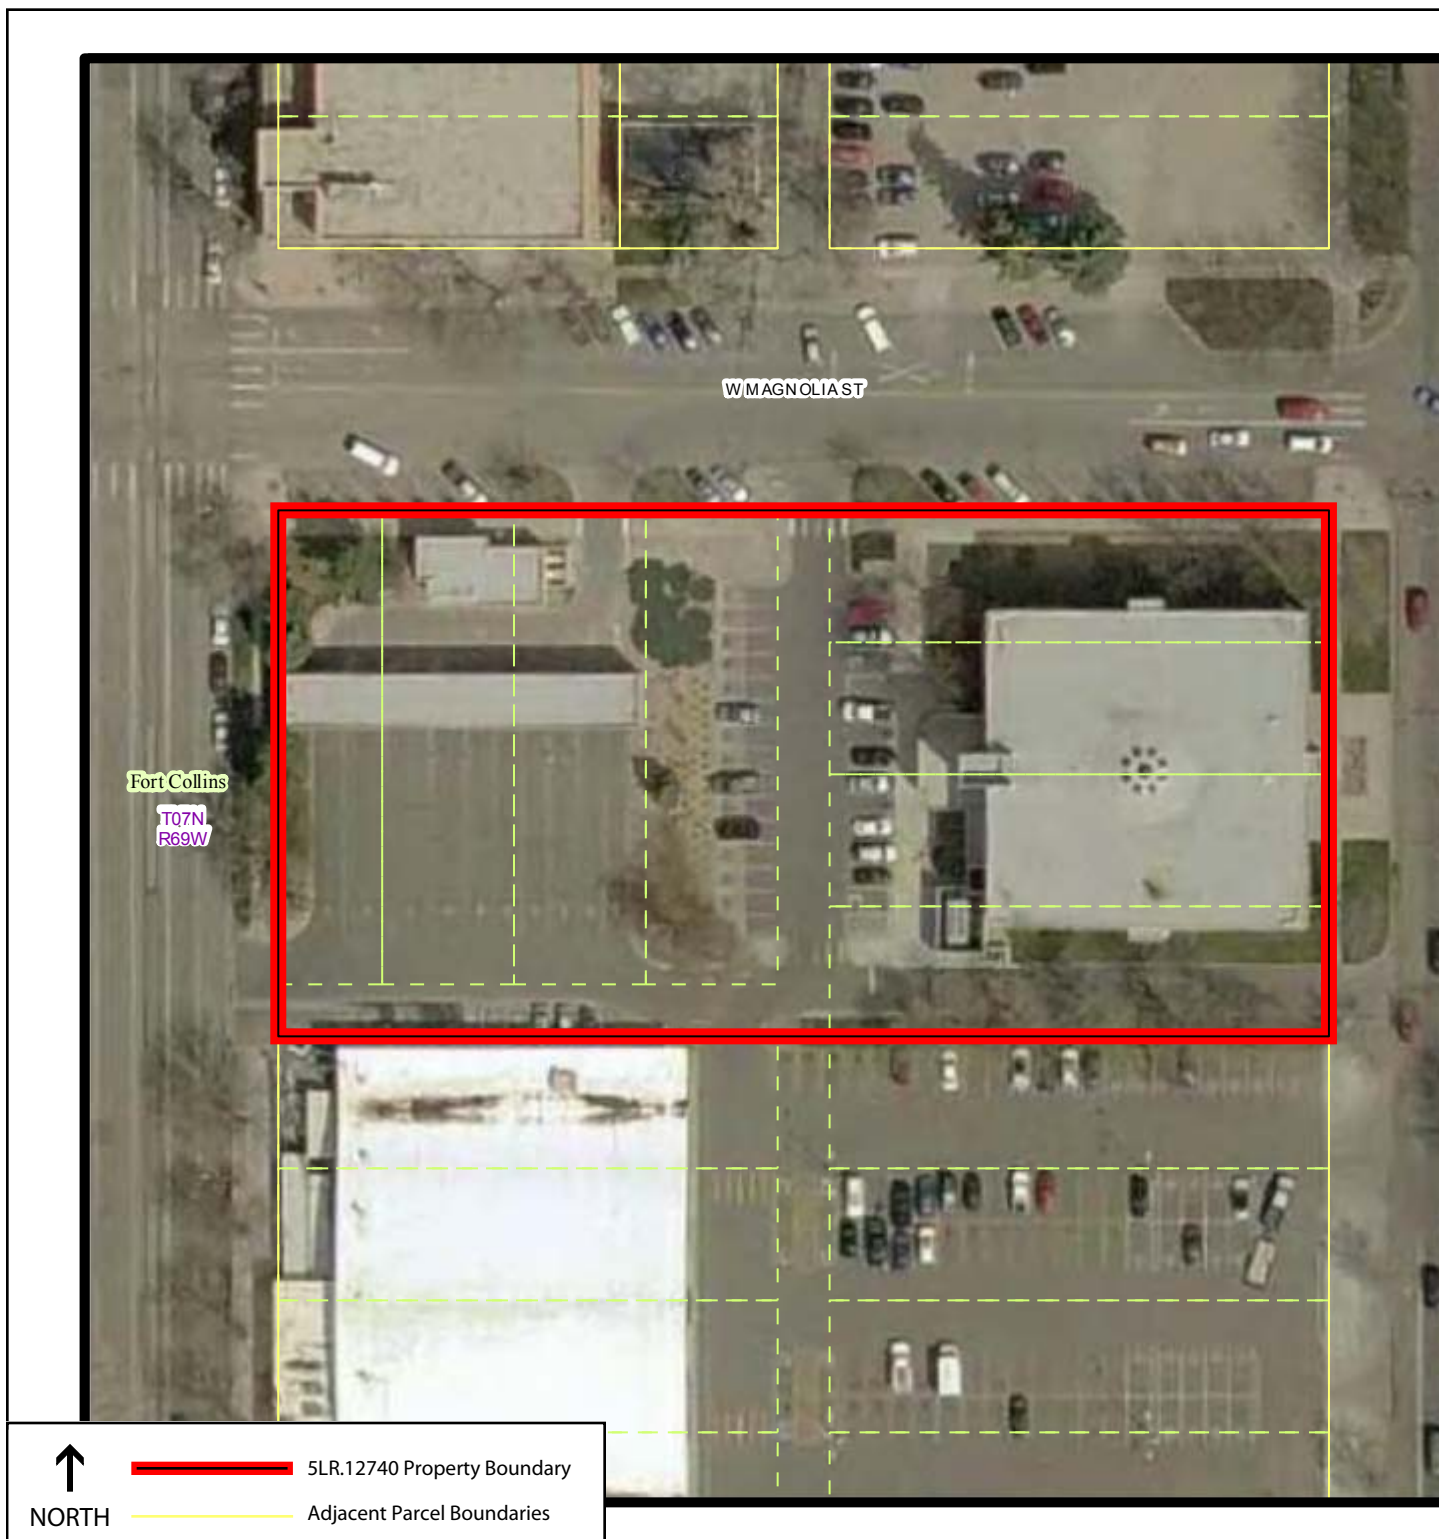
## SKETCH MAP

This building is located on a wide rectangular lot at the corner of South College Avenue and East Magnolia Street. The bank is located on the front of the parcel, with a large parking lot and the drive-thru building located near the rear of the site. A grass lawn surrounds the bank and there are small bushes along the foundation on both the north and south sides; there is also a small tree island in the rear parking lot. The elevation of the site is 4997 feet above mean sea level.

Located at the northwest corner of the lot, there is a rectangular stucco, flat-roofed drive-thru building. It allows for service to at least eight cars. According to Larimer County assessor records, this building was constructed in 1986.
