COLORADO CULTURAL RESOURCE SURVEY

Architectural Inventory Form

1. Resource number: 5LR.10494
2. Temporary resource number: SHF-12
3. County: Larimer
4. City: Fort Collins
5. Historic building name: Vern's Tile & Linoleum
6. Current building name: Weingang Building
7. Building address: 1618 South College Avenue
8. Owner name: Irma L. Weingang
Owner organization:
Owner address: 3398 S Broadway
Englewood, CO 80113

Fort Collins Post-World War II Survey

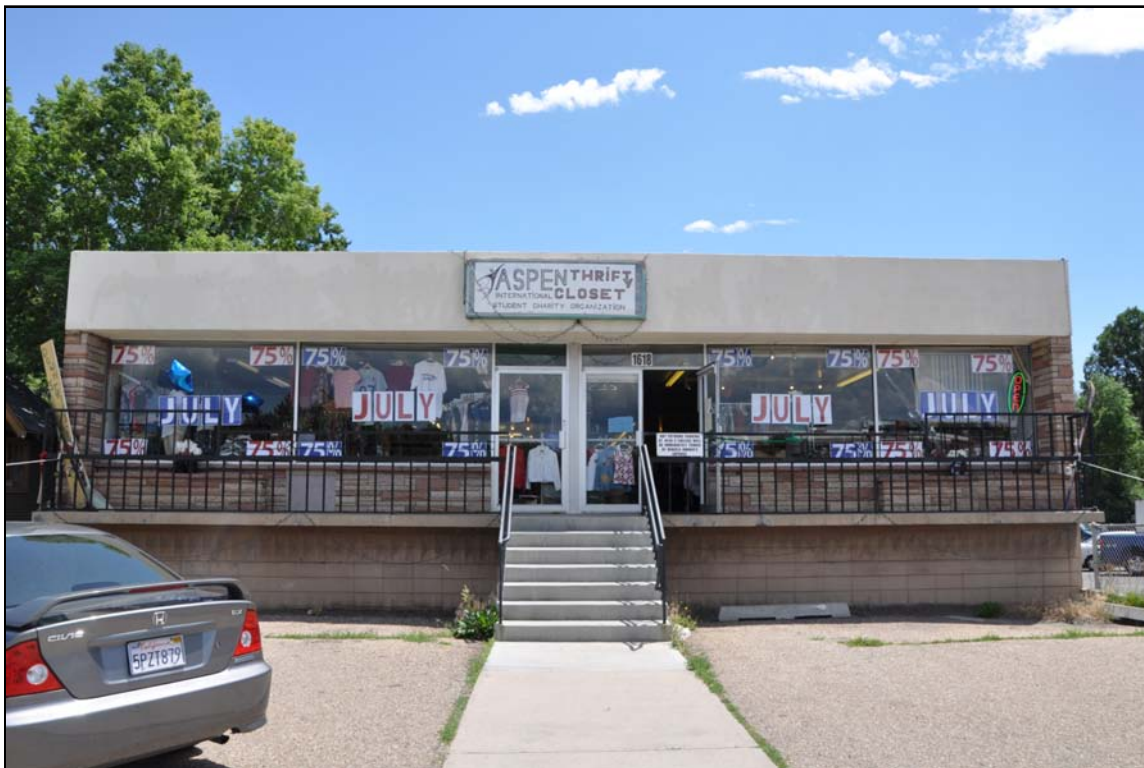
19. Primary external roof material: **Synthetic Roof**
 Other roof materials:
20. Special features: **Garage/Attached Garage**
21. General architectural description:
Oriented to the west, the Modern Movements commercial building rests on a concrete foundation. The rectangular-shaped building is constructed of concrete block and features both stone and decorative concrete detailing. The flat roof appears to slope slightly toward the back of the building. The store unit is slightly elevated with a series of concrete steps leading from the front parking area to the primary entry. Black iron railings surround these stairs and similar iron work runs across the façade, giving the storefront a porch-like appearance. Centered on the façade there are three primary entry doors, all glass and each with its own transom. Four large plate glass display windows are evenly spaced across the façade. At the top of the façade there is a simple band of stucco and there is a small illuminated sign within this band and centered above the front door. The south and north elevations of the building feature solid walls decorated with what appear to be large precast concrete panels. The decorative pattern is comprised of a number of tightly spaced diamonds and the surface is either painted or tinted a pinkish-brown. There are also diagonal parking spaces along the southern elevation. The east (rear) elevation has a rectangular, vertically oriented casement window with dark brown painted trim on the upper portion of the southeast corner of the building. Immediately below this window there is a

secondary entry painted the same color as the concrete block wall. There are two more rear doors; these appear to be metal and are painted dark brown. These two doors are reached via an elevated metal platform which resembles a fire escape. There are four windows near the pair of doors, two between the doors and the other two beneath the platform. All of these windows appear to be divided light fixed pane openings. At the northeast corner of the façade there is a single attached garage with a metal door. Character-defining features of this Modern Movements commercial building include its large display windows, flat roof, integrated stone details, and adjacent parking lot.

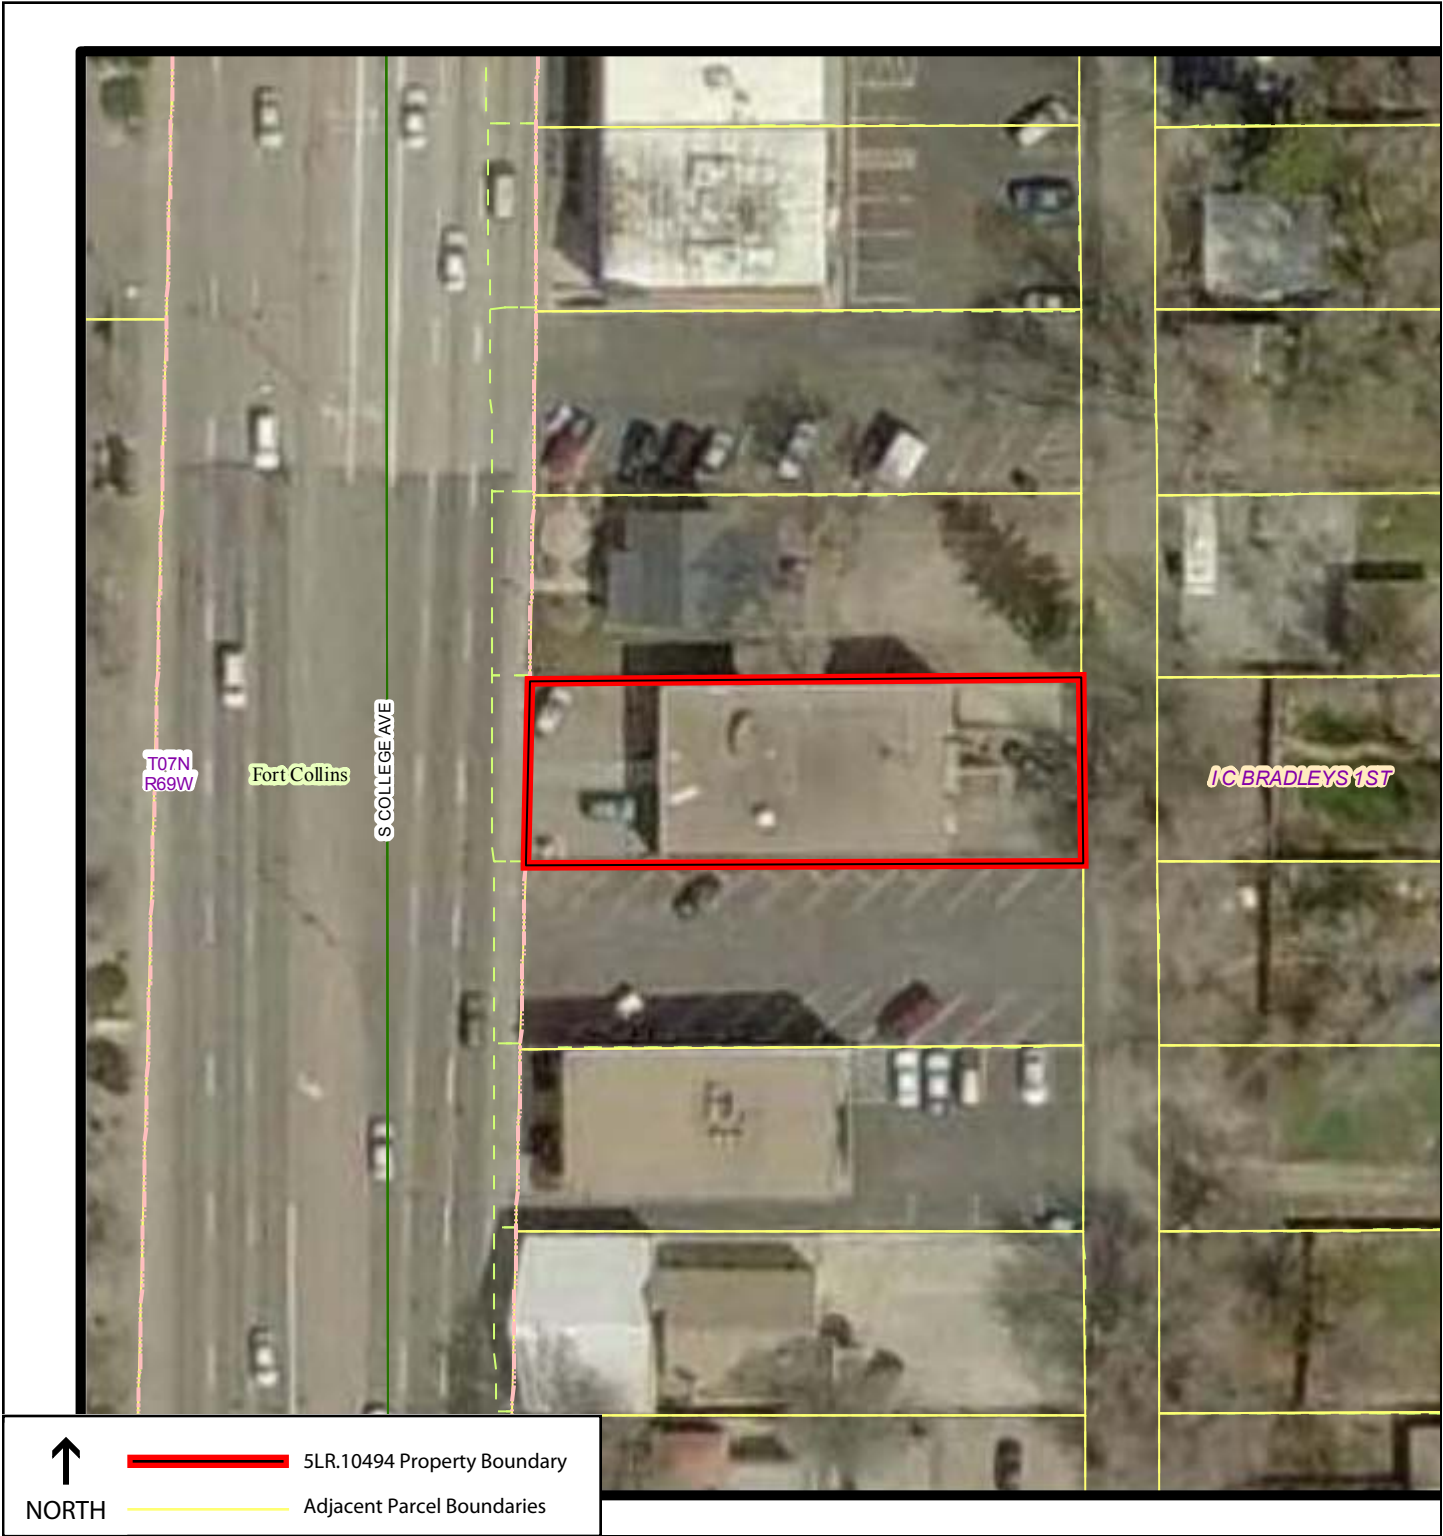
SKETCH MAP

This building is located on a compact rectangular lot along S. College Avenue. Visible vegetation seems to belong to the adjacent property to the north. There are diagonal parking places available both in the front of the building and along the south side. The property is sited on a lot with an elevation of 4993 feet above mean sea level.
