COLORADO CULTURAL RESOURCE SURVEY

Architectural Inventory Form

Fort Collins Post-World War II Survey

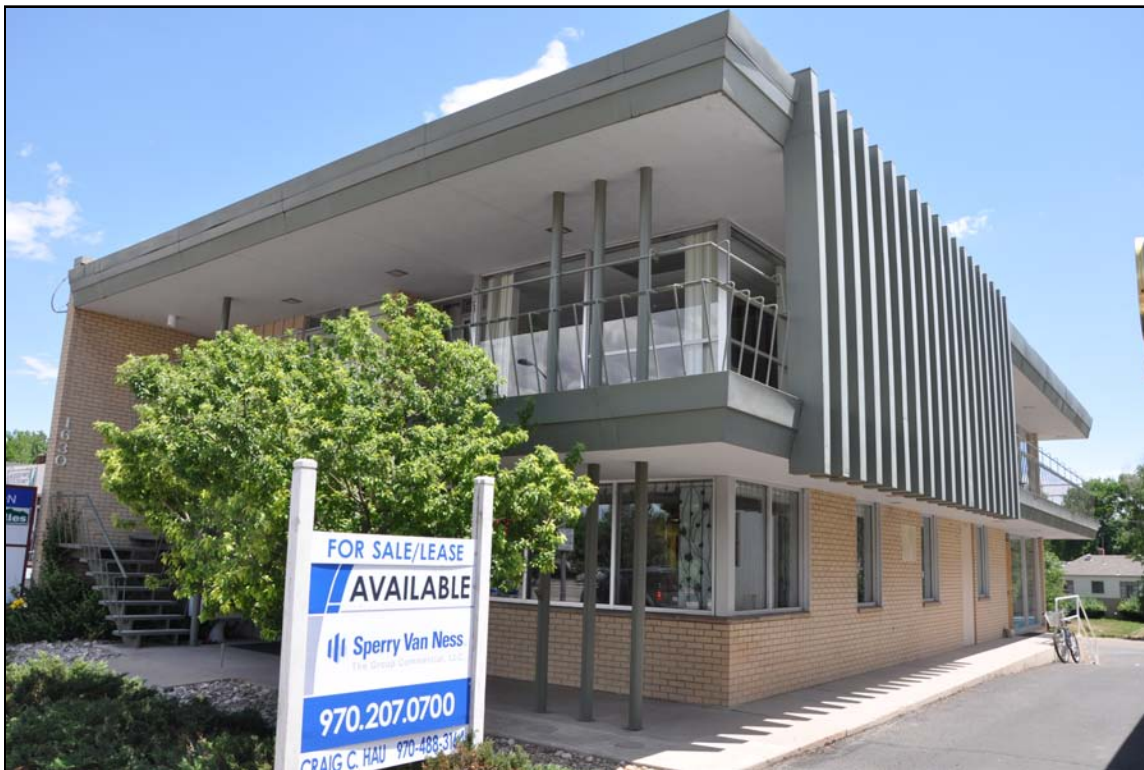
20. Special features: **Balcony**
21. General architectural description:
Oriented to the west, this Modern Movements two-story office building rests on a concrete foundation. The rectangular-shaped building features siding of blonde brick. It has a flat roof with a wide metal cornice painted gray and overhanging eaves. Despite the fact Larimer County assessor records indicate the building contains four units, there are five glass entry doors visible on the façade. Three of these doors are located on the first story. The door labeled "B1" has a sidelight. The other two first floor doors, labeled "2B" and "A2," have fixed-pane transoms. There is a corner window, facing west and south, with a brick half-wall below the window on the southwest portion of the facade. At the opposite corner of the façade, there is a wooden staircase with metal supports. All parts of the staircase are painted the same shade of gray as the cornice and the staircase offers access to upper story units. A brick wall shelters this staircase from the elements on its north side. Behind these stairs there is a panel of vertical siding painted light brown; this siding extends to the second story of the building. There is a rectangular, vertically oriented fixed-pane window at the northwest corner of the façade. On the second story there are two glass entry doors. One of these entrances is nearly centered on the façade, slightly recessed, and features both a sidelight and a fixed-pane transom. The large corner window matches the

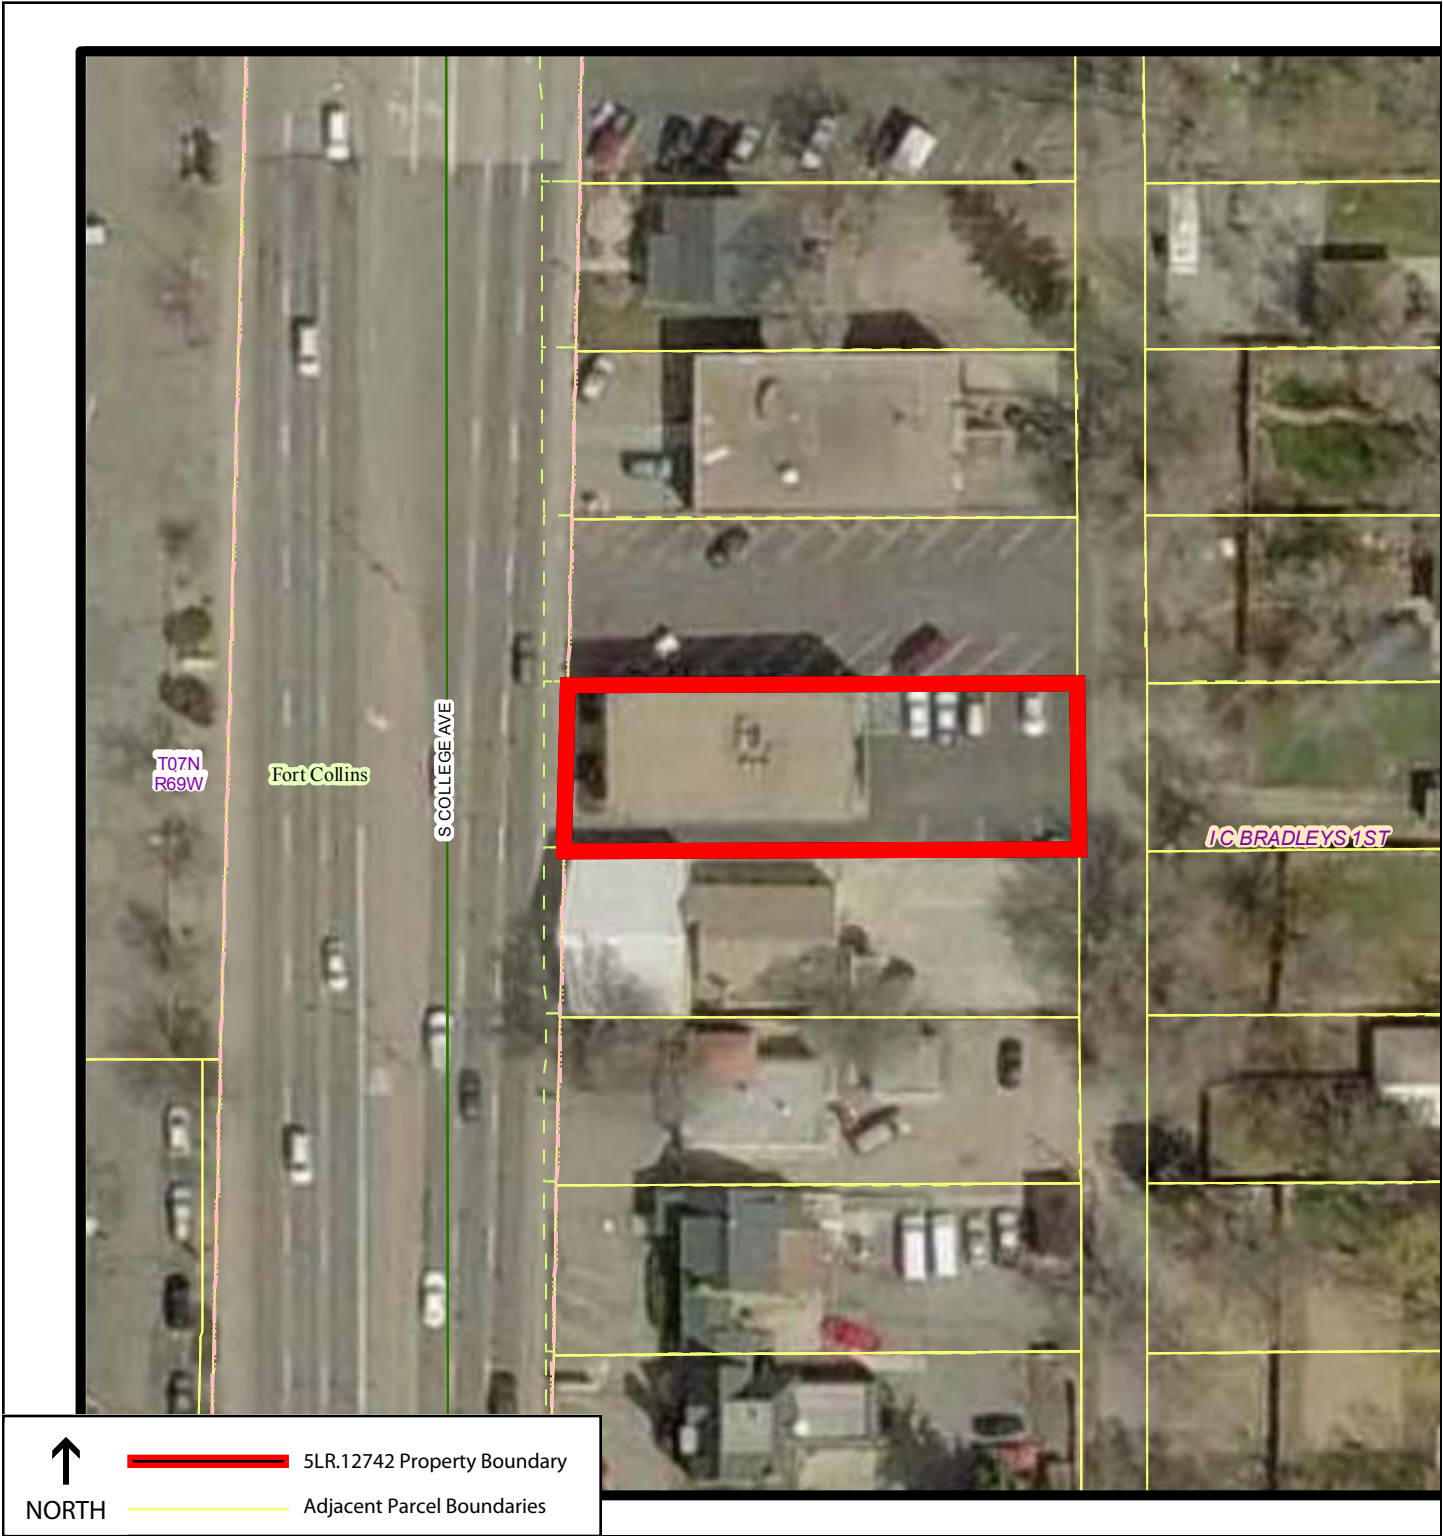
SKETCH MAP

This building is located on a narrow rectangular lot along South College Avenue. It is covered in concrete or asphalt. There are a total of twenty-five diagonal parking spaces on the north and south sides of the building. This property is 4993 feet above mean sea level.
