COLORADO CULTURAL RESOURCE SURVEY

Architectural Inventory Form

Date	Initials
	Determined Eligible- NR
	Determined Not Eligible- NR
	Determined Eligible- SR
	Determined Not Eligible- SR
	Need Data
	Contributes to eligible NR District

1.	Resource number:	5LR.12750				Parcel number:	97241-10-081
2.	Temporary resource number:	SHF-19					
3.	County:	Larimer					
4.	City:	Fort Collins					
5.	Historic building name:	Robert and Margaret Zimmerman Residence					
6.	Current building name:	Jerry and Susan Tho	mpson House				
7.	Building address:	712 Dartmouth Trail					
8.	Owner name:	Jerry J. and Susan H.	Thompson				
	Owner organization:						
	Owner address:	712 Dartmouth Trail					
		Fort Collins, CO 805	25				
44.	 National Register eligibility field assessment: 		Individually eligible	🛛 Not eligible	Needs data	Previously listed	
	State Register eligibility field assessment:		Individually eligible	🛛 Not eligible	Needs data	Previously listed

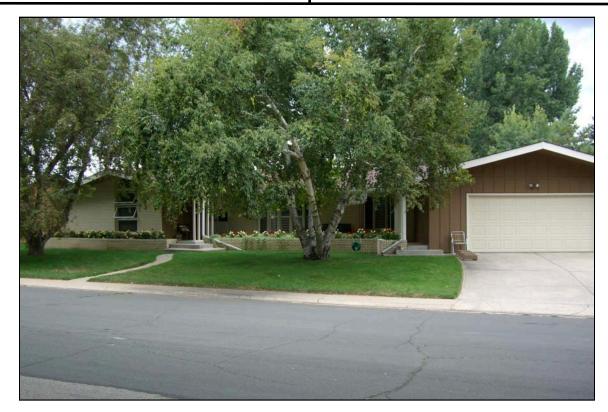
Oriented to the south, this spacious later Ranch type home rests on a concrete foundation. The U-shaped house features blonde, nearly white Roman brick siding. The attached two-car garage and one of the walls of the porch are sided in vertical siding painted dark tan. The home has a cross-gabled roof formed by a side gabled form with two projecting front gable bays located at either corner of the façade. The roof has overhanging eaves and is covered in asphalt shingles. The southwest projection features four large rectangular casement windows centered on this portion of the façade. There is also an integrated planter constructed on the same light Roman brick as the rest of the house. In the center portion of the façade a long recessed porch appears. Another long integrated brick planter marks the front edge of the porch. There are two sets of concrete entry steps, located at either end, to the front porch. Three wooden or metal posts, painted cream to match the brickwork, form an open entryway to the porch from each set of steps. The primary entry, difficult to discern from the public right of way, is located at the southwest

end of the recessed porch and features double doors (possibly stained wood) with what appear to be replacement vinyl or metal storm doors. There are two large picture windows, with prominent internal blinds, on the façade wall within the recessed porch. The southeast projection contains the two-car garage; it appears to have a replacement door. The west elevation, sided in vertical siding painted dark tan, contains four fixed pane rectangular windows. The overhanging eaves of the side gabled portion of the roof, a wooden privacy fence painted the same color as the home's siding, and the portion of the integrated planter which is located across the gable projection all are visible from this side of the house. The wooden fence mostly obscures views of the east elevation; however, what appears to be an opening for a covered back patio is discernible. The north (rear) elevation is not visible from the public right of way. According to Larimer County assessor records, the home has four bedrooms and three bathrooms. Character-defining features of this property type evident at 712 Dartmouth Trail: Roman brick siding, streamlined decorative roof supports, recessed entry porch, and integrated planters. The elongated horizontal orientation of the home, impressive doubledoor primary entry, and the prominent two-car attached garage are particularly associated with Ranch homes built in the later 1960s.
