COLORADO CULTURAL RESOURCE SURVEY

Architectural Inventory Form

1. Resource number: 5LR.12751
2. Temporary resource number: SHF-20
3. County: Larimer
4. City: Fort Collins
5. Historic building name: Bridgette and Stephen Greene Residence
6. Current building name: Ross and Olive Hansen House
7. Building address: 631 Del Norte Place
8. Owner name: Stephen S. and Bridgette M. Greene
Owner organization:
Owner address: 631 Del Norte Place
Fort Collins, CO 80521

Fort Collins Post-World War II Survey

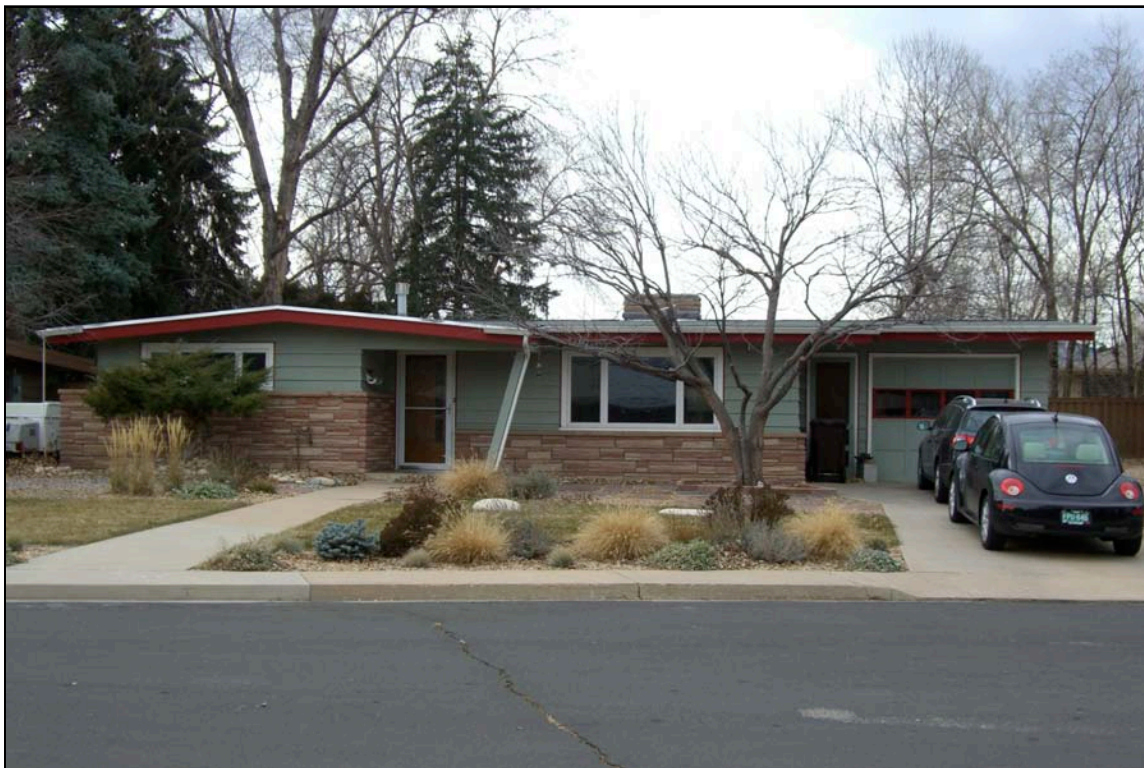
21. General architectural description:
Oriented to the east, this Ranch type home rests on a concrete foundation. The rectangular-shaped house features wide horizontal siding painted sage green. There is also stone cladding from the foundation to just below the windows on the façade. The home has a shallow (nearly flat) front gabled roof with overhanging eaves and a prominent cornice painted brick red. The roof is covered in built-up rock. The primary entry, a stained wooden door with three rectangular windows arranged vertically near the door's edge, is located within the recessed porch. There is also a two-lite storm door. The porch support, a basic (likely wooden) beam painted sage green, is set on the diagonal. Southeast of the entry door, located in the gable projection, is a tripartite fixed pane rectangular window partially obscured by a juniper bush. A large tripartite picture window dominates the façade north of the front door. There is a single-car attached garage located at the northeast corner of the façade. The garage

door is painted sage green with brick red trim around the row of square windows in this door. A secondary entry, difficult to see due to the shadow cast by the overhanging eaves, is located between the garage and the rest of the house. There is a stone chimney along the home's ridgeline. On the southern side of the house, three windows are visible. One of these is a large opening filled in with multiple glass blocks. There is at least one tripartite rectangular window on the northern elevation of the home. The west (rear) elevation was not visible from the public right of way. According to Larimer County assessor records, the home has two bedrooms and two bathrooms. Character-defining features of this property type evident at 631 Del Norte Place include: horizontal orientation, picture window, and prominent chimney.
