COLORADO CULTURAL RESOURCE SURVEY

Architectural Inventory Form

- 1. Resource number: **5BL.10470** Parcel number: **158321003009**
- 2. Temporary resource number:
- 3. County: **Boulder**
- 4. City: **Eldora**
- 5. Historic building name: **Phebus Cabin**
- 6. Current building name: **"The Pumphouse" Cabin**
- 7. Building address: **225 Eldorado Avenue**
- 8. Owner name: **John C. Heiney Sr.**
- Owner organization:
- Owner address: **10726 Kipling Way  
Broomfield, CO 80021-7316**

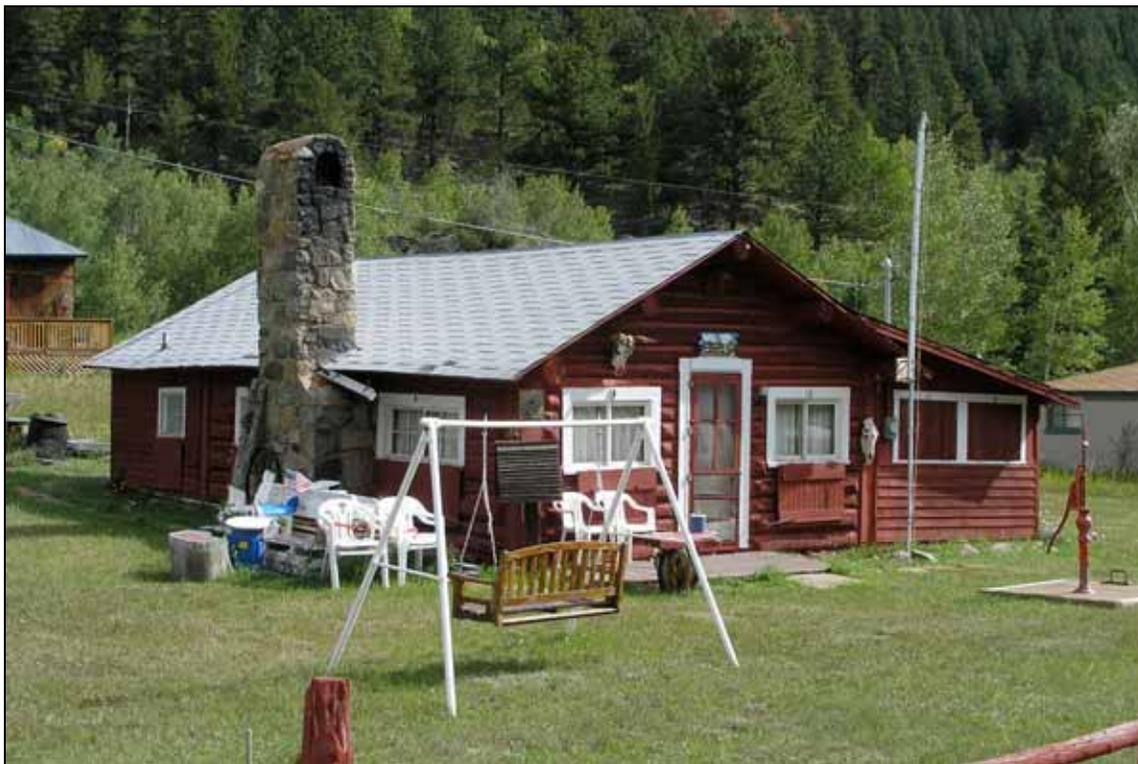
**Oriented to the south, this cabin rests on a dry-laid stone foundation. The building consists of a front-gabled log box, with a shed-roof addition spanning the entire east elevation and a gabled addition to the rear (north) elevation; the entire building is painted red. The log portion features boxed, hog-trough corners. Horizontal wood siding, with narrow cornerboards, clads the exterior walls of the additions. Windows are generally 1-beside-1-light or 4-beside-4-light, sliding sash, with white-painted wood frames and surrounds. Secondary elevations also host 4-light hopper, awning, or casement windows. Most windows have beadboard and plywood shutters, hinged at the window sills. The principal doorway opens in the center of the original log building's front (south) elevation. It hosts a white-painted, 4-panel wood door, opening behind a wood-frame screen door. A similar door opens west of center in the rear (north) elevation. Gray, interlocking asphalt shingles cover the front-gabled roof. The rafter ends and log perlin ends are exposed. A large, random-coursed granite hearth and chimney are engaged to the west elevation. The chimney has a round-arch cap.**
