COLORADO CULTURAL RESOURCE SURVEY

Architectural Inventory Form

- 1. Resource number: **5BL.10471** Parcel number: **158321004003**
- 2. Temporary resource number:
- 3. County: **Boulder**
- 4. City: **Eldora**
- 5. Historic building name: **Alex Ryan Cabins; William Gustafson Cabin; Martin Cabins**
- 6. Current building name: **Kladstrup Family Cabins**
- 7. Building address: **305 Eldorado Avenue**
- 8. Owner name:
- Owner organization: **Kladstrup Family Limited Partnership**
- Owner address: **5 Timbercrest Ln
Bella Vista, AR 72715**

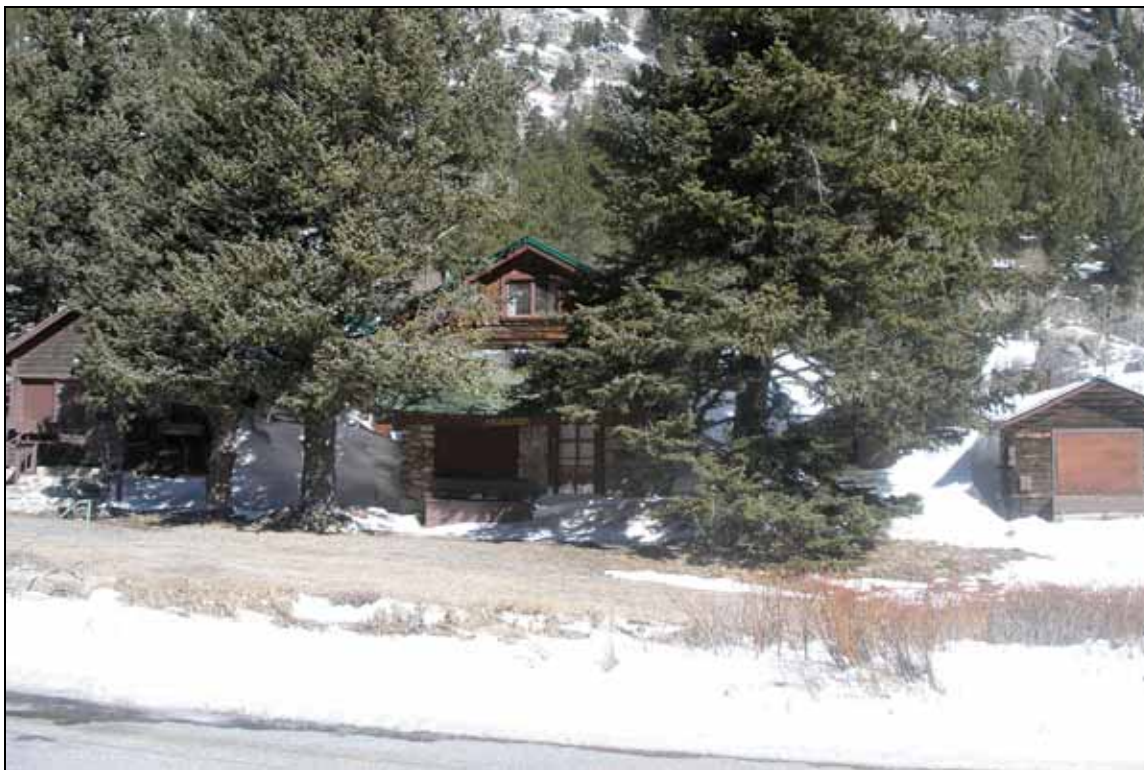
19. Primary external roof material: **Asphalt Roof/Composition Roof**
Other roof materials:
20. Special features: **Chimney**
Roof Treatment/Dormer
21. General architectural description:
CABIN NO. 3 (1899)
Oriented to the south, this cabin rests on a random-coursed granite foundation. The exterior walls consist of unpeeled logs, with spike-butt corners. Random-coursed granite covers the first story of the front (south) facade. Covering the gables is unpainted, vertical tongue-and-groove siding, with a scalloped bottom edge. The window dominating the western half of the asymmetrical facade has been boarded shut for the winter. Above it, in the gable, open a pair of single-light casement windows, with brown-painted wood frames. Shed-roof dormers protrude from the roof's east- and west-facing slopes. They host 1-beside-1-light, sliding-sash windows, with aluminum frames. The principal doorway opens east of center in the facade. It hosts a 4-light, glass-in-wood-frame door, protected behind a wood-frame storm door. It is sheltered beneath a pent roof that spans the entire facade. A green-painted, standing-seam metal roof covers the front-gabled main roof. Green asphalt shingles cover the pent roof. The rafter ends are exposed but capped by a fascia board. A pink sandstone hearth and chimney are engaged to the rear (north) elevation.
