COLORADO CULTURAL RESOURCE SURVEY

Architectural Inventory Form

- 1. Resource number: **5PE.6503** Parcel number: **525119004**
- 2. Temporary resource number:
- 3. County: **Pueblo**
- 4. City: **Pueblo**
- 5. Historic building name: **Louis W. Biele House**
- 6. Current building name: **Michael C. and Debra L. Polunci House**
- 7. Building address: **1930 North Grand Avenue**
- 8. Owner name: **Michael C. and Debra L. Polunci**
- Owner organization:
- Owner address: **1930 N Grand Ave  
Pueblo, CO 81003**

48. Report title: **Pueblo North Side Neighborhood Survey, Phase 2**

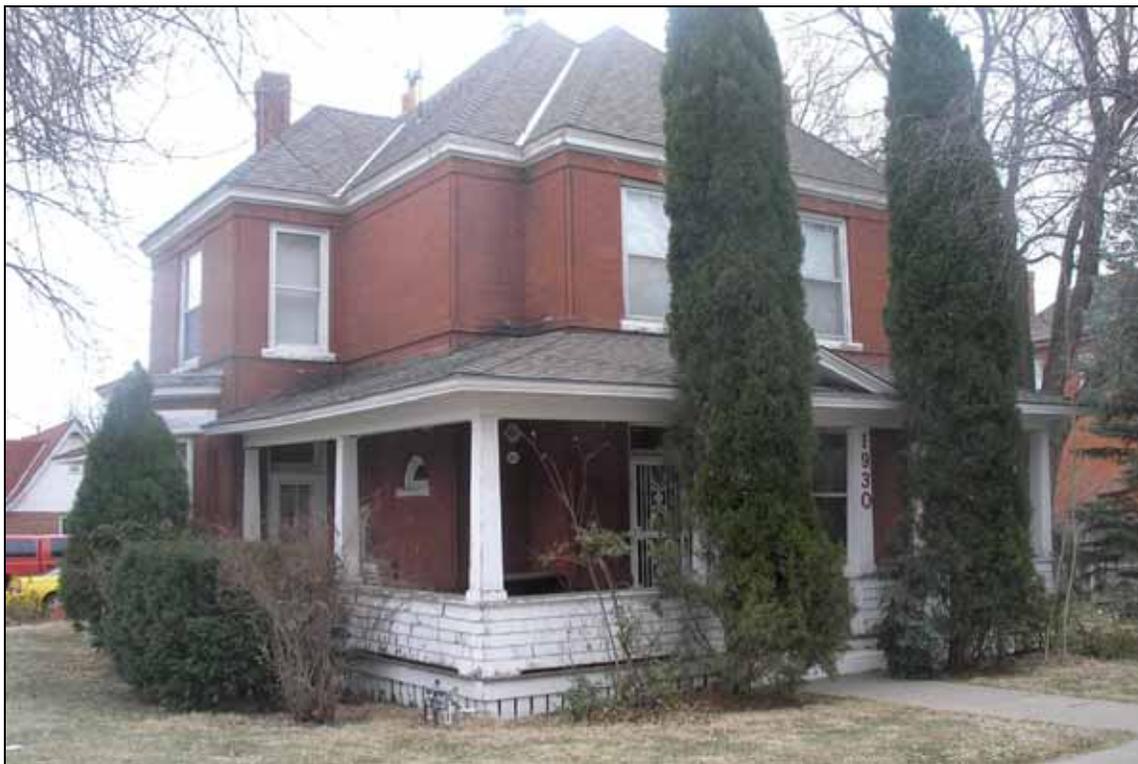
21. General architectural description:  
**Oriented to the west, this house rests on a foundation of regular-coursed, rock-faced, pink rhyolite ashlar. Basement windows open beneath brick, segmental arches, and a bulkhead provides access to the basement at the north end of the rear (east) elevation. A red, pressed-brick veneer, with tight, pink mortar, clads the exterior walls. The brickwork features protruding belt courses corresponding to the first- and second-story window sills and the second-story lintels, as well as round, molded brick corners. Dividing to the south elevation is a broad belt course, aligned to the first-story window lintels, featuring angle-set bricks. Covering a second-story sleeping porch at the east end of the south elevation's second story are red-painted, variegated wood shingles. Windows are generally 1-over-1-light, double-hung sash, with white-painted wood frames and aluminum-frame storm windows. They open above white-painted, rock-faced stone sills. The windows opening in the first story of the south elevation also have white-painted, rock-faced stone lintels. Windows in the rear elevation open beneath segmental arches. A small, round-arch window with leaded, beveled glass pierces the west end of the north elevation's first story. A single-story, three-sided canted bay protrudes from the center of a hipped-roof wing emerging near the center of the north elevation. It hosts narrow, 4-over-6-light windows flanking a central 6-over-9-light window. A hipped-roof porch spans the asymmetrical front (west) facade and wraps around the northwest corner of the house, terminating at the north wing. The porch features a wood floor; kneewalls covered in white-painted square-cut wood shingles; and white-painted, battered piers. A single concrete step approaches the center of the porch's west elevation, beneath a pediment. The step and pediment align to the principal doorway. Above the doorway is a transom. A secondary doorway in the west elevation of the north wing also opens onto the porch and has a transom. Another doorway and transom pierce the east end of the north elevation. It provides access to a small, hipped roof porch similar to the front porch. Concrete steps approach this porch from the east. This building lacks overhanging eaves, but the fascia hosts projecting cornices. Gray asphalt shingles cover the cross-hipped main roof. Tall, brick chimneys, with corbelled caps, protrude from the west end of the south elevation and east of the projecting wing on the north elevation.**
