COLORADO CULTURAL RESOURCE SURVEY

Architectural Inventory Form

1. Resource number: 5LR.7453
2. Temporary resource number: SHF-25
3. County: Larimer
4. City: Fort Collins
5. Historic building name: Roy and Iris Case Residence
6. Current building name: One Vantage Property House
7. Building address: 523 South Grant Avenue
8. Owner name: One Vantage Properties, LLC
Owner organization:
Owner address: 1319 Paragon Place
Fort Collins, CO 80525

Fort Collins Post-World War II Survey

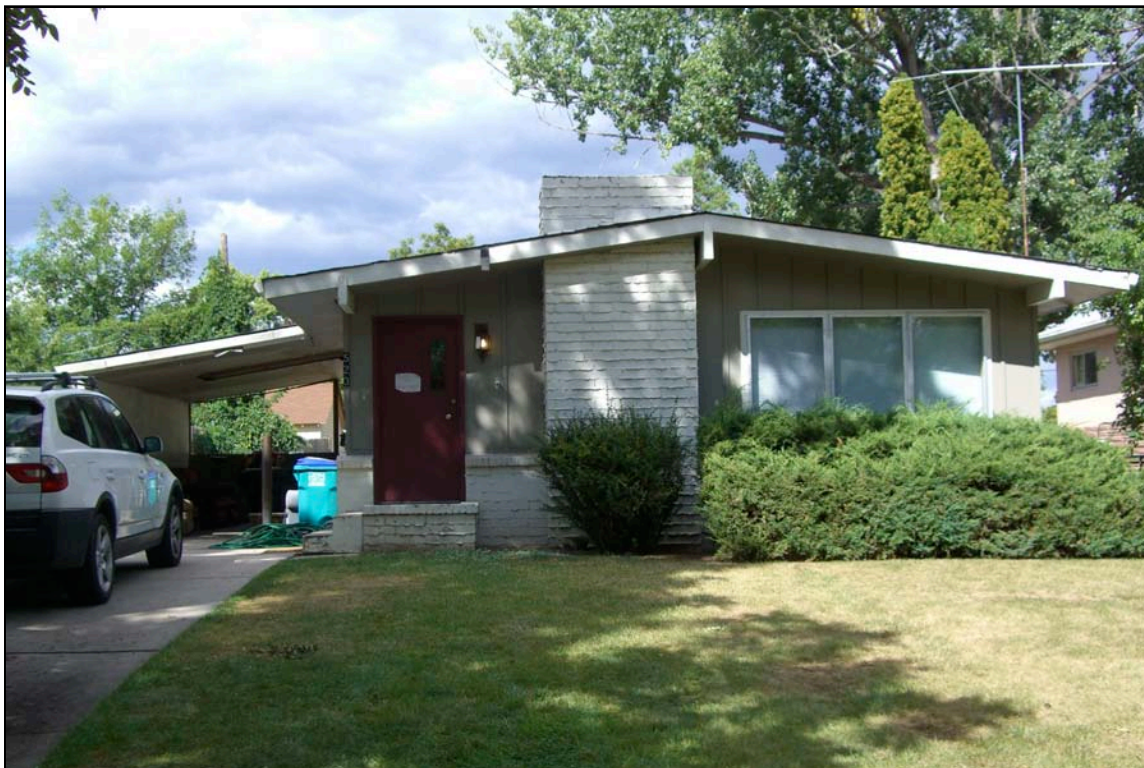
Oriented to the east, this Modern Movements style home with Contemporary influences rests on a concrete foundation. The rectangular-shaped house features wide vertical siding (or perhaps weatherboard) painted a very light brown. The home has a somewhat shallow front-gabled roof with exposed rafter ends and it is covered in asphalt shingles; it also features a large television antenna. There is a single-car carport on the southeast corner of the façade. The primary entry—a wooden door painted maroon with a short rectangular, vertically oriented, frosted window—is reached via two stairs adjacent to the driveway. The entry stoop features a facing of white brick with weeping mortar. A dominant chimney, also of white brick with weeping mortar, is centered on the façade. This same brick treatment appears across the façade between the foundation and about one-third of the way up the front of the house. There is a tripartite picture window near the northeast corner of the façade. The south elevation, partially inside the carport, features at least two rectangular casement windows and what appears to be either a large picture window or a sliding glass door. There is a secondary wooden entry door; it is either stained or painted maroon and features three square windows. There

is wide horizontal siding, painted the same color as the siding on the façade, from the foundation to approximately halfway up the surface of this wall. The northern elevation has similar siding and windows (at least two visible) the same as those evident on the south side of the home. The west (rear) elevation was not visible from the public right of way. According to Larimer County assessor records, the home has three bedrooms and two bathrooms. Character-defining features of this style, particularly the Contemporary influences, evident at 523 South Grant Avenue include: the shallow gable roof with overhanging eaves, single-car attached carport, and use of weeping mortar as a decorative feature.
