Architectural Inventory Form

1. Resource number: 5LR.12764
2. Temporary resource number: City-8
3. County: Larimer
4. City: Fort Collins
5. Historic building name: Church of Jesus Christ Latter Day Saints
6. Current building name: Church of Jesus Christ Latter Day Saints
7. Building address: 1400 Lynnwood Drive
8. Owner name: Church of Jesus Christ of the Latter Day Saints
Owner organization:
Owner address: 50 E. North Temple
Salt Lake City, UT 84150

Fort Collins Post-World War II Survey

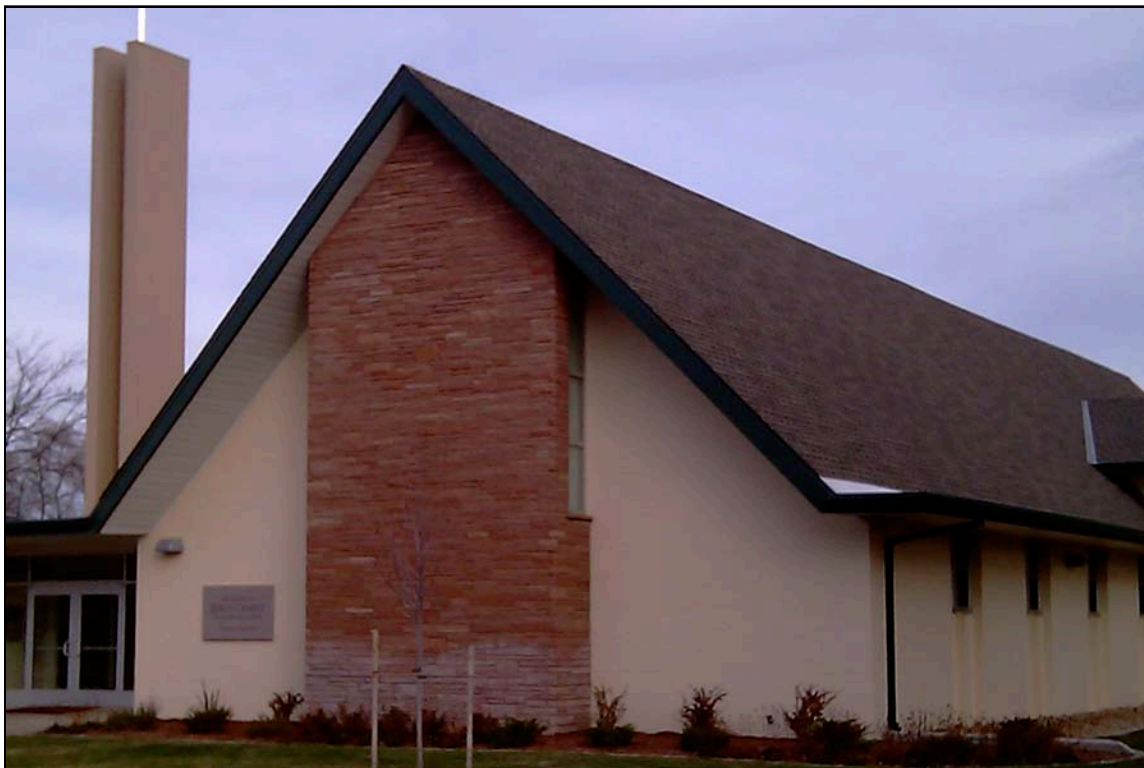
19. Primary external roof material: **Asphalt Roof/Composition Roof**
Other roof materials:
20. Special features: **None Applicable**
21. General architectural description:
Oriented to the west, this irregular-shaped stucco church rests on a concrete foundation. The Modern Movements building has a cross-gabled roof covered in asphalt shingles. The front-gabled sanctuary, located at the southwest corner of the façade, rises to two stories and features a wide center panel of stone running from the foundation to the gable peak. The narrow wooden cornice is painted forest green. The primary entry, a pair of glass doors with a fixed pane transom, is located within a stucco vestibule slightly recessed from the sanctuary façade. The vestibule has a flat roof. A tall tower lacking in ornamentation appears behind this vestibule. On the façade north of the entry there are five rectangular, vertically oriented, slider windows. At the northwest corner of the façade the building projects outward and the visible portion is solid stucco, except for a multi-lite window into the basement. The north elevation is comprised of a long, rectangular, two-story bay. There are six windows, similar to those on the façade, along the upper floor. A flat roof projection is centered on this side of the building and covers two stairways leading to basement doors. Partially obscured, these doors appear to be fixed pane with white, either wood or vinyl, trim. On either side of this projection, there is a multi-lite window, like the one on the northwest corner of the façade. The northeast corner has no openings except a

window into the basement. A recessed bay, faced in stucco at the top and stone veneer from the foundation to a half-height, connects this portion of the building to the side of the sanctuary. Visible from this side and facing north, there are a few multi-lite windows in the section of the church running alongside the sanctuary. Facing south there is a secondary entry, a single glass door with a white wood (or vinyl) trim. A number of fixed pane windows surround this rear door and this entry vestibule also has a flat roof. The rear of the sanctuary is located at the southeast corner of the building. Between the rear entry and the sanctuary there is another flat-roofed section of the building; this area has three rectangular, vertically oriented, slider windows with white trim. Character-defining features of this Modern Movements church include: the minimal decoration, flat roof sections with prominent cornice, and use of stone accents.

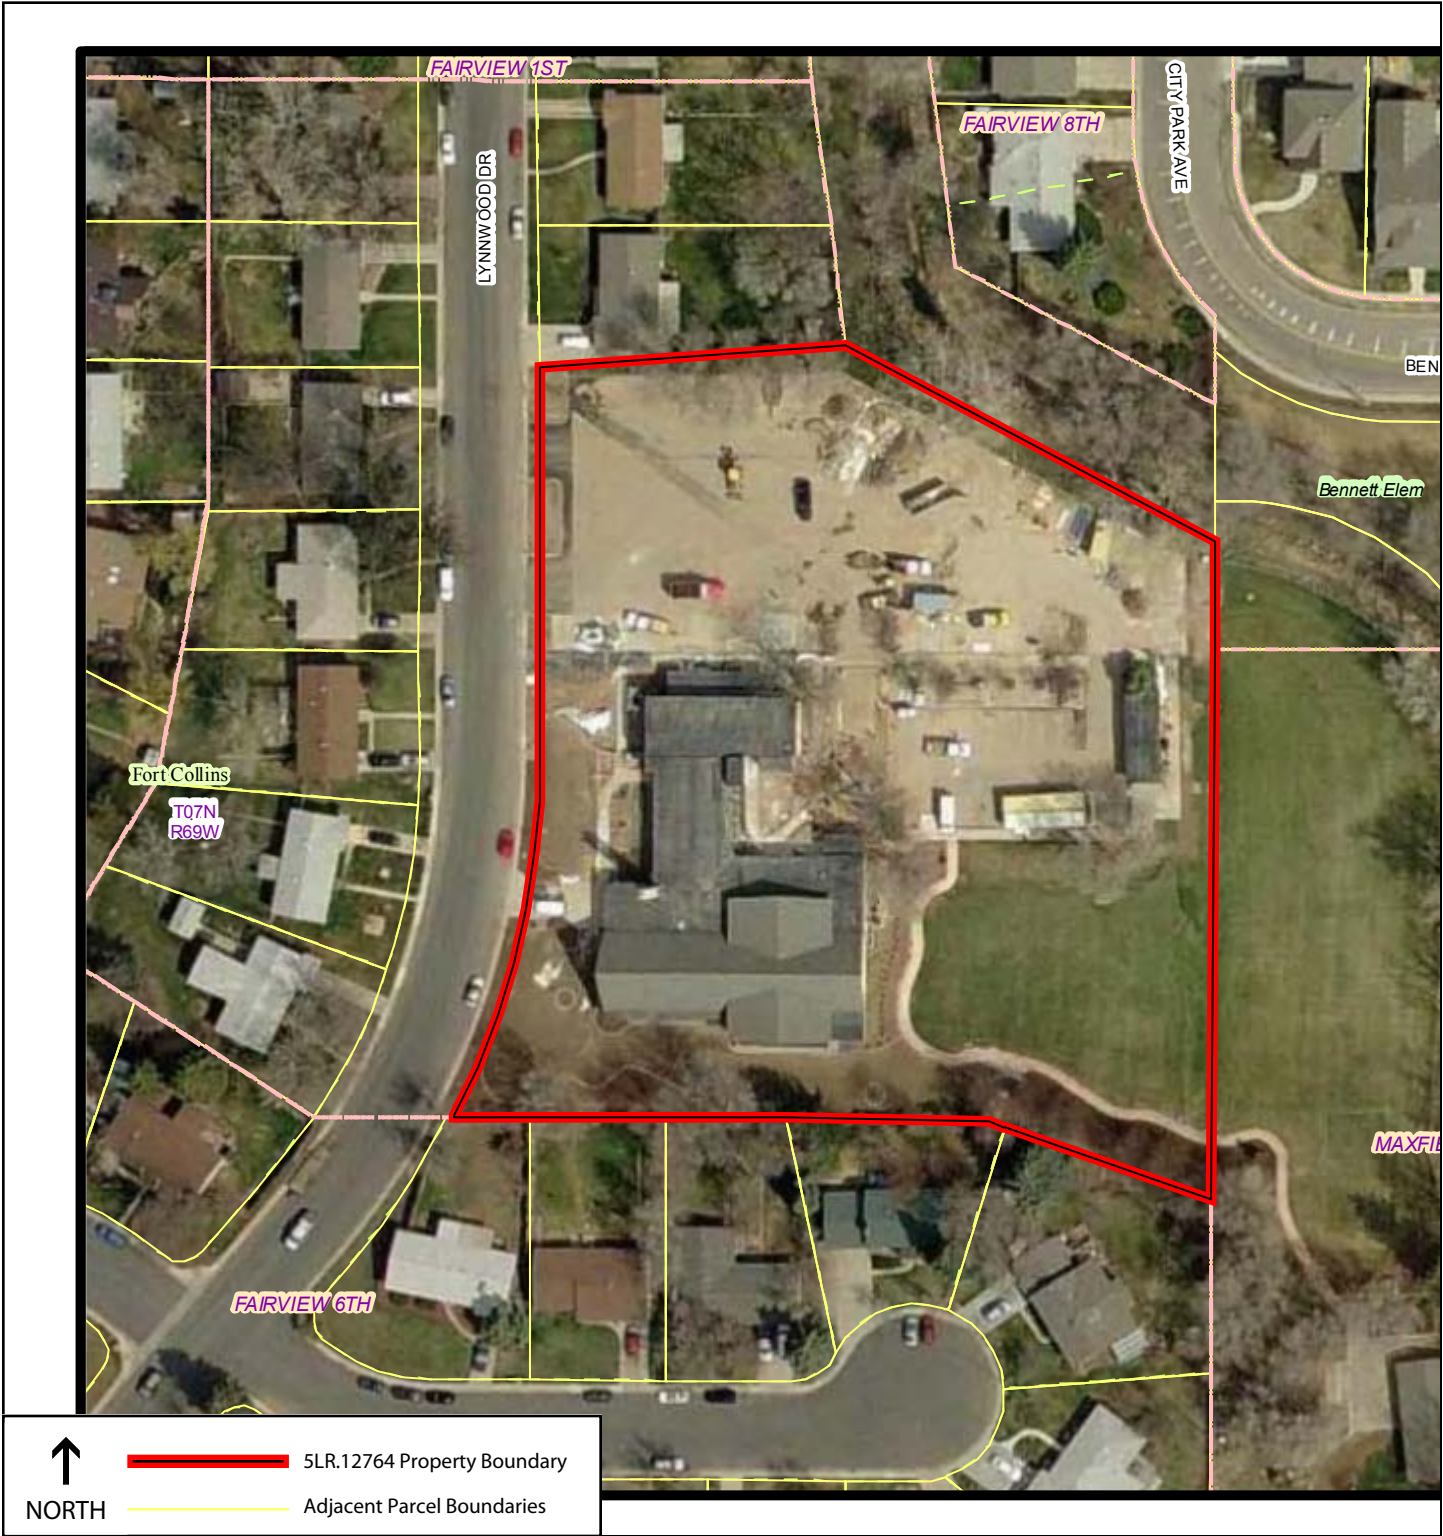
SKETCH MAP

This building is located on an extremely spacious, irregular shaped lot in a suburban neighborhood. There is an expansive paved parking lot on the north and east sides of the church. There is a grass lawn in front with low shrubs, young trees, and recently planted decorative grasses in beds and/or in planting areas along the foundation of the building. There is a mature deciduous tree near both the northeast corner and rear entry to the building. At the eastern edge of the site there is a large grass lawn used as a playing field for soccer or football. The elevation of the site is 5049 feet above mean sea level.
