COLORADO CULTURAL RESOURCE SURVEY

Architectural Inventory Form

- 1. Resource number: **5WL.5604** Parcel number: **080716308015**
- 2. Temporary resource number: **Not Applicable**
- 3. County: **Weld**
- 4. City: **Windsor**
- 5. Historic building name: **George Manweiler Agricultural Implements**
- 6. Current building name: **Martin & Martin Building**
- 7. Building address: **400 Main Street**
- 8. Owner name: **Martin & Martin Properties, LLC**
- Owner organization:
- Owner address: **4125 W Noble Ave #381
Visalia, CA 93277**

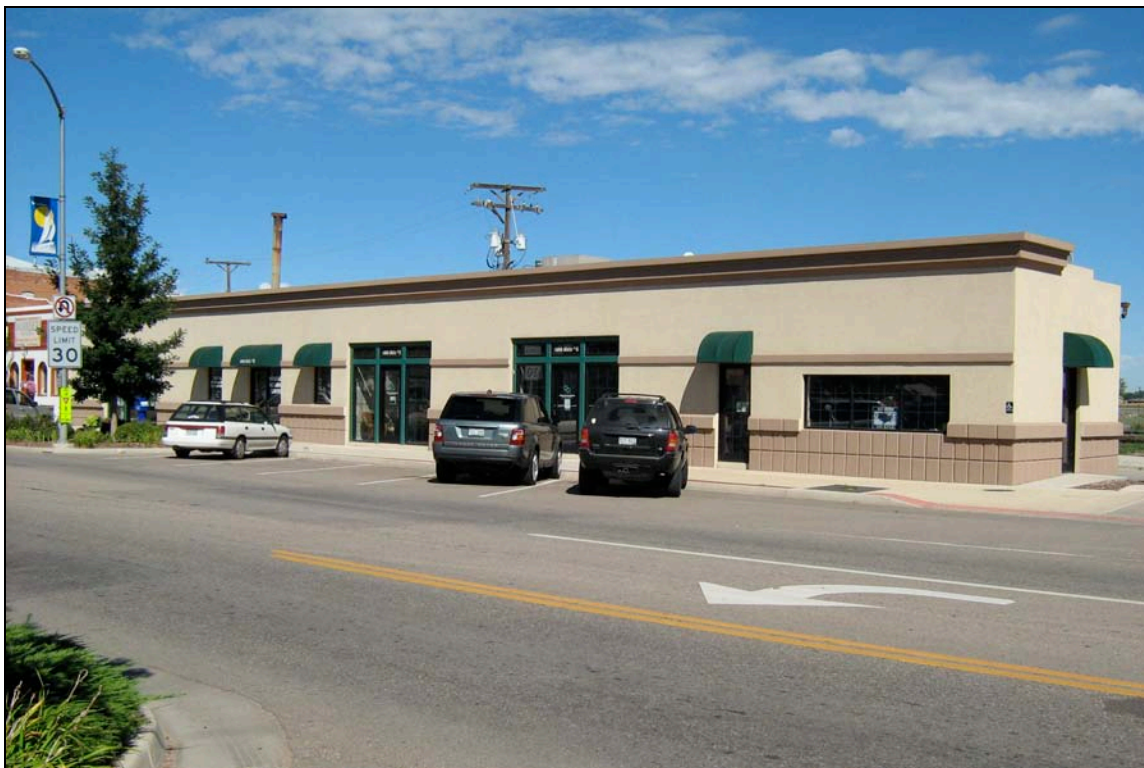
20. Special features: **None Applicable**
21. General architectural description:
Oriented to the south, this building rests on a concrete foundation. Stucco clads the exterior walls. The bottom 4 feet of the walls are tinted brown and consist of raised squares beneath a projecting watertable. The rest of the wall is tinted tan, with a brown projection corresponding to the tops of the doors. All windows have faux divided lights and are generally 9-light fixed frame, with dark-tinted glazing and brown, aluminum frames. Those in the rear elevation are 6-light. Doorways in the front (south) façade have brown, aluminum-frame doors, with 12-light glazing. Those corresponding to units A, B, and C have sidelights. Units A and C also have transoms. The easternmost doorway lacks both transoms and sidelights. Some doorways and windows have green canvas awnings above them. Rear elevation doorways host brown-painted, 6-panel metal doors. A rubber membrane covers the nearly flat roof. A brown stucco cornice protrudes from the parapet.

29. Construction history:
According to Weld County Tax Assessor records, this building was completed in 1934. An analysis of the building materials and historical records corroborates this date. As originally constructed, the building consisted of structural clay tiles or concrete blocks. A pair of large garage openings dominated the center of the front (south) façade and the west end of the same elevation. The building remained relatively unchanged from its construction to between 2002 and 2007, when owner Jonathan Sysum remodeled it into offices. While stucco conceals the original wall material, the fenestration remains the same, except that the large, glass-enclosed doorways replaced the garage doors.

43. Assessment of historic physical integrity related to significance:
Constructed in 1934 and significantly altered between 2002 and 2007, this commercial building exhibits a low level of physical integrity relative to the seven aspects of integrity as defined by the National Park Service and the Colorado Historical Society: location, setting, design, materials, workmanship, feeling, and association. The installation of new wall cladding and the replacement of all of the original windows and doors have substantially altered the original design, materials, workmanship, and feeling of this building. It does not retain sufficient physical integrity to convey its historical and architectural significance.
