COLORADO CULTURAL RESOURCE SURVEY

Architectural Inventory Form

- 1. Resource number: **5WL.5605** Parcel number: **080721203022**
- 2. Temporary resource number: **Not Applicable**
- 3. County: **Weld**
- 4. City: **Windsor**
- 5. Historic building name: **Vern's Conoco Service Station**
- 6. Current building name: **Shell Gas Station and Convenience Store**
- 7. Building address: **401 Main Street**
- 8. Owner name: **401 Main Street, LLC**
- Owner organization:
- Owner address: **401 Main St
Windsor, CO 80550**

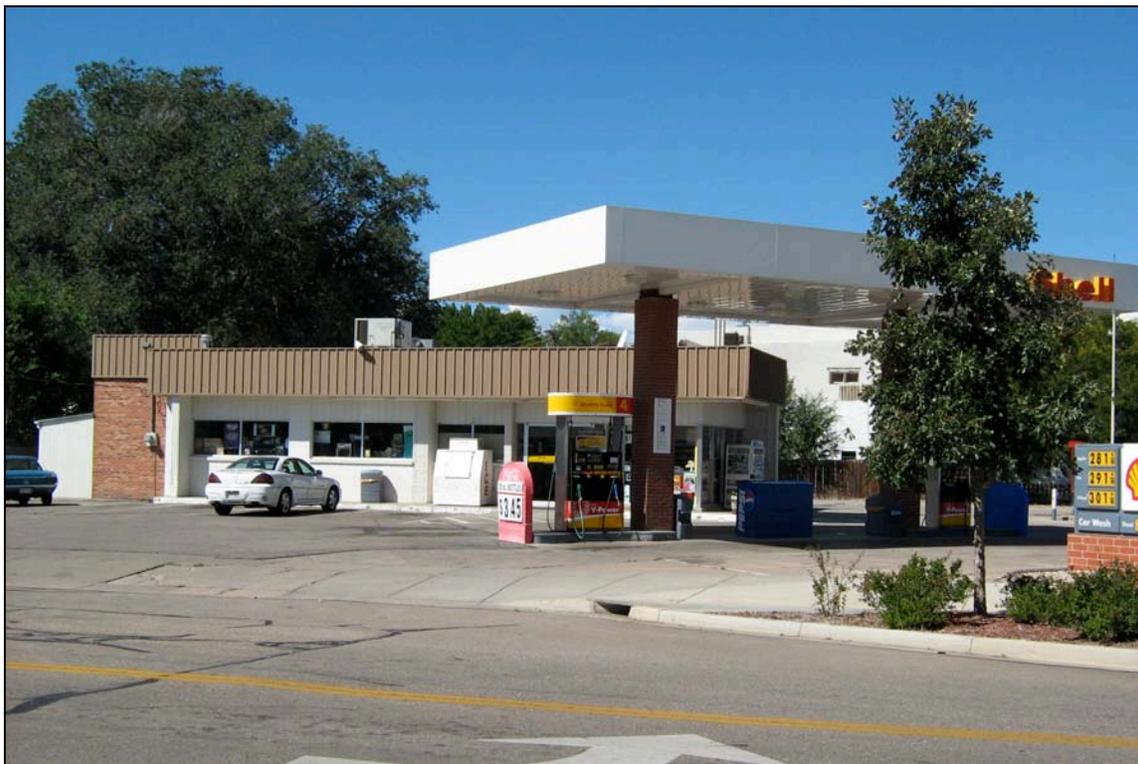
19. Primary external roof material: **Synthetic Roof/Rubber Roof**
Other roof materials:
20. Special features: **Car Port**
21. General architectural description:
Oriented to the east, this building rests on a concrete foundation. The walls consist of concrete blocks, painted white. Dividing the walls into recessed bays are pilasters of stack-bond Roman brick. Above the windows in each bay are white-painted sheets of plywood. An addition to the south elevation and a three-bay carwash extending off the south end of the rear (west) elevation have red-brown brick walls. Another small addition to the south elevation has tan-painted plywood walls. Windows are generally plate-glass, with aluminum frames. The principal doorway opens in the north end of the asymmetrical front (east) façade. Secondary doorways open in the north half of the west elevation and in the plywood addition to the south elevation. A rubber membrane covers the flat roof, and a brown-painted sheet metal bulkhead protrudes from the parapet.
