COLORADO CULTURAL RESOURCE SURVEY

**Architectural Inventory Form**

- 1. Resource number: **5WL.5606** Parcel number: **080716308012**
- 2. Temporary resource number: **Not Applicable**
- 3. County: **Weld**
- 4. City: **Windsor**
- 5. Historic building name: **J.T. Wilson Blacksmith Shop; George Manweiler Blacksmith Shop; Ehrlich Building**
- 6. Current building name: **The Border Restaurant**
- 7. Building address: **404 Main Street**
- 8. Owner name: **Reinhold Ehrlich**
- Owner organization:
- Owner address: **820 Elm St  
Windsor, CO 80550**

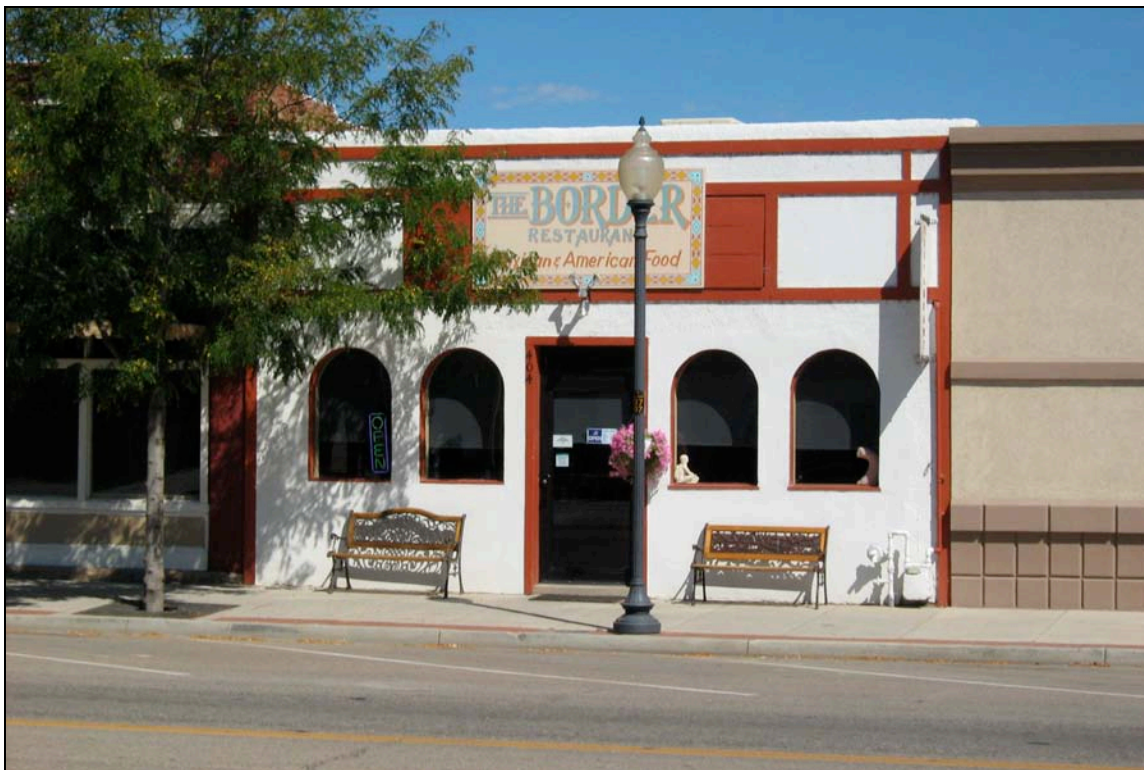
20. Special features: **None Applicable**
21. General architectural description:  
**Oriented to the south, this building rests on a concrete foundation. White stucco clads the structural clay tile walls. Windows in the façade are single-light fixed frame, round arch. The principal doorway opens in the center of the façade. It hosts a plate-glass, aluminum-frame door, opening beneath a single-light transom. A secondary doorway opens west of center in the rear (north) elevation. It hosts a white-painted metal slab door, with a single-light. A rubber membrane covers the shed roof.**
