COLORADO CULTURAL RESOURCE SURVEY

Architectural Inventory Form

- 1. Resource number: **5WL.5608** Parcel number: **080716308010**
- 2. Temporary resource number: **Not Applicable**
- 3. County: **Weld**
- 4. City: **Windsor**
- 5. Historic building name: **Edwards & Hunt Butcher Shop; Duck Inn**
- 6. Current building name: **Bizarber; Hair Sculptors**
- 7. Building address: **408 Main Street**
- 8. Owner name: **Mona R. McCarthy**
- Owner organization:
- Owner address: **615 Oak St
Windsor, CO 80550**

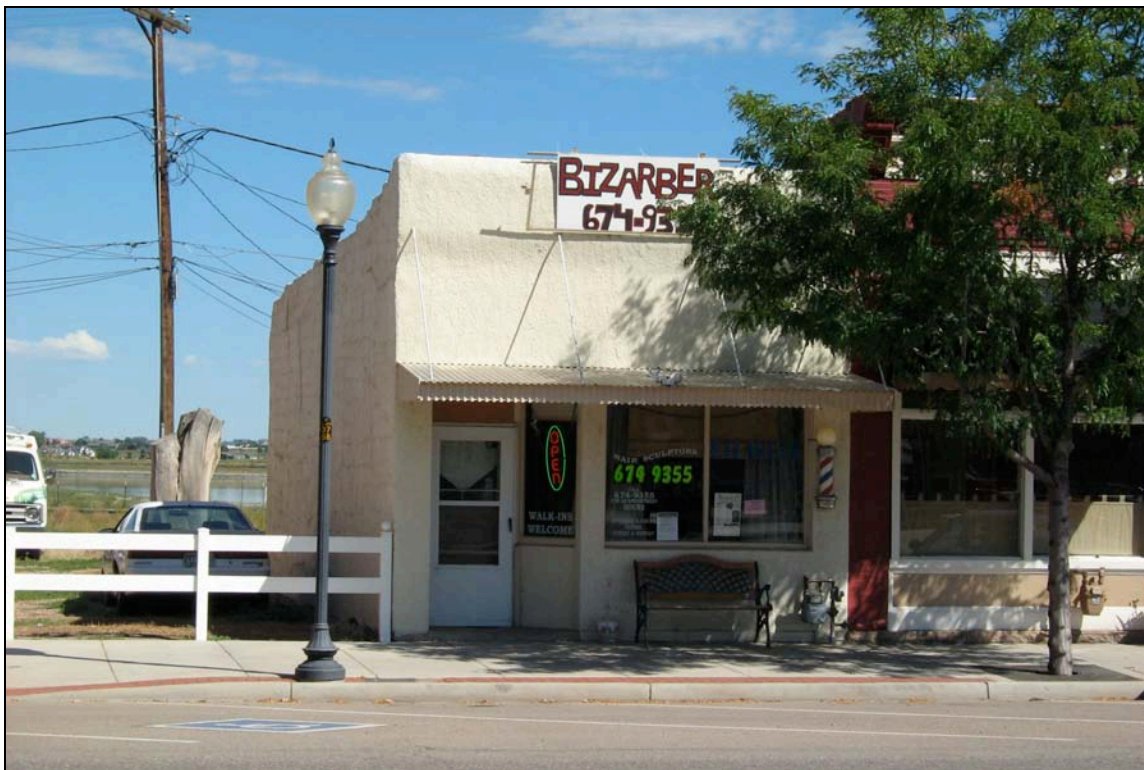
20. Special features: **Window/Segmental Arch**
21. General architectural description:
Oriented to the south, this building rests on a dressed sandstone foundation. Cream stucco clads the exterior walls and protrudes from what was once a corbelled cornice across the front (south) façade. Windows in the façade are plate glass, with wood frames. The principal doorway opens within a canted recess at the east end of the asymmetrical façade. It hosts a cream-painted, paneled wood door, opening behind a white, vinyl-frame storm door. At the opposite end of the façade is a red-, white-, and blue-striped barber's pole. Spanning the façade is a cream-painted, corrugated fiberglass awning. The rear (north) elevation hosts a 1-over-1-light, double-hung sash window in its west side. It opens within the recess of a larger window opening, beneath a segmental arch. East of it is a doorway hosting a 6-panel wood door, behind a wood-frame storm door. A rubber membrane covers the shed roof.
