COLORADO CULTURAL RESOURCE SURVEY

Architectural Inventory Form

1.	Resource number:	5WL.5609	Parcel number:	080721203012
2.	Temporary resource number:	Not Applicable		
3.	County:	Weld		
4.	City:	Windsor		
5.	Historic building name:	Osterhout Building; Windsor Barber Shop; George Onstot Barber Shop		
6.	Current building name:	Absolute Hair		
7.	Building address:	411 Main Street		
8.	Owner name:	Ruthayn Fetterolf		
	Owner organization:			
	Owner address:	206 Pelican Cove		
		Windsor, CO 80550

47.	Digital photograph file name(s):	mainst411 - 1 to mainst411 - 3
	Digital photographs filed at:	Town of Windsor
		301 Walnut St Windsor, CO 80550
48.	Report title:	Downtown Windsor Survey Report
49.	Date(s):	09/04/2007
50:	Recorder(s):	Adam Thomas, Jeffrey DeHerrera, and Rachel Kline
51:	Organization:	Historitecture, LLC
52:	Address:	PO Box 419
		Estes Park, CO 80517-0419
53:	Phone number(s):	(970) 586-1165

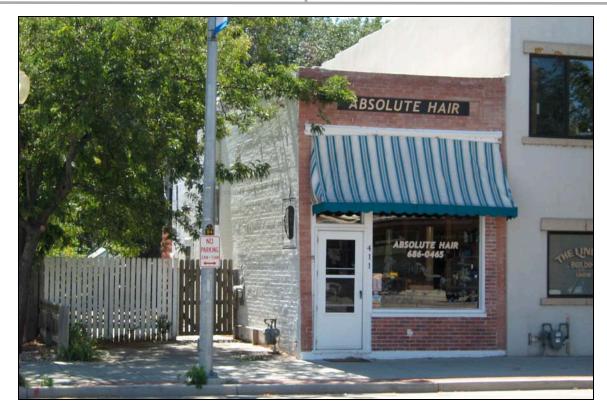
Oriented to the north, this building rests on a concrete foundation. The walls consist of red pressed bricks, set in an irregular common bond. Punctuating the exposed east elevation are wrought-iron tie rods, with S-shaped ends. Covering the front (north) façade is a red, pressed brick veneer, with thin, white mortar. Dominating the center of the façade is a large, plate-glass window, with transom. The principal doorway opens in the east end of the façade. It hosts a glass-in-wood-frame door, opening behind a white-vinyl storm door. Above the doorway is a transom. Spanning above the window and doorway is a canvas awning and projecting, green-painted wood cornice. Above the cornice is a recessed signband and corbelled parapet. A secondary doorway opens in the south end of the east elevation. Piercing the center of the rear (south) elevation is a 1-over-1-light, aluminum-frame window. A rubber membrane covers the shed roof. A brick chimney protrudes south of center on the east elevation.

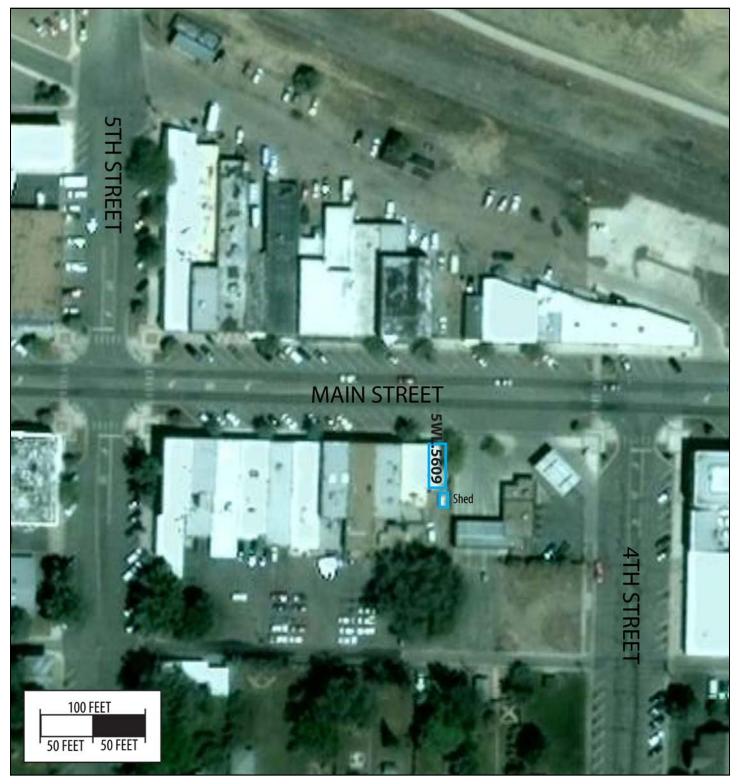
SKETCH MAP

This commercial building is located on Main Street, the principal east-west thoroughfare through downtown Windsor. It is situated on the south side of the street, between 401 Main Street to the east and 413 Main Street to the west. Separating the building's front (north) facade from the street is a concrete sidewalk. Gravel covers a parking area behind (south of) the building. Gravel covers the rest of the lot.
