COLORADO CULTURAL RESOURCE SURVEY

Architectural Inventory Form

1.	Resource number:	5WL.5612	Parcel number:	080721203015
2.	Temporary resource number:	Not Applicable		
3.	County:	Weld		
4.	City:	Windsor		
5.	Historic building name:	L.C. Schmidt Building; Middleton Furniture Company		
6.	Current building name:	Li'l Flower Shop		
7.	Building address:	417 Main Street		
8.	Owner name:	Dixie Lou Phillips		
	Owner organization:			
	Owner address:	4644 Zion Dr		
		Greeley, CO 80634

48. Report title: **Downtown Windsor Survey Report**

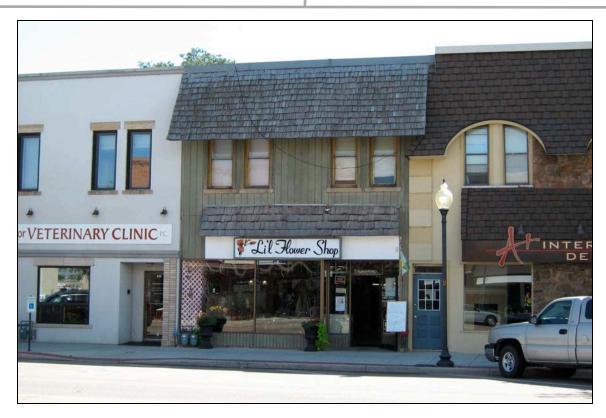
Oriented to the north, this building rests on a sandstone foundation. The walls consist of red, pressed bricks, set in a 7-over-1 common bond. Green-stained sheets of plywood clad the front (north) elevation. Covering the rear (south) and west elevations is gray stucco. Windows in the first story of the façade are plate-glass, with aluminum frames. The principal doorway opens in the west end of the façade. It hosts a plate-glass door. Spanning the windows and doorway is a pent-roof awning, covered in wood shingles. A similar pent roof descends from the parapet to just above the second-story windows. Second-story windows are paired, 1-over-1-light, double-hung sash, with yellow-painted wood frames. They open above rock-faced, buff-colored sandstone sills. Similar windows open in the rear and west elevations. Dominating the east end of the rear elevation's first story is a large doorway, opening beneath a segmental arch. The windows west of this doorway have been boarded shut. A window opens midway between the first and second stories, at the east end of the façade. This window is 2-over-2-light, and lacks a segmental arch. A doorway at the same level, but on the west end of the elevation, hosts a 6-panel, white-painted metal door, approached from the south by a steel staircase. Sheets of brown asphalt cover the nearly flat roof. A brick chimney protrudes from the south end of the wall separating this building from 419 Main Street, to the west.

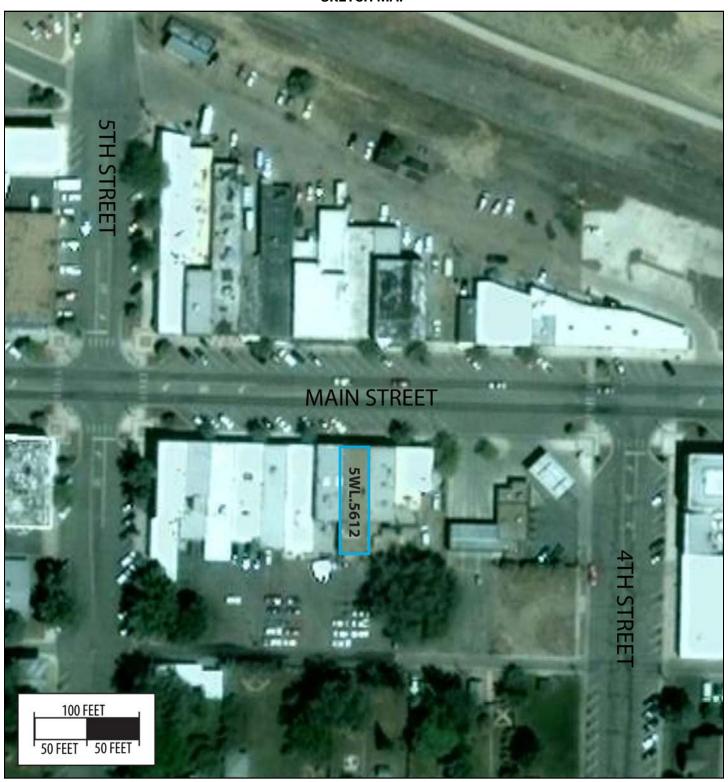
SKETCH MAP

This commercial building is located on Main Street, the principal east-west thoroughfare through downtown Windsor. It is situated on the south side of the street, between 415 Main Street to the east and 419 Main Street to the west. Separating the building's front (north) facade from the street is a concrete sidewalk. Macadam covers a parking area behind (south of) the building.
