COLORADO CULTURAL RESOURCE SURVEY

Architectural Inventory Form

- 1. Resource number: **5WL.5614** Parcel number: **080721203016**
- 2. Temporary resource number: **Not Applicable**
- 3. County: **Weld**
- 4. City: **Windsor**
- 5. Historic building name: **Felmlee-Schmidt Block; Huntington Bowling Alley & Pool Hall; Ben Franklin; Gambles**
- 6. Current building name: **A+ Interior Design**
- 7. Building address: **419 Main Street**
- 8. Owner name: **Winter Investments, LLC**
- Owner organization:
- Owner address: **33652 Weld County Rd 21
Windsor, CO 80550**

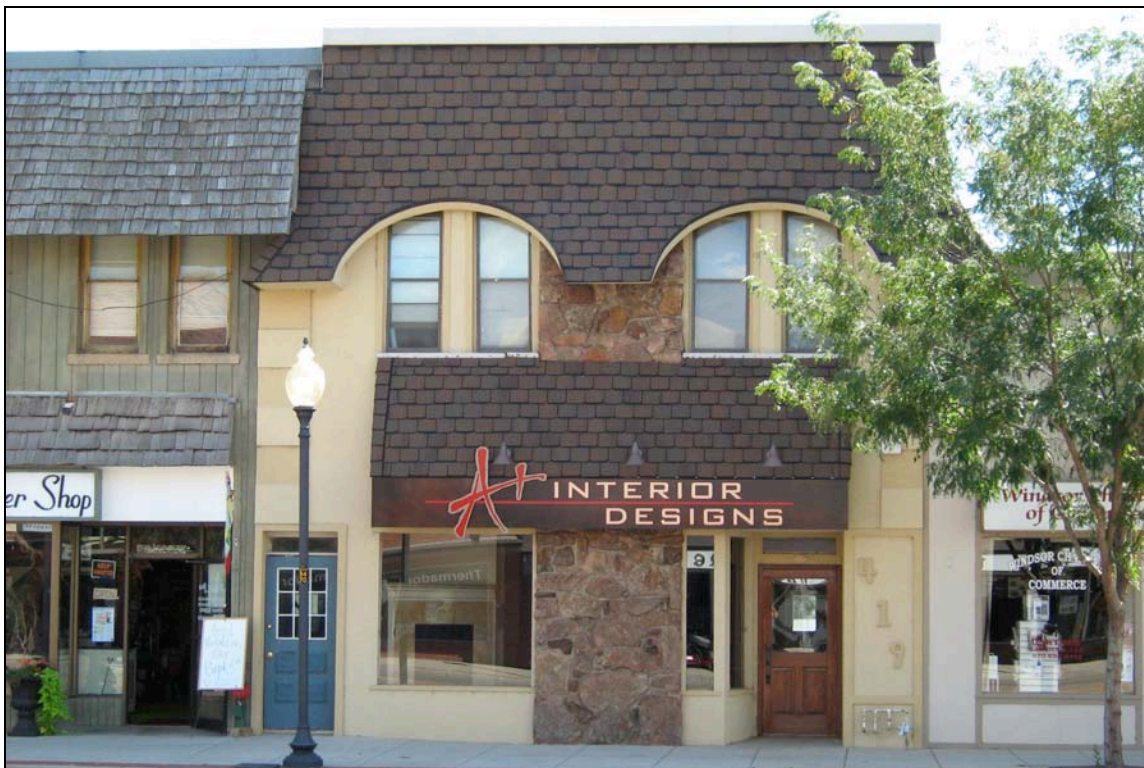
20. Special features: **Chimney**
Window/Segmental Arch
21. General architectural description:
Oriented to the north, this building rests on a sandstone foundation. Cream stucco, with protruding quoins, clads the exterior walls. A vertical shaft of random-coursed sandstone marks the center of the façade. The first story of the façade hosts plate-glass windows. The principal doorway opens within a canted recess in the west end of the façade. It hosts a 2-panel, 1-light wood door, opening beneath a transom. Windows in the second story of the façade are 1-over-1-light, double-hung sash, with brown aluminum frames. They are grouped in pairs beneath round arches cut from the mansard roof descending from the parapet. Brown asphalt shingles cover this roof and the pent-roof awning spanning the first-story windows and the doorway. Another doorway at the east end of the façade provides access to a staircase rising to the second story. A secondary doorway opens in the west end of the rear elevation. It hosts a tan-painted metal slab door, with a single light. Windows opening in the rear (south) elevation are 1-over-1-light, double-hung sash and single-light casement, with white vinyl frames. They open beneath segmental arches. A doorway opens in the east end of the rear elevation's second story, providing access to an unsheltered deck over the single-story rear half of the building. The doorway hosts a brown-painted, paneled wood door, with 3 lights, opening behind an aluminum-frame storm door. Wood steps descend to the south and west. A rubber membrane covers the nearly flat roof. A chimney protrudes from the south end of the wall shared with the building immediately east.
