COLORADO CULTURAL RESOURCE SURVEY

Architectural Inventory Form

- 1. Resource number: **5WL.5616** Parcel number: **080716308006**
- 2. Temporary resource number: **Not Applicable**
- 3. County: **Weld**
- 4. City: **Windsor**
- 5. Historic building name: **T.R. Brooks Building; Windsor Hardware & Supply Company**
- 6. Current building name: **Public Service Credit Union**
- 7. Building address: **422 Main Street**
- 8. Owner name: **Norlarco Credit Union**
- Owner organization:
- Owner address: **PO Box 528
Fort Collins, CO 80522**

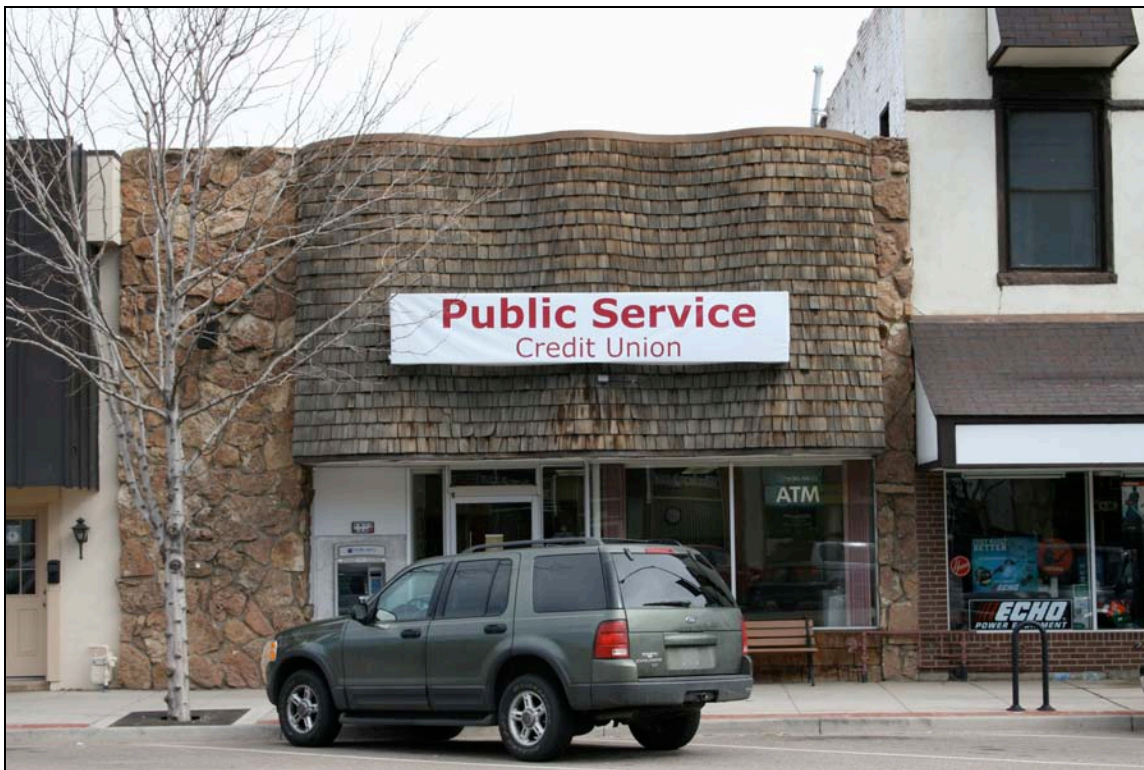
20. Special features: **Chimney**
21. General architectural description:
This commercial building is oriented to the south. The nature of the foundation could not be determined. Tan stucco clads the exterior of the masonry walls. Covering the front (south) façade is a veneer of random-coursed sandstone. Dominating the façade are plate-glass windows, with aluminum frames. The principal doorway opens west of center and hosts a plate-glass door, with an aluminum frame. An automated teller machine is situated just west of the principal doorway. Extending from the tops of the display windows and door to the top of the parapet is an undulating bulkhead, covered in unpainted, square-cut wood shingles. Similar shingles cover the kickplate beneath the windows. Opening in the east elevation are single-light, fixed-frame windows, with green-painted wood frames. They appear behind iron grilles. Similar windows open in the west elevation. Dominating the rear (north) elevation is a 14-panel, 16-light, wood, overhead-retractable garage door. It is painted white, with the bottom row of panels painted green. A large window opening immediately east of the garage door has been boarded shut. Secondary doorways open in either face of the inside corner created by the junction of the rear elevation with a small, shed-roofed wing protruding from the west end of the rear elevation. The north-facing doorway hosts a green- and white-painted wood slab door. The east-facing doorway has a similar door, but it consists of vertical planks. A rubber membrane covers the nearly flat roof. Stucco-covered chimneys, truncated at the parapet, are engaged to the northern ends of the side elevations. A red-brick chimney protrudes near the northeast corner of the building.
