COLORADO CULTURAL RESOURCE SURVEY

Architectural Inventory Form

- 1. Resource number: **5WL.5627** Parcel number: **080721204012**
- 2. Temporary resource number: **Not Applicable**
- 3. County: **Weld**
- 4. City: **Windsor**
- 5. Historic building name: **Bank of Northern Colorado; First National Bank of Windsor; Bank Hotel**
- 6. Current building name: **Windsor Professional Plaza**
- 7. Building address: **501 Main Street**
- 8. Owner name: **Windsor Professional Plaza, LLC**
- Owner organization:
- Owner address: **501 Main St
Windsor, CO 80550-5131**

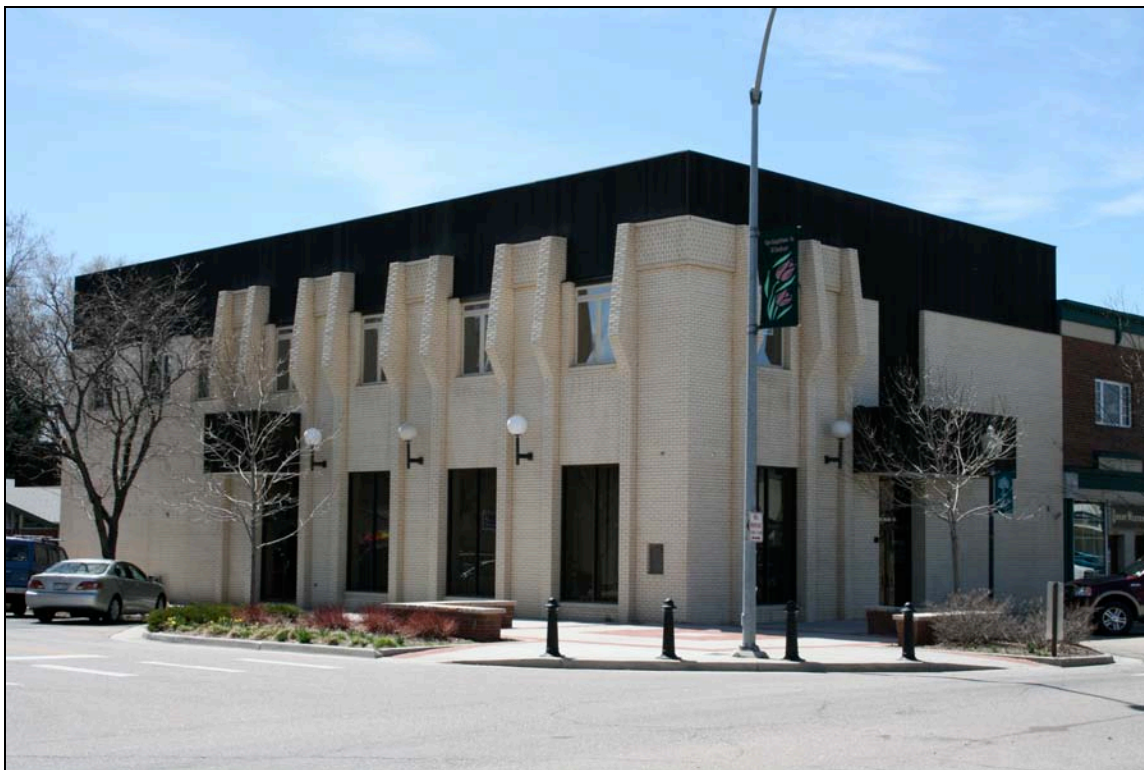
20. Special features: **Chimney**
Porte Cochère/Porte Cochere
21. General architectural description:
This building is oriented to the north. The nature of the foundation could not be determined. A blonde, pressed-brick veneer clads the exterior walls of the front (north), east, and rear (south) elevations. The brickwork features paired buttresses, which corbel outward at the second story and divide the front (north) and east elevations into bays. The brickwork terminates in a wide, slightly protruding cornice, with the bricks set vertically. Lining the parapet above the cornice are vertically ribbed, brown sheets of aluminum. The west elevation consists of red, pressed bricks, set in a 5-over-1 common bond. Opening between the paired buttresses in the first story are tall, paired plate-glass windows, with black aluminum frames and brown-tinted glass. The windows in the second story, between the buttresses, consist of paired, single-light casements opening beneath a narrow transom. They have polarized glass and white vinyl frames. Windows in both stories of the rear (south) elevation are brown-tinted plate glass. Windows that open into the two atriums, which punctuate the second story of the west elevation, appear to be 1-beside-1-light, sliding sash. The principal doorway opens near the center of the asymmetrical façade, beneath a flat, cantilevered box awning. It hosts plate-glass doors with transoms. A nearly identical doorway opens south of center in the east elevation. Recessed doorways open in either end of the rear elevation. The east doorway hosts a plate-glass door and the west doorway has a brown-painted, metal slab door. A flat-roof porte cochère, sheltering a former drive-up banking facility, protrudes from the rear elevation. Providing access to the roof of this structure is a second-story doorway hosting a white-painted, steel slab door. A rubber membrane covers the nearly flat main roof. Spanning the atriums are sheets of translucent fiberglass. A chimney emerges from the southwest corner of the building.
