COLORADO CULTURAL RESOURCE SURVEY

**Architectural Inventory Form**

- 1. Resource number: **5WL.5633** Parcel number: **080716307016**
- 2. Temporary resource number: **Not Applicable**
- 3. County: **Weld**
- 4. City: **Windsor**
- 5. Historic building name: **Raines & Hainey Building**
- 6. Current building name: **Rexford Building**
- 7. Building address: **514 Main Street**
- 8. Owner name: **William R. Rexford**
- Owner organization:
- Owner address: **11316 Weld County Rd 70  
Windsor, CO 80550-3220**

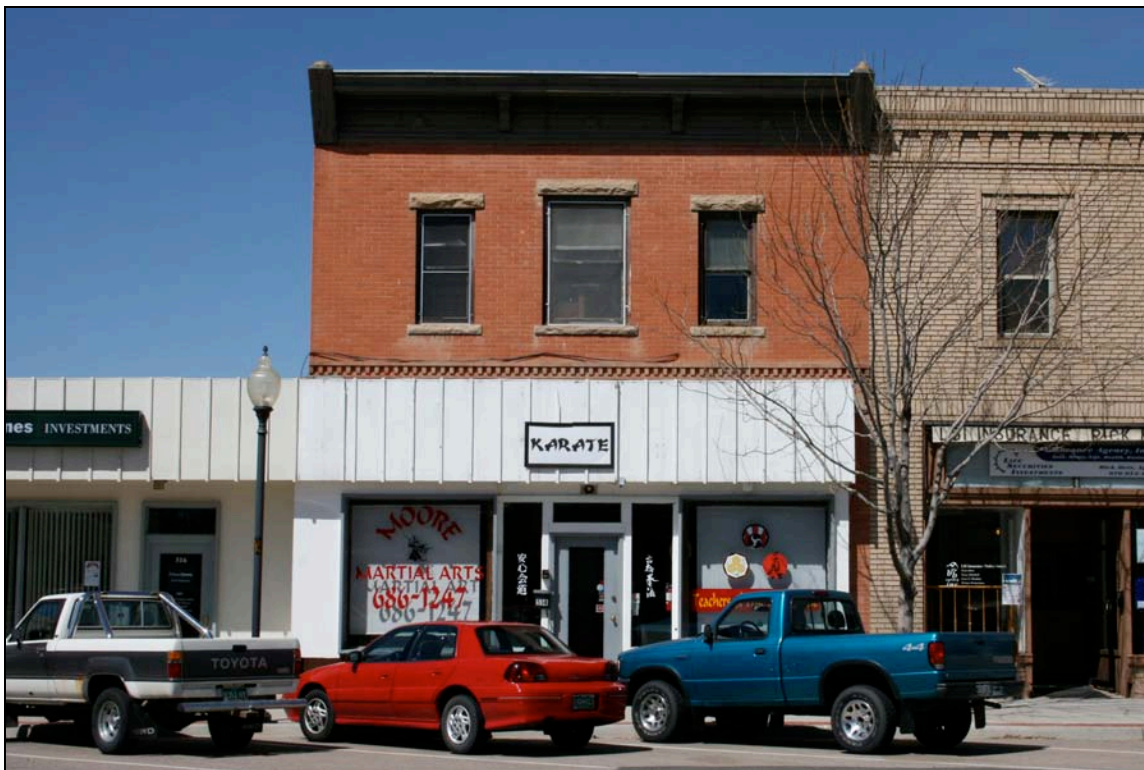
20. Special features: **Balcony**  
**Chimney**  
**Roof Treatment/Decorative Cornice**
21. General architectural description:  
**Oriented to the south, this building rests on a sandstone foundation. Separating the foundation from the exterior walls is a watertable of rock-faced sandstone. The walls consists of red, pressed bricks, set in a 7-over-1 common bond. The bricks are painted white on the exposed west elevation. Covering the front (south) façade is a red, pressed-brick veneer, with thin, white mortar. White stucco clads the rear (north) elevation. Dominating either side of the symmetrical façade's first story are plate-glass windows. Spanning above the windows and principal doorway is a white-painted, board-and-batten box awning, which extends across the façade of the adjacent building (516 Main Street, 5WL.5634). Opening in the center of the second story of the façade is a large, 1-over-1-light, double-hung sash window, with brown-painted wood frames. Flanking this window on either side are similar but smaller windows. They all have rock-faced sandstone sills and lintels. Opening in the second story of the west elevation are 1-over-1-light, double-hung sash windows, with white vinyl frames. They occupy larger window openings that have been largely bricked shut. Opening beneath a segmental arch at the west end of the rear (north) elevation, partially obscured, is another opening hosting either a window or a door. A 1-over-1-light, double-hung sash window, with a white vinyl frame, opens beneath a segmental arch in the east end of the rear elevation's second story. The principal doorway opens in the center of the façade. It hosts a blue-gray painted, single-light, glass-in-wood-frame door, with sidelights and a transom. A secondary doorway opens south of center in the west elevation's second story, providing access to the roof of the adjacent building (516 Main Street, 5WL.5634). Dominating the center of the rear elevation are paired, white-painted, six-panel steel doors. A single, nearly identical door opens in the west end of the rear elevation's second story, providing access to an unsheltered steel balcony with a wood railing. Approaching the west end of the balcony from the north is a wood staircase. A black rubber membrane covers the nearly flat roof. Two truncated, white-painted brick chimneys protrude from the west parapet. Crowning the façade is a pressed tin or cast-iron cornice.**
