COLORADO CULTURAL RESOURCE SURVEY

**Architectural Inventory Form**

**I. IDENTIFICATION**

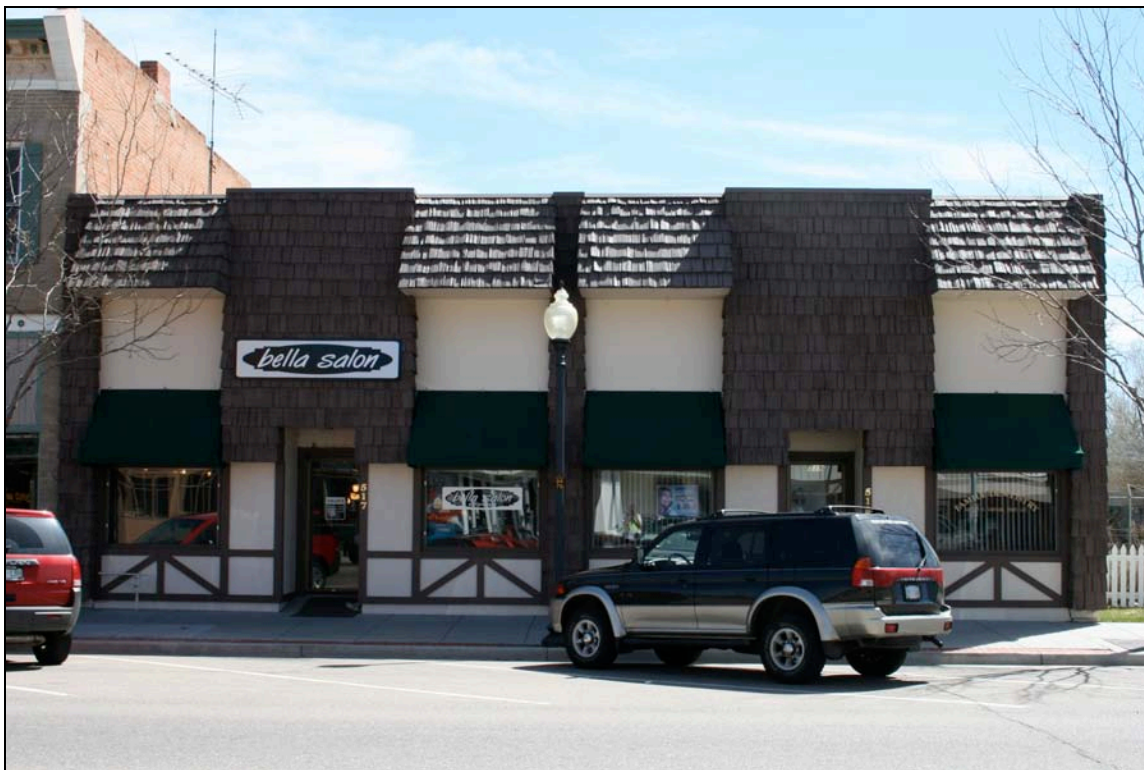
20. Special features: **Chimney**  
**Facade Treatment/False Front**  
**Fence**
21. General architectural description:  
**Oriented to the north, this building appears to rest on a stone foundation. White stucco clads the majority of the exterior walls. Brown-painted false half-timbering has been applied beneath the façade's windows and around its two principal doorways. Brown wood shingles cover the northeast and northwest corners of the building, as well as dividing the front (north) façade into halves. Windows are plate-glass, with brown-painted wood frames and green canvas awnings. Doorways open within recesses at the center of each half of the symmetrical façade. Each doorway hosts a plate-glass door. Spanning from the top of the doorway to the top of the parapet is a box-like bulkhead, covered in brown wood shingles. Pent roof awnings protrude from the extended parapet or false front between the corners and doorway bulkheads. They, too, are covered in brown wood shingles. A white-painted slab door opens in the center of the eastern half's rear elevation, flanked by window openings. A shed-roof addition spans the rear (south) elevation of the western half. Opening west of center in the rear elevation of this addition is a secondary doorway, hosting a white-painted slab door opening behind a white, aluminum- or vinyl-frame storm door. Approaching the doorway from the east is a concrete ramp with a white-painted, steel railing. Either end of the elevation has paired, single-light casement windows, with vinyl frames. A rubber membrane covers the nearly flat main roof. The addition has a standing seam metal roof. A stucco-covered chimney protrudes from the wall dividing the two storefronts.**
