COLORADO CULTURAL RESOURCE SURVEY

Architectural Inventory Form

- 1. Resource number: **5WL.2464** Parcel number: **080716307002**
- 2. Temporary resource number: **Not Applicable**
- 3. County: **Weld**
- 4. City: **Windsor**
- 5. Historic building name: **Dr. Frank R. Porter House**
- 6. Current building name: **Porter House Bed & Breakfast Inn**
- 7. Building address: **530 Main Street**
- 8. Owner name: **Thomas E. and Marneth A. Schmittling**
- Owner organization:
- Owner address: **530 Main St
Windsor, CO 80550**

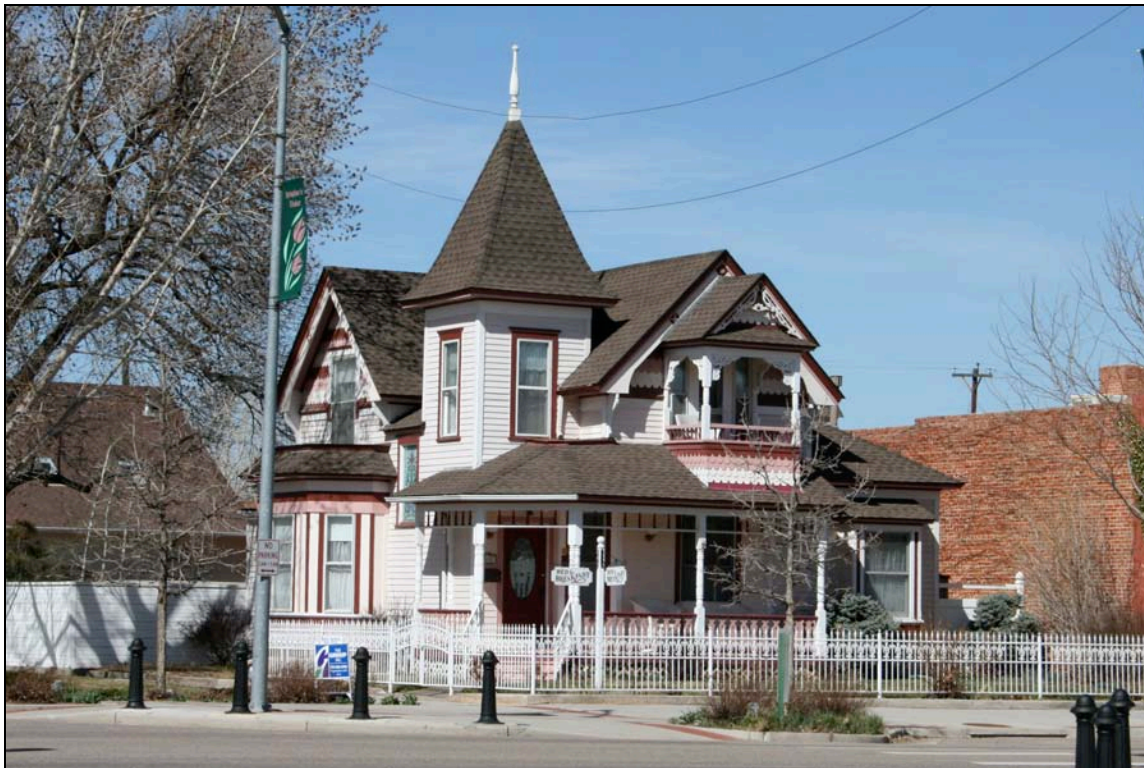
21. General architectural description:
Oriented to the south, this building rests on a regular-coursed, rock-faced, sandstone ashlar foundation. Additions spanning the rear (north) elevation have a concrete foundation. Pale-pink-painted, horizontal wood siding, with white cornerboards, clads the exterior walls. Variegated wood shingles, painted in bands of white, pink, and dark red, cover the gables and the knee wall of the second-story porch. Windows are generally 1-over-1-light, double-hung sash, with white vinyl frames. The red-painted wood surrounds have protruding cornices. A rectangular, shed-roofed bow window protrudes shallowly from the first story of the asymmetrical front (south) façade. A three-sided, canted bay window emerges from near the center of the west elevation. Between this bay window and a tower at the southwest corner of the house is a stained-glass window, corresponding to the landing of the interior staircase. Windows in the second story of the tower have leaded-glass upper sashes. A single-light casement window opens north of the bay window, in the west elevation. An aluminum- or vinyl-frame canted bow window protrudes from the western half of the rear (north) elevation. The principal doorway opens in the south elevation of the tower. It hosts a red-painted wood door, with a leaded, oval light. A shed-roofed porch spans the western two thirds of the façade and wraps around the tower. It has an elaborately scroll-cut balustrade, turned wood porch supports, and spindlework friezes. Wood steps approach the porch at its canted, southwest corner. A small, front-gabled second-story porch dominates the house's front (south-facing) gable. It has a spindlework railing, turned wood porch supports, an elaborately scroll-cut wood brackets. Providing access to the second-story porch is a white-painted, paneled wood door, with single light. It opens behind a white-painted, wood-framed screen door. Flanking the door are 1-over-1-light sidelights. A secondary doorway open in the north elevation of a small room protruding between the west-facing bay window and the northwest corner of the house. Opening near the center of the west elevation of the single-story wing protruding from the eastern half of the rear elevation is a red-painted wood door, with two, round-arch lights. Framing the principal gables are vergeboards, resting on scroll-cut brackets. Covering the cross-gabled main roof and all other roof surfaces are brown, asphalt shingles. A bell-cast, pyramidal roof, with a finial, caps the tower. Protruding from the hip roof of the rear wind is a front-gabled dormer.
