COLORADO CULTURAL RESOURCE SURVEY

Architectural Inventory Form

1. Resource number: **5LR.12766**
2. Temporary resource number: **SHF-35**
3. County: **Larimer**
4. City: **Fort Collins**
5. Historic building name: **John P. and Leah Hill Building**
6. Current building name: **Mark Workman Building**
7. Building address: **419-423 South Mason Street**
8. Owner name: **Mark Workman**
- Owner organization:
- Owner address: **149 W Oak St
Fort Collins, CO 80524**

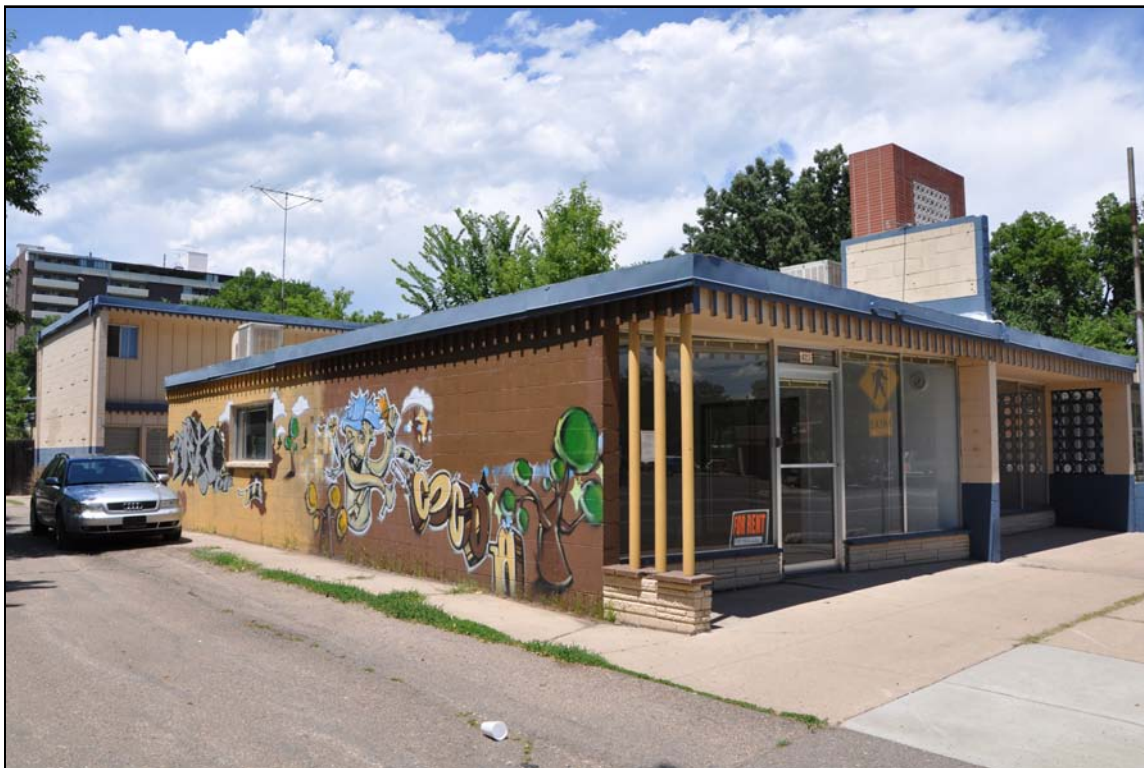
19. Primary external roof material: **Asphalt Roof**
 Other roof materials:
20. Special features: **Chimney**
Garage/Attached Garage
Fence
21. General architectural description:
Oriented to the east, this two-unit commercial building rests on a concrete-block foundation. The walls also consist of concrete blocks, painted cream and blue across the front (east) façade. Both halves of the exposed south elevation have been painted, brown to the east and tan to the west. Covering the elevation is graffiti art. Covering the area beneath the façade's plate-glass windows is a veneer of buff-colored, random-coursed sandstone ashlar. Dividing the recessed storefronts is a vertical shaft of concrete blocks that runs through the roof. At the north end of the façade is a shaft of decorative concrete breeze blocks. At the opposite end of the facade are three steel poles, resting on a buff-colored sandstone kneewall, with red sandstone caps. Separating the exterior walls from the eaves is a frieze of metal battens. Opening near the center of each storefront is a plate-glass door, with a steel frame. Piercing the western half of the south elevation is an aluminum-frame, tripartite window, with single-light casements flanking a central fixed frame. A secondary doorway opens in the southern face of the inside, southeast-facing corner.

It hosts a blue-painted steel slab door. Dominating the rest of the recessed portion of the south elevation (the attached garage) is a white-painted, 28-panel, four-light, steel, overhead-retractable garage door. Blue-painted metal covers the boxed overhanging eaves. Poured asphalt and gravel cover the flat roof. A brick chimney protrudes from the southwest corner of the building.
