COLORADO CULTURAL RESOURCE SURVEY

Architectural Inventory Form

- 1. Resource number: **5BL.11026** Parcel number: **158136119006**
- 2. Temporary resource number: **Not Applicable**
- 3. County: **Boulder**
- 4. City: **Wondervu**
- 5. Historic building name: **Harold and Loraine Millard Cabin**
- 6. Current building name: **Eugene and Virginia Caranci Cabin**
- 7. Building address: **27 Millard Road**
- 8. Owner name: **Eugene A. and Virginia L. Caranci**
- Owner organization:
- Owner address: **1101 Main Street
Louisville, CO 80027-1727**

Wondervu Historical and Architectural Survey

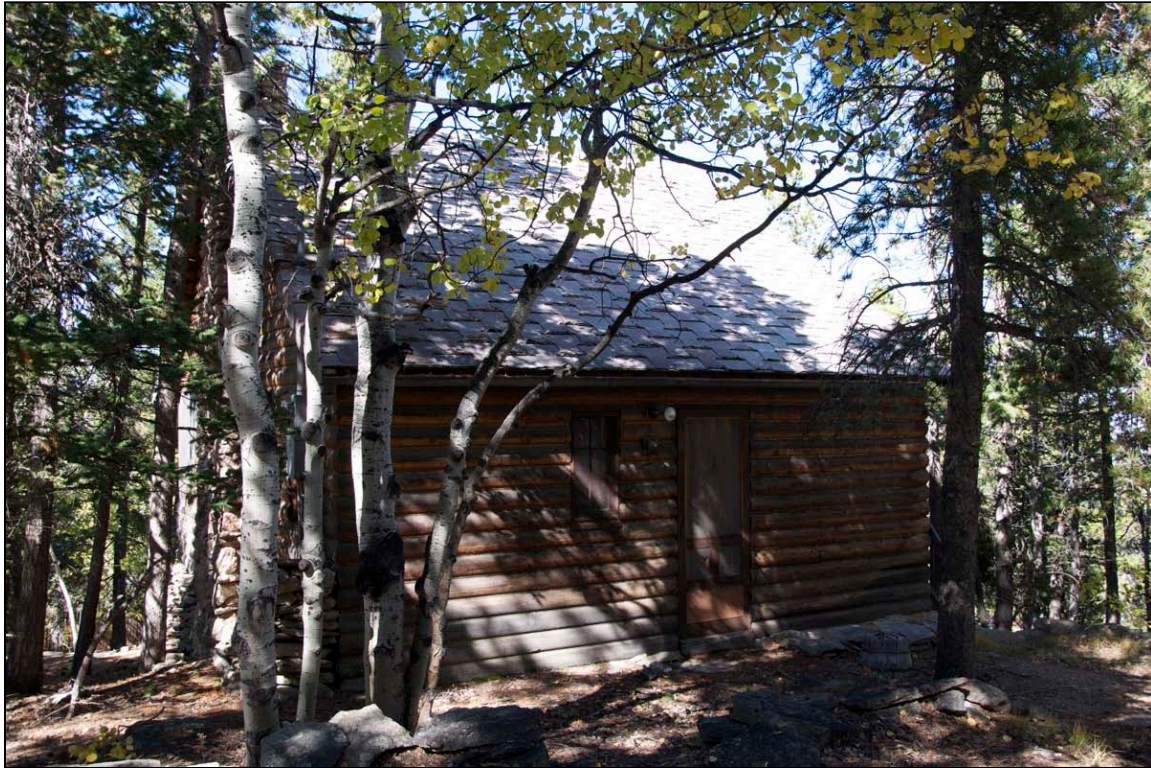
19. Primary external roof material: **Asphalt Roof/Composition Roof**
Other roof materials:
20. Special features: **Chimney**
Porch
21. General architectural description:
Oriented to the south, this cabin rests on a random-coursed granite foundation. Unpainted, simulated log siding clads the exterior walls. Windows are 6- to 8-light casement, with brown-painted wood frames and surrounds. The gables host small, 4-light casement windows. The principal doorway opens near the center of the asymmetrical front (south) façade. It hosts a vertical simulated log door, opening behind a wood-framed screen door. Spanning the entire rear (north) elevation is a integral porch, enclosed temporarily for the winter with plywood. A random-coursed granite hearth and chimney are engaged to the center of the west elevation. A small, unsheltered, second-story deck is attached to the east elevation. A wood staircase approaches the deck from the south. Gray, interlocking asphalt shingles cover the side-gabled roof and wrap around the fascia board. The rafter ends are exposed.
