COLORADO CULTURAL RESOURCE SURVEY

Architectural Inventory Form

1. Resource number: **5LR.10486**
2. Temporary resource number: **SHF-42**
3. County: **Larimer**
4. City: **Fort Collins**
5. Historic building name: **Frank and Virginia Taylor Residence**
6. Current building name: **DG Properties House**
7. Building address: **628 Monte Vista Avenue**
8. Owner name: **DC Properties, LLC**
Owner organization:
Owner address: **3050 Macintosh Drive
Longmont, CO 80503**

Fort Collins Post-World War II Survey

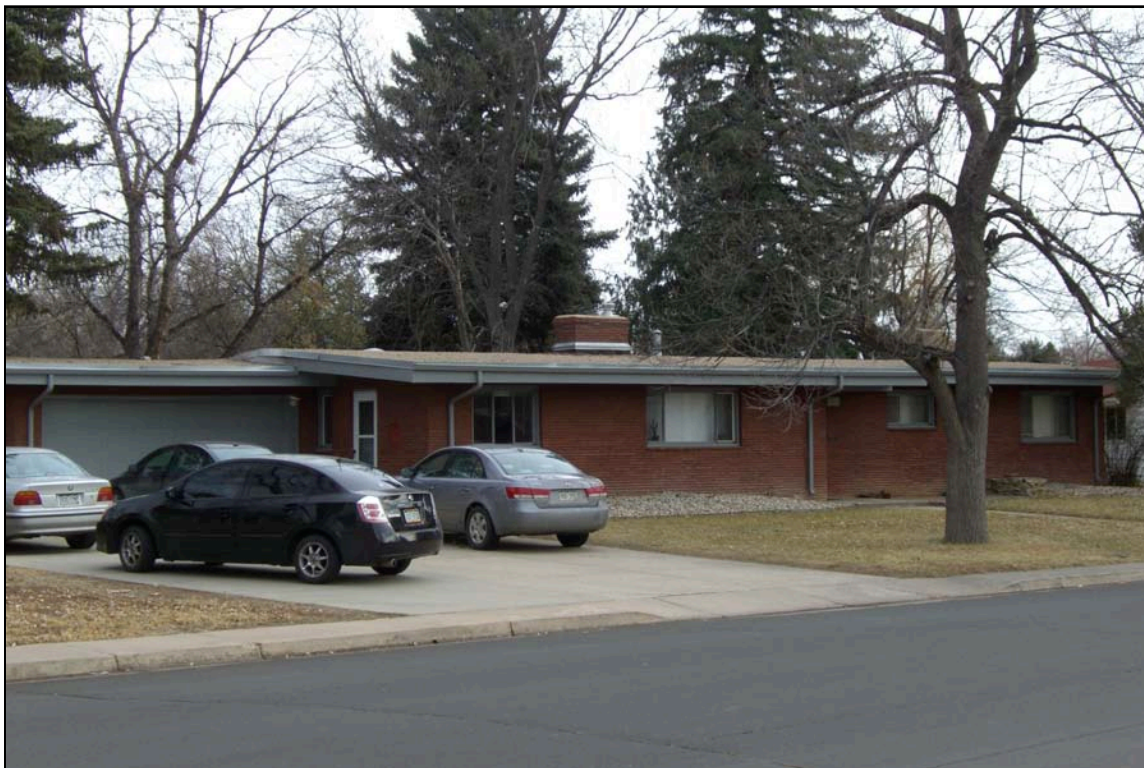
Oriented to the west, this Ranch type home rests on a concrete foundation. The rectangularly shaped house features red Roman brick siding. The home has a side-gabled roof with overhanging eaves and is covered in built-up rock. The cornice, like all trim on the house, is painted light gray. The recessed primary entry is centered on the façade. It appears to be an unadorned wooden door painted light green or gray. The storm door is white metal with a rectangular glass opening. There is a south-facing opening with a large pane of corrugated plastic or patterned and frosted glass near the front door. South of the primary entry there are two windows. The one nearer the front door appears to be a slider and is located quite high on the façade. The opening closer to the southwest corner of the façade is a tripartite picture window; the outside windows in this unit appear to be operable casements. A large chimney appears on the ridgeline near the center of the home. The slightly projecting bay north of the

primary entry includes a large (possibly replacement) window on the façade. There is a secondary entry on the northern wall of this part of the home; it appears to match the primary entry. A window (details not visible from the public right of way) flanks this door. The northwest corner of the façade features an attached two-car garage. There are no visible openings on the south elevation. A wooden privacy fence blocks the view of most of the north elevation; however, the top portion of a window into the garage is visible. The east (rear) elevation was not visible from the public right of way. According to Larimer County assessor records, the home has three bedrooms and two bathrooms. Character-defining features of this type evident at 628 Monte Vista Avenue include: horizontal orientation, gabled roof, Roman brick siding, picture windows, and large chimney.
