COLORADO CULTURAL RESOURCE SURVEY

Architectural Inventory Form

1. Resource number: 5LR.12774
2. Temporary resource number: SHF-43
3. County: Larimer
4. City: Fort Collins
5. Historic building name: Truman and Betty Harsha Residence
6. Current building name: Wendy Mosher and John McKay House
7. Building address: 1300 Morgan Street
8. Owner name: Wendy Mosher and John McKay
Owner organization:
Owner address: 1300 Morgan Street
Fort Collins, CO 80524

Fort Collins Post-World War II Survey

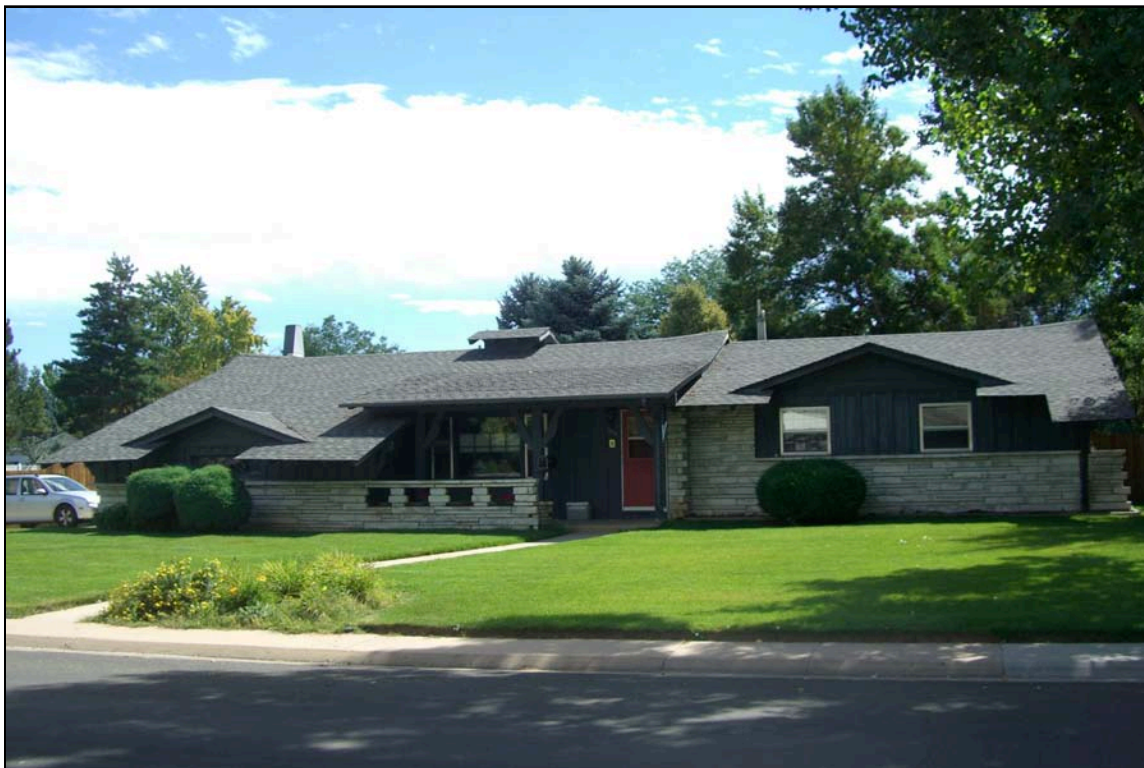
21. General architectural description:
Oriented to the west, this Ranch type home with Asian influences rests on a concrete foundation. The rectangularly shaped house features both vertical siding painted slate gray and distinctive white stone. The home has a side-gabled roof with overhanging, dramatically flared eaves and is covered in asphalt shingles. The primary entry is located within a recessed porch centered on the façade. An integrated stone planter defines the front edge of this entry porch. The wooden porch supports, branching off from a basic square wooden beam, have stylized curved shapes. These supports are painted to match the vertical siding. The front door, with its storm door painted a striking hue of red, is located at the southwest corner of this porch. A large picture window dominates the remainder of the façade inside the porch. The southwestern corner of the façade

features half wall siding in white stone with this facing extending upward to cover the entire façade in the portion of this bay closest to the front porch. A front-gabled roof is centered on the vertical siding part of the bay and features two four by four-lite windows with aluminum storm windows. On the opposite side of the front porch there is another projecting bay with a front-gable roof and a stylized diamond-patterned rectangular window above the half-wall height stone siding. This siding extends southward to form a low wall in front of the northern half of the front porch. A small monitor-roofed decorative feature appears along the ridgeline of the main roof. The south elevation contains two windows like those which appear on the façade and has horizontal siding in the gable face. The north elevation features an attached two-car garage and large stone chimney. The gable face above the garage has horizontal siding and there is a stylized pendant (or perhaps a free-hanging vent) in the gable peak. A wooden privacy fence blocks the view of the east (rear) elevation, although the gabled roof of a covered patio was visible from the public right of way. According to Larimer County assessor records, the home has three bedrooms and three bathrooms. Character-defining features of this type evident at 1300 Morgan Street include: horizontal orientation, gabled roof, attached two-car garage, and large chimney. The dramatically flared eaves, use of irregularly cut stone, red storm door, pagoda-like front gabled roofs, and curved porch supports all give this property its Asian appearance.

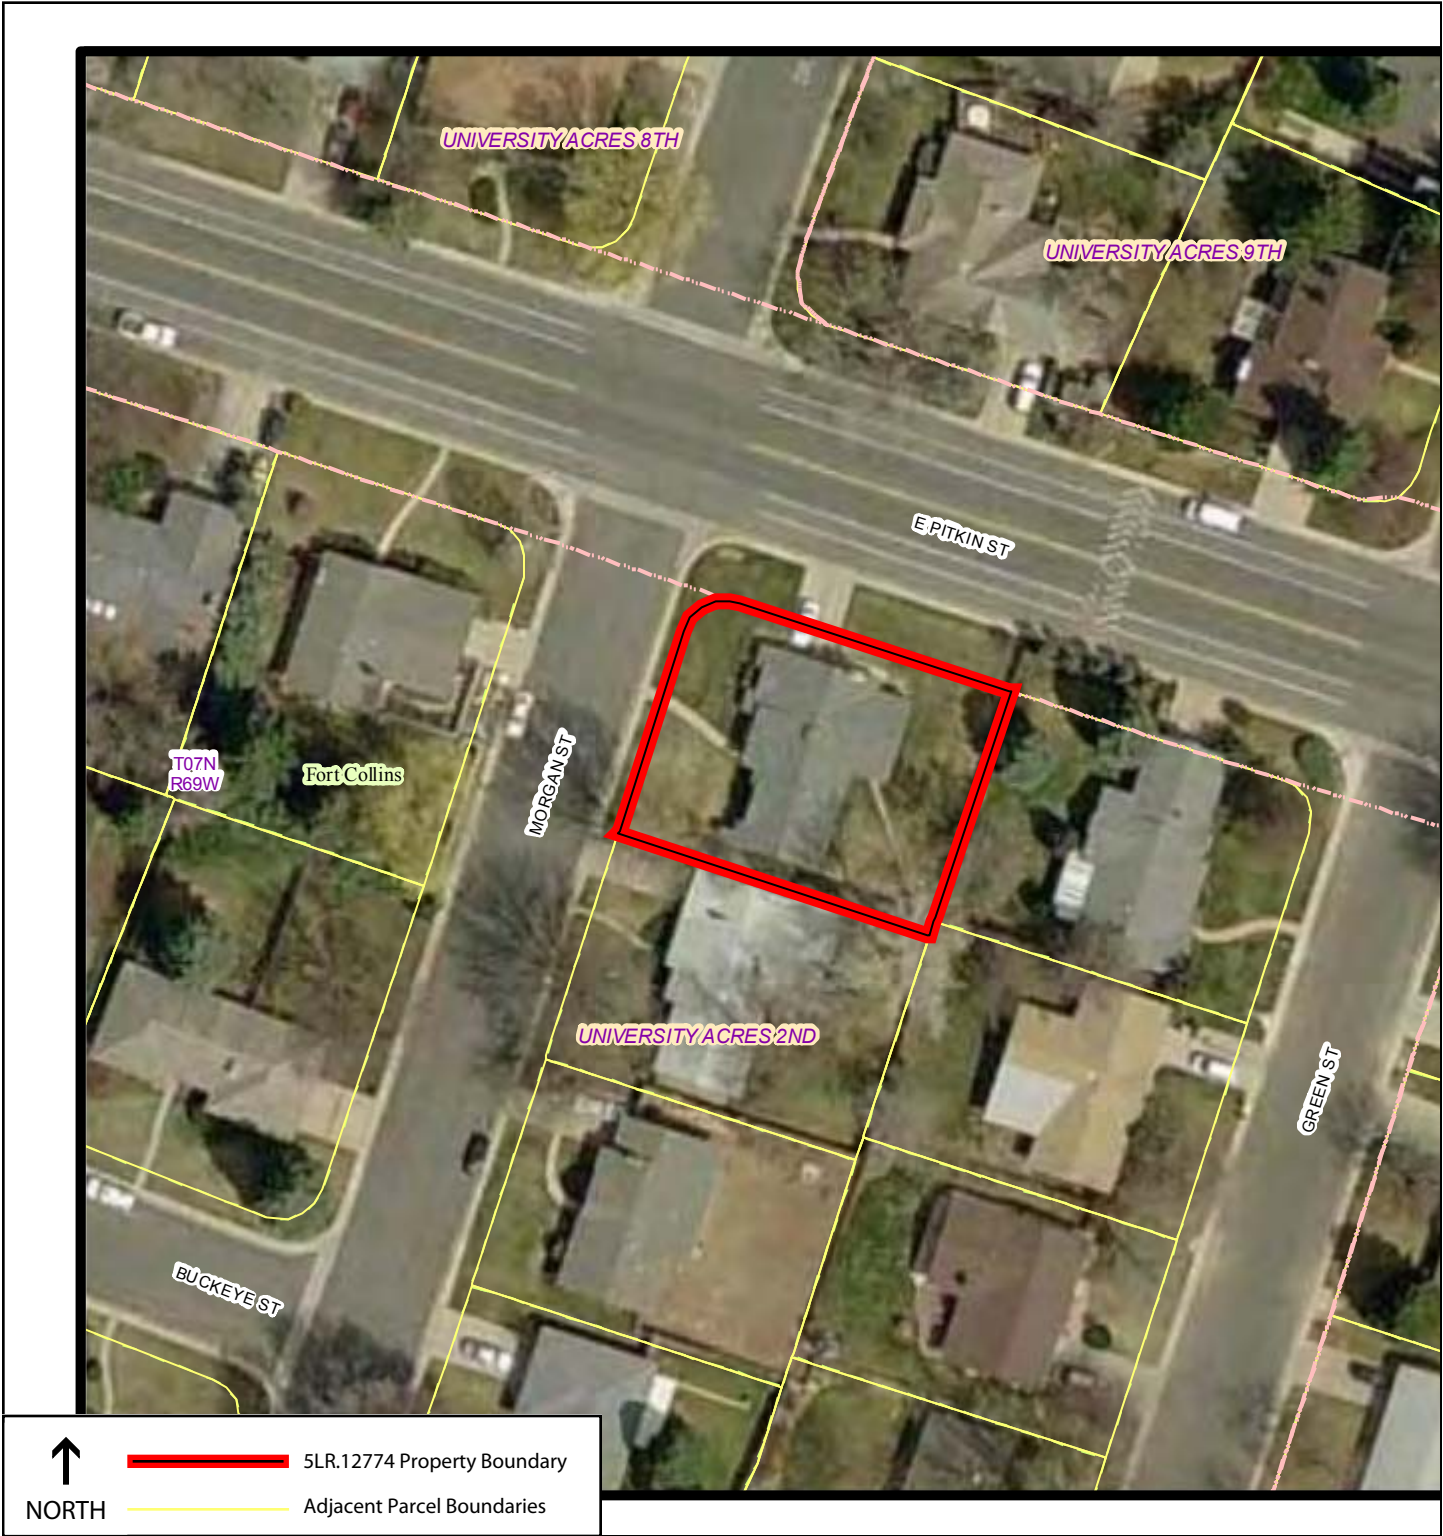
SKETCH MAP

The house is located on a spacious corner lot at East Pitkin and Morgan streets. The lot has an elevation of nearly 5000 feet above mean sea level. There is a grass lawn surrounding the home. The front juniper bushes have been cut into rounded shapes. Geraniums bloom inside the integrated planter. A concrete walk leads from the sidewalk to the front entry.
