COLORADO CULTURAL RESOURCE SURVEY

Architectural Inventory Form

1. Resource number: 5LR.3205
2. Temporary resource number: City-20
3. County: Larimer
4. City: Fort Collins
5. Historic building name: Seventh Day Adventist Church
6. Current building name: Seventh Day Adventist Church
7. Building address: 502 East Pitkin Street
8. Owner name: Seventh Day Adventist
Owner organization:
Owner address: 2520 S. Downing Street
Denver, CO 80210

Fort Collins Post-World War II Survey

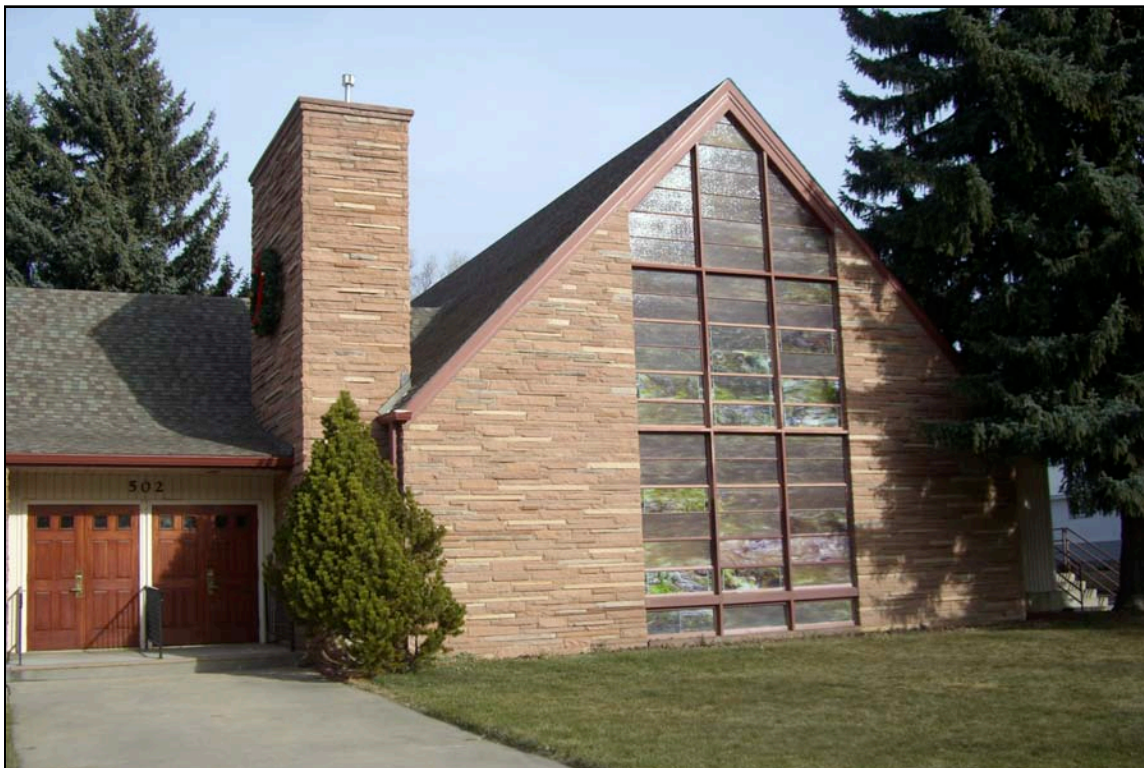
19. Primary external roof material: **Asphalt Roof/Composition Roof**
 Other roof materials:
20. Special features: **Window/Stained Glass**
21. General architectural description:
Oriented to the south, this mid-1950s Modern Movements church rests on a concrete foundation. The T-shaped building is faced in pinkish stone, likely sandstone. The religious building has a cross gabled roof covered in asphalt shingles. The primary entry is located within a slight recess formed by the roof overhang and reached via a single concrete step. There are basic iron railings beside the doors. The pair of double doors is cherry-hue stained wood and each door has a row of small square windows along the top. The remainder of the façade features a side view of the tall stone tower which faces west and extends above the plane of the roof. A front-gabled bay with a foundation to gable peak, centered, stained glass window comprises the east half of the façade. The stained glass panes are large horizontally oriented rectangular lites and do not depict any image or religious motif. Instead they are opaque and include a milky or marbled combination of dark green and white. The east elevation features a single story, front-gabled secondary entry bay faced in vertical siding painted off-white. This plain stained wooden double door is reached via five concrete steps on the south or a concrete ramp to the north end of this platform. Iron supports painted a light pink to complement the stone of the church surround this entrance area. The remainder of the east elevation, north of this secondary entry, is the side-

gabled length of the church. There are four bands of stained glass windows, one a single and the rest doubles, along this side of the building. The hues in these windows include the green and white evident on the façade, but also include a few blue-gray, gold, and pinkish-brown examples. The north elevation is front-gabled and has another secondary entry, a plain wooden stained door, at its northeast corner. There is a single-story front-gabled vestibule with a double door secondary entry; this bay is flanked by lean-to storage sheds faced in vertical siding painted off-white. The west elevation features a front-gabled bay near the northwest corner. This portion of the building features more double bands of stained glass windows and there is yet another secondary entry. This door, stained wood with a fixed glass pane in the upper portion, faces south and is reached via four concrete steps faced in stone; there is a black iron railing. The center of the west elevation features three more double bands of stained glass windows. At the southwest corner there is a front gabled bay with a cat-slide roof which angles toward the south. This portion of the church also features a double band of stained glass. There are three small, square, cut outs in the stone, allowing a glimpse into the primary entry area. The large stone tower is most visible from this angle. Character defining features of this mid-1950s Modern Movements church include the stone siding, tower which pierces the roof plane, and vertical bands of nontraditional stained-glass windows.

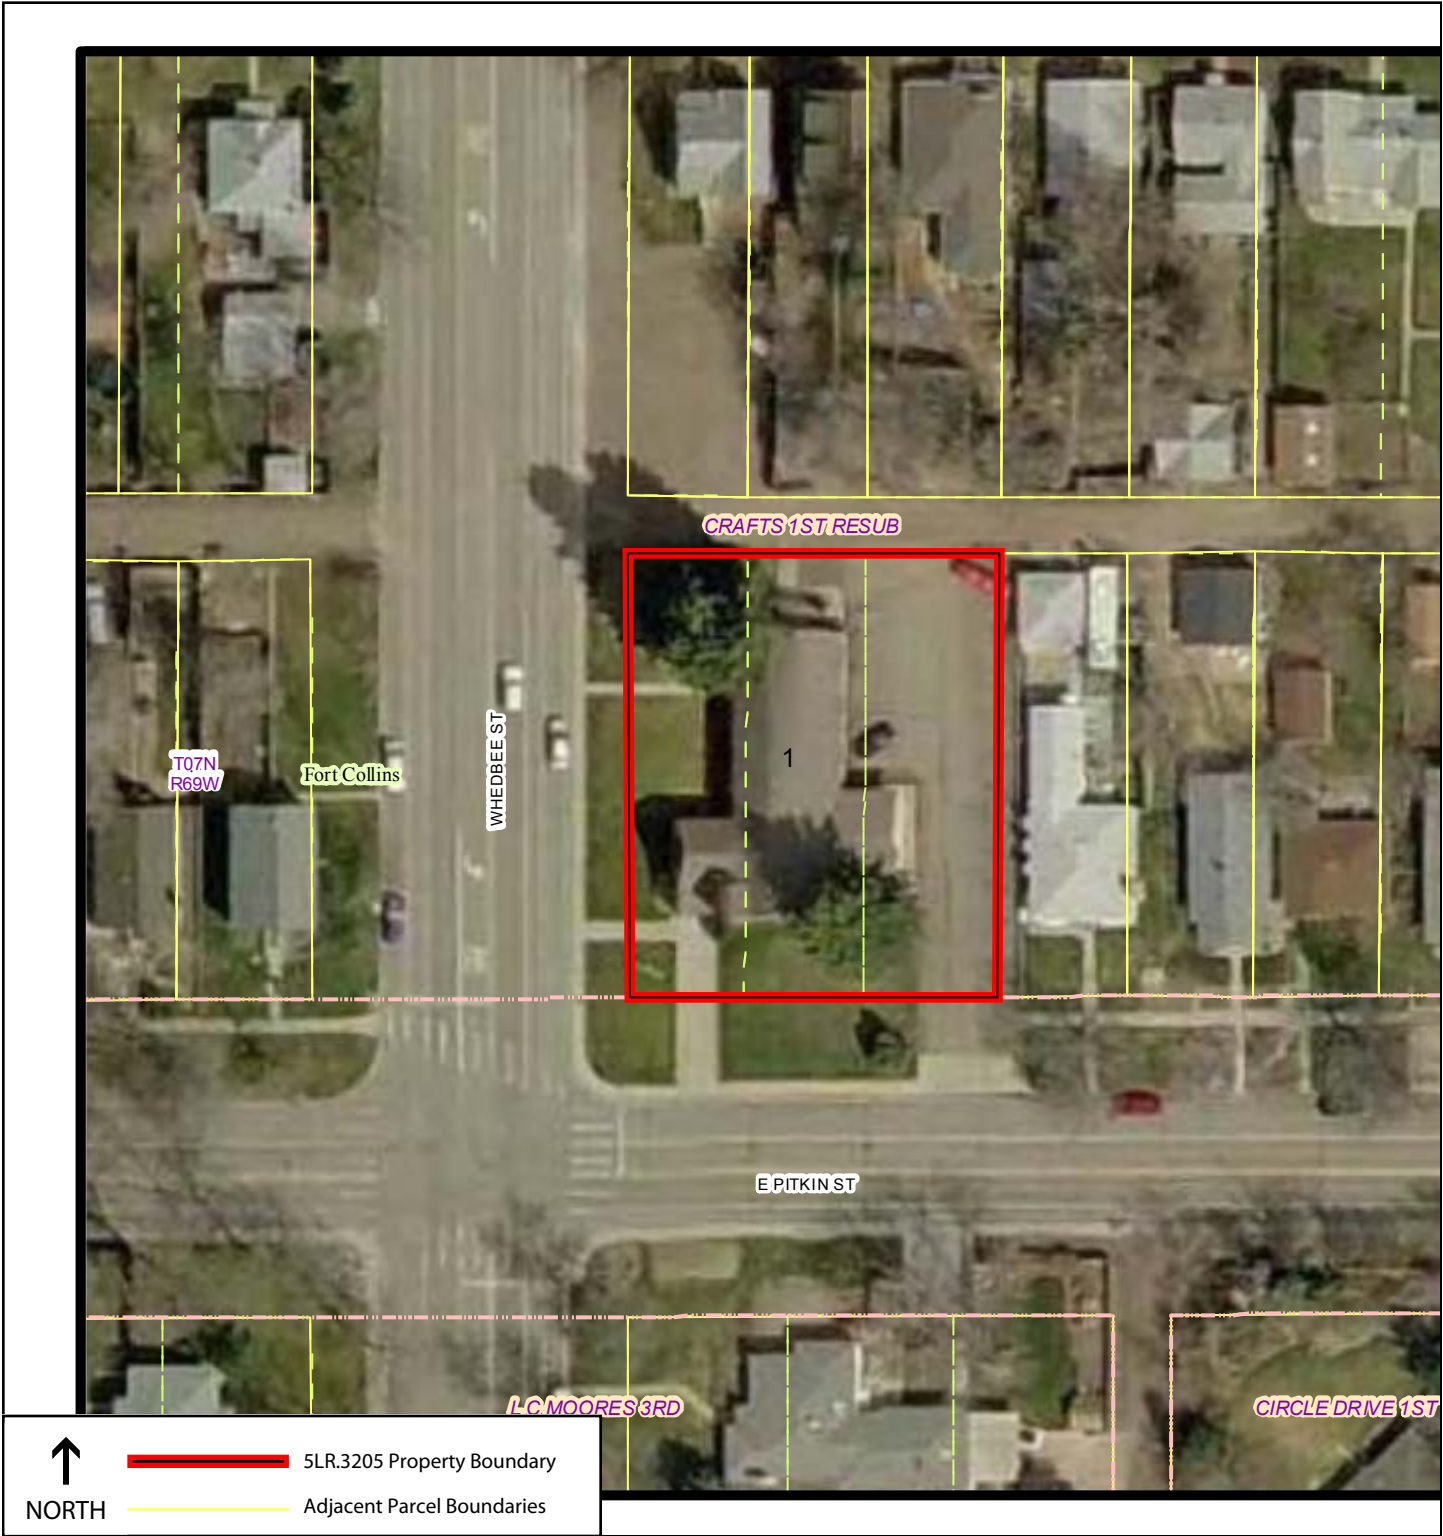
SKETCH MAP

This building is located on a series of narrow rectangular-shaped lots at the intersection of E. Pitkin and Whedbee streets. There is a grass lawn and several large evergreen trees. The sign for the church, made of stone matching the building, is located in the lawn near the primary entrance. There is a large paved parking lot with diagonal parking spaces east of the building. The property is sited on a lot with an elevation of 4988 feet above mean sea level.
