COLORADO CULTURAL RESOURCE SURVEY

Architectural Inventory Form

1. Resource number: **5LR.12790**
2. Temporary resource number: **City-24**
3. County: **Larimer**
4. City: **Fort Collins**
5. Historic building name: **Banwell Motor & Tire Company**
6. Current building name: **Burt's Shirts**
7. Building address: **142 Remington Street**
8. Owner name: **Burt Nunnelee**
- Owner organization:
- Owner address: **PO Box 1813**
Fort Collins, CO 80522

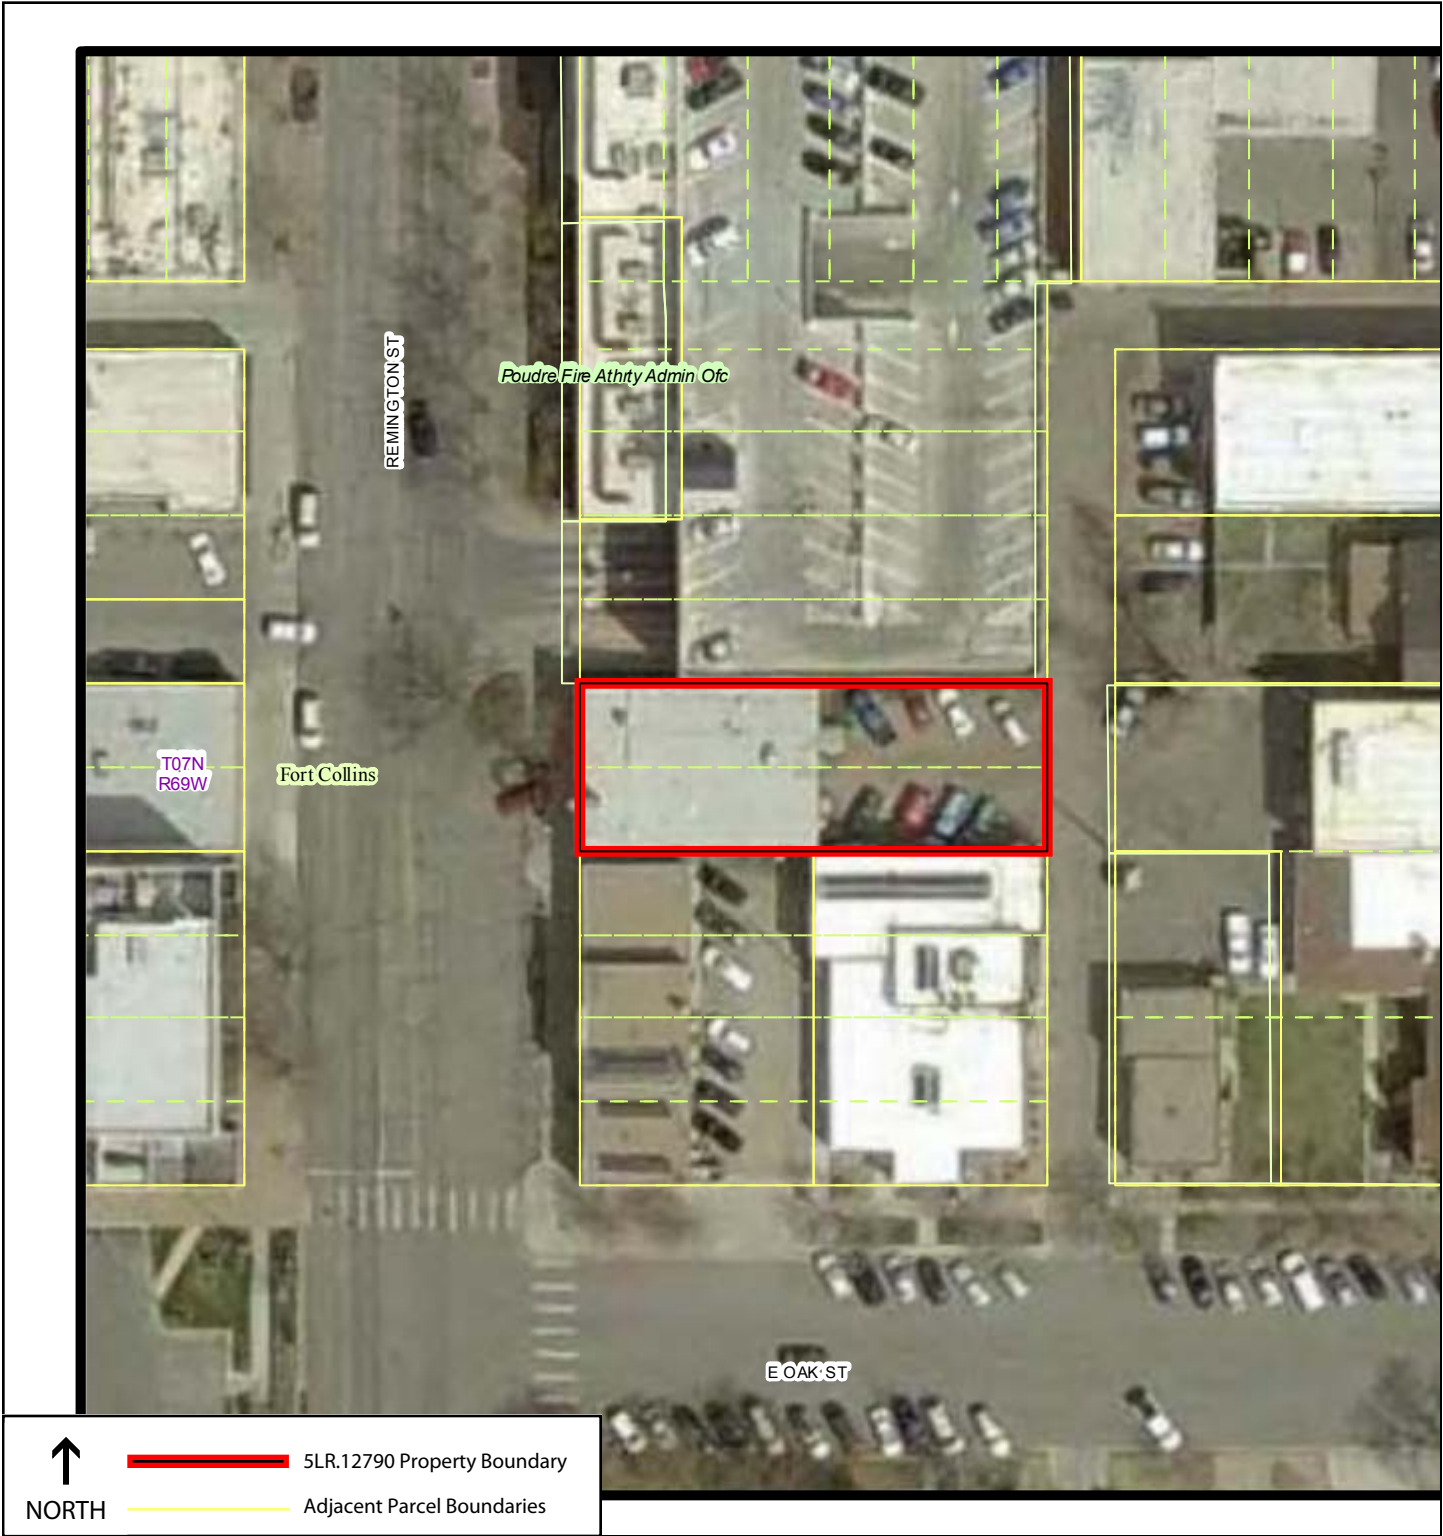
SKETCH MAP

This building is located on two narrow rectangular lots with a parking lot in the back. A City parking garage abuts the building to the north. There is a narrow walkway from the front of the building to the rear along the south elevation of the building. Hollyhocks bloom on the property. The elevation of the site is 4984 feet above mean sea level.
