Architectural Inventory Form

1. Resource number: 5LR.8477
2. Temporary resource number: City-26
3. County: Larimer
4. City: Fort Collins
5. Historic building name: Glenn and Mary Kinghorn Residence
6. Current building name: Glenn and Kathleen Konen Home
7. Building address: 121 North Sherwood Street
8. Owner name: Glenn W. and Kathleen Konen
Owner organization:
Owner address: 121 N. Sherwood Street
Fort Collins, CO 80521

Fort Collins Post-World War II Survey

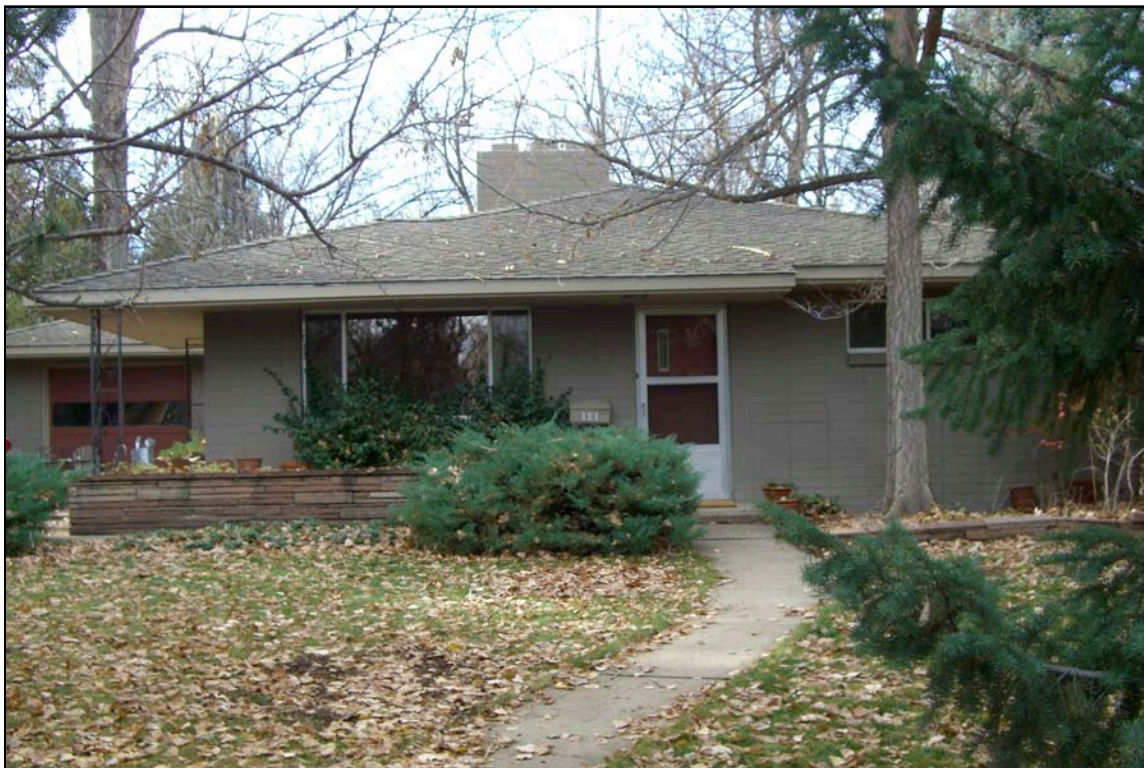
Oriented to the east, this sprawling Ranch type home rests on a concrete foundation. The L-shaped house features Roman brick siding painted a tan brown. The cross-hipped roof with overhanging eaves is clad in asphalt shingles. The primary entry is centered in the portion of the façade facing Sherwood Street. This door appears to be wooden, perhaps painted red, with a long, vertically oriented, rectangular window. The storm door is metal with a screen and, it appears, an upper portion of glass. North of the front door there is a rectangular, horizontally oriented window located high on the façade, close to the eaves. South of this same entry there is a large tripartite picture window centered over an integrated stone planter near the foundation; this planter continues around the corner, also defining about half of the south-facing portion of the facade. A large brick chimney is located near the roof peak. A secondary entry, similar in appearance to the front door, is centered on the south-facing portion of the façade. This side of the house has a large fixed pane picture window east of the secondary entry. Decorative iron supports near the

southeast corner of the house and the secondary entry define a porch underneath the overhanging eaves. West of the secondary entry there is another window; it appears to be square and may be fixed pane. A single-car attached garage with a wooden door painted rusty-red faces east. This portion of the house also seems to have another door, although vehicles parked in the unpaved driveway obscured the view. Due to the heavily wooded lot, none of the other elevations of this house were visible from the public right of way.
