## COLORADO CULTURAL RESOURCE SURVEY

**Architectural Inventory Form**

| 5. Historic building name: | <b>Rickard Smits Cabin</b> | |

Wondervu Historical and Architectural Survey

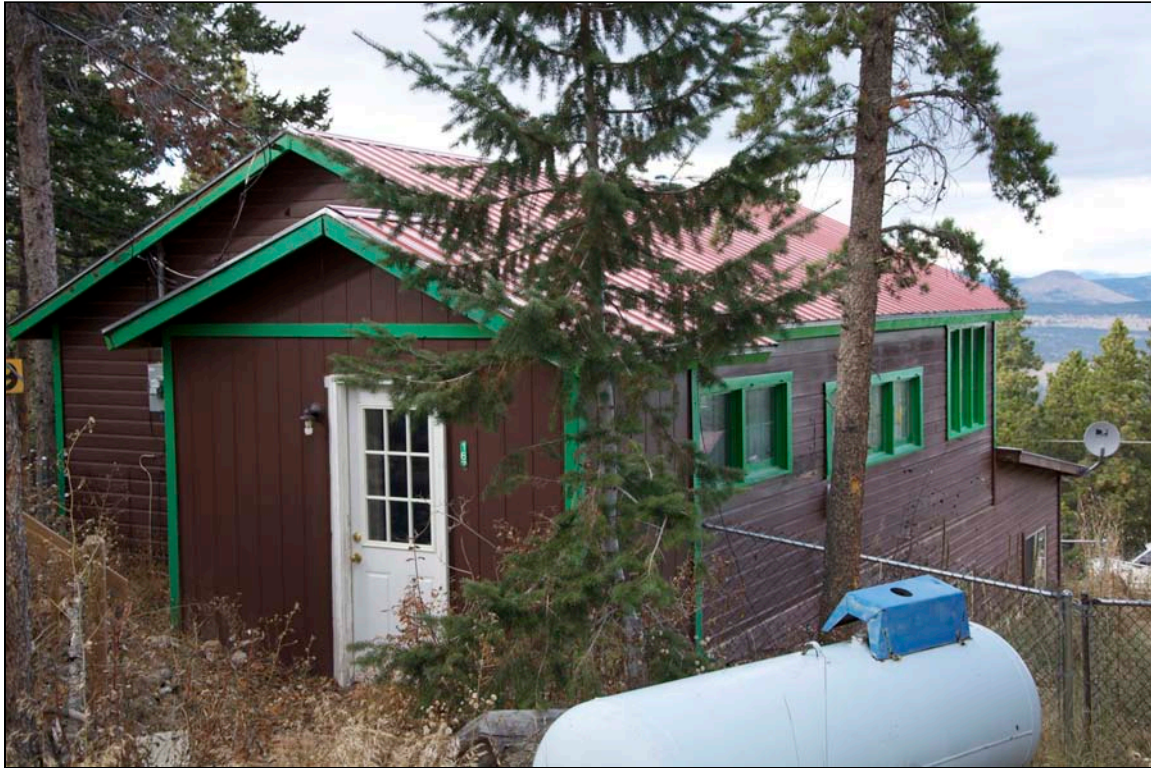
19. Primary external roof material: **Metal Roof**  
 Other roof materials:
20. Special features: **Fence**
21. General architectural description:  
**Oriented to the south, this cabin rests on a concrete foundation. Because of the steep slope downward from south to north, the basement level is exposed on all but its south elevation. Brown-painted wood weatherboard, with green-painted cornerboards, clads the exterior walls. Covering a small, front-gabled foyer or mudroom protruding from the east end of the asymmetrical front (south) façade are sheets of brown-painted, vertically scored plywood. Windows in the basement level are 1-beside-1-light, sliding-sash, with aluminum frames and brown-painted wood surrounds. Flanking a doorway at the center of the basement's north elevation are large, single-light picture windows. First-story windows are generally 6-light hopper, awning, or casement, with green-painted wood frames and surrounds. Opening in the north ends of the east and west elevations and dominating the rear (north) elevation are tripartite windows. They consist of 8-light casement windows flanking a fixed sash of 6-lights. These windows have green-painted wood frames and surrounds. The principal doorway opens in the south elevation of the foyer or mudroom. It hosts a 9-light, white-painted, two-panel steel door. A nearly identical door opens in the north elevation of the basement. An**

unsheltered wood deck, with a wood railing, spans the west elevation. Red-painted sheets of metal, with standing seams, cover the front-gabled main roof and all other roof surfaces. The rafter ends are exposed but capped by a green-painted fascia board.
