COLORADO CULTURAL RESOURCE SURVEY

Architectural Inventory Form

| 5. Historic building name: | O'Herron-Morrato Cabin; Palsgrove Cabin; West Cabin | |

Wondervu Historical and Architectural Survey

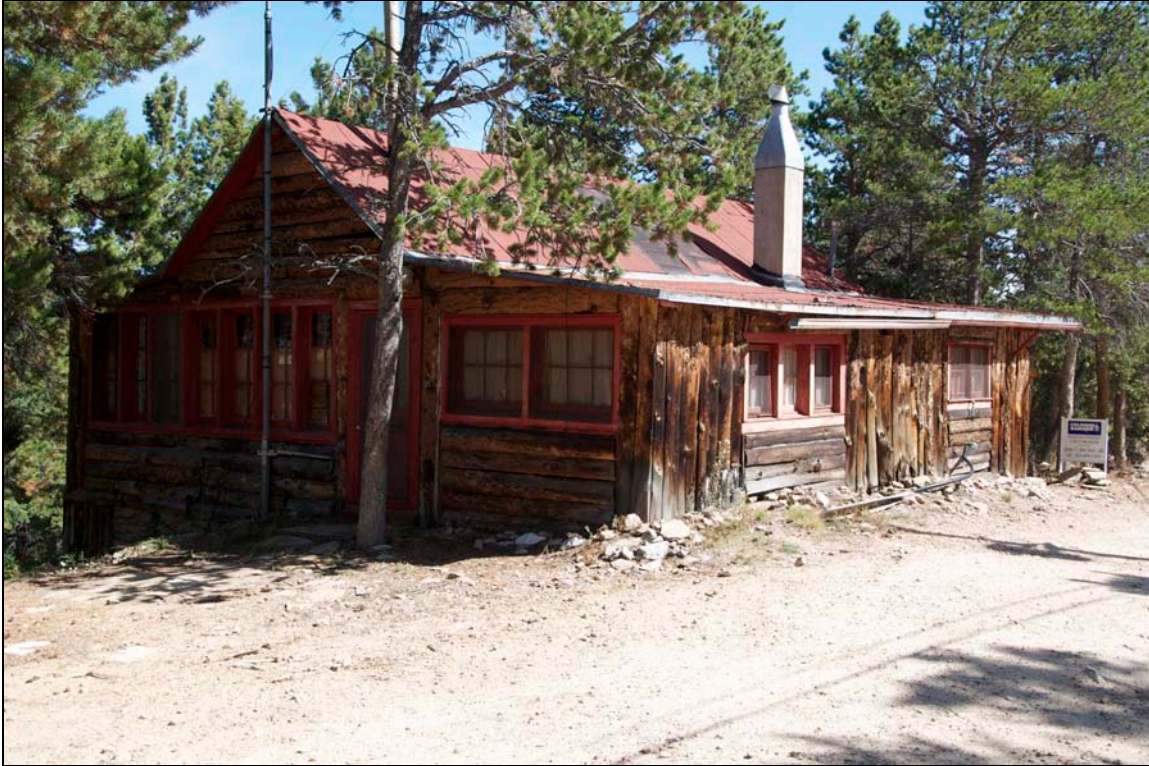
19. Primary external roof material: **Asphalt Roof/Composition Roof**
 Other roof materials:
20. Special features: **Chimney**
21. General architectural description:
Oriented to the east, this cabin rests on random-coursed sandstone and granite foundations. Vertical, unpeeled split-log siding clads the exterior walls. It is set horizontally above and below the windows and in the gables. Opening in the asymmetrical front (east) façade are paired, 4-light casement window, with red-painted wood frames and surrounds. Nearly identical windows open in the east end of the south elevation. The west end of the same elevation hosts a band of 3, single-light windows, with red-painted wood frames and surrounds. The south end of the rear (west) elevation has a pair of 6-light hopper or awning windows. Spanning most of the rest of this elevation is a band of 6-light casement windows. The north elevation consists almost entirely of 4-light casement windows, with some sashes modified as 2-light windows. The principal doorway opens in the south end of the façade. It hosts a red-painted, single-panel wood door, opening behind a red-painted, wood-frame storm door. A secondary doorway opens south of center in the rear elevation. It host a red-painted, paneled wood door, with a red-painted, wood frame screen door. Red sheets of asphalt cover the front-gabled main roof and all other roof surfaces. The log rafter ends are exposed but capped by a fascia board. A concrete chimney or a brick chimney encased in concrete protrudes near the southeast corner of the building.
