COLORADO CULTURAL RESOURCE SURVEY

Architectural Inventory Form

Fort Collins Post-World War II Survey

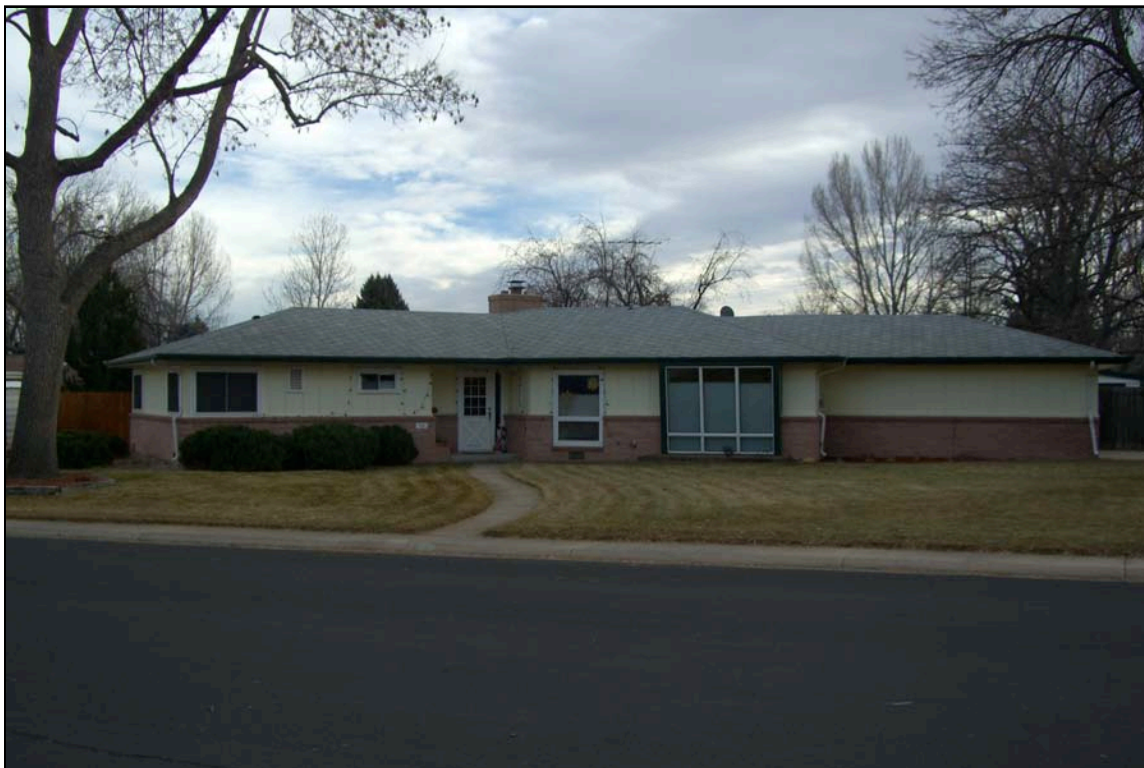
19. Primary external roof material: **Asphalt Roof**
 Other roof materials:
20. Special features: **Chimney**
Fence
Garage/Attached Garage
21. General architectural description:
Oriented to the northwest, this sprawling corner lot Ranch home rests on a concrete foundation. The L-shaped house features weatherboard siding painted a creamy yellow with stone cladding from the mid-line to the foundation. The house has a cross-hipped roof with the cornice trim painted dark green and covered in asphalt shingles. The primary entry appears on a recessed entry stoop near the intersection of the two portions of the home. The visible portion of the door has at least ten fixed pane windows. The storm door is white metal (or vinyl) with a sawbuck pattern. A large stone chimney appears on the ridgeline near the center of the home. There is a sidelight window south of the entry door. There is a rectangular, horizontally oriented slider window at the far north corner of the façade. There is a smaller rectangular slider window closer to the front door. The portion of the façade south of the primary entry contains two more windows. One is fixed pane, two-lite, rectangular, and vertically oriented. The other is a tripartite picture window which slopes outward from the façade; it has the same dark green trim. The far

southwest corner of the façade is composed of the length of the attached garage. The only portion of the south elevation visible from the public right of way is the vinyl two-car garage door. The north elevation features two rectangular slider window at the corners of this side. The southeast (rear) elevation was not visible from the public right of way. According to Larimer County assessor records, this building contains three bedrooms and two bathrooms. Character-defining features of the Ranch type home at 168 Yale Avenue include the horizontal orientation, minimal ornamentation, large chimney, picture windows, and attached garage.
