COLORADO CULTURAL RESOURCE SURVEY

Architectural Inventory Form

| 5. Historic building name: | Primo "Pete" Gilli Cabin; William G. and Ruby E. Taylor Caib | |

Wondervu Historical and Architectural Survey

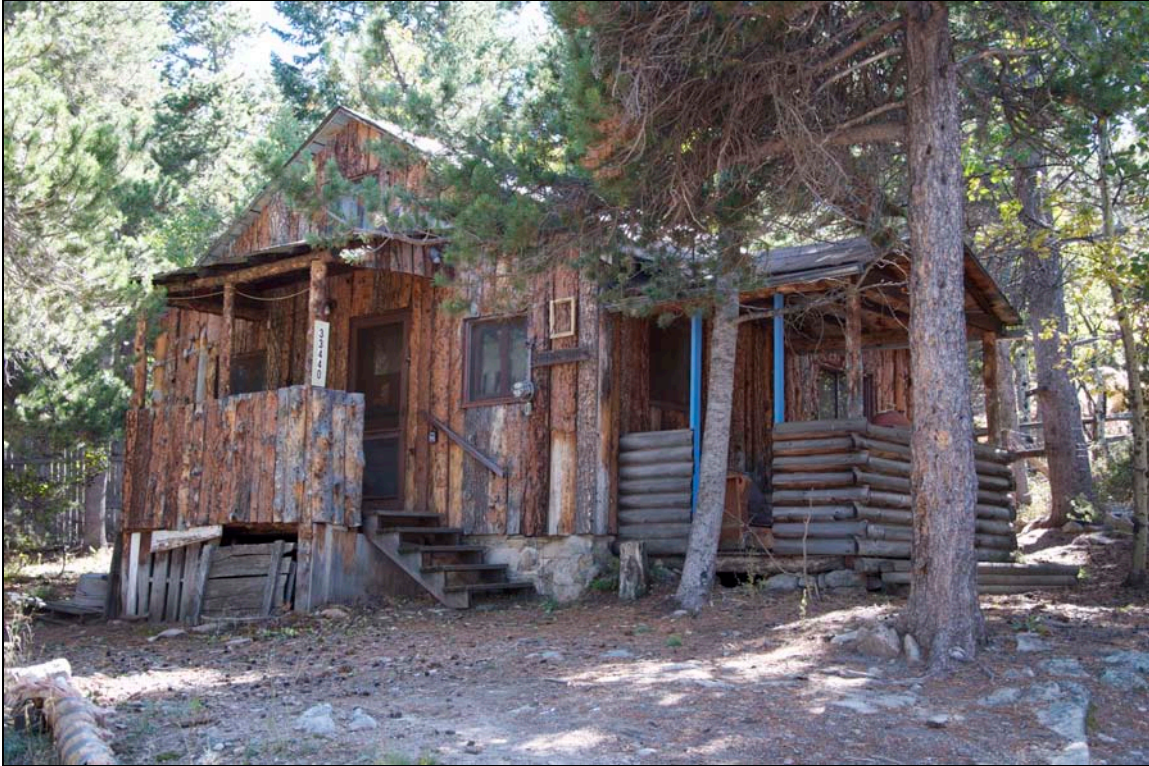
19. Primary external roof material: **Asphalt Roof/Composition Roof**
 Other roof materials:
20. Special features: **Porch**
21. General architectural description:
Oriented to the northeast, this cabin rests on a random-coursed granite foundation. Unpeeled, vertical split-log siding clads the exterior walls. Windows are generally paired, single-light casement, with brown-painted wood frames. The principal doorway opens near the center of the nearly symmetrical front (northeast) elevation. It hosts a brown-painted, single-panel, single-light wood door, opening behind a wood-frame storm door. The doorway provides access to a small shed roof porch protruding from the center of the façade. It has split-log kneewalls as well as long posts and beams. Five wood steps approach the porch on its northwest end. A larger, front-gable porch dominates the northwestern end of the southwest elevation. It has high, peeled-log kneewalls as well as log posts and beams. A single step approaches the porch on its northeast elevation. The porch does not shelter a doorway. Both porches lack formal foundations. Sheets of brown asphalt cover the front-gabled roof, and the rafter ends are exposed.
