COLORADO CULTURAL RESOURCE SURVEY

Architectural Inventory Form

- 1. Resource number: **5BL.10467** Parcel number: **158321002001**
- 2. Temporary resource number:
- 3. County: **Boulder**
- 4. City: **Eldora**
- 5. Historic building name: **Clara E. Nipher Cabin**
- 6. Current building name: **Eleanor E. Busch Cabins**
- 7. Building address: **125 Eldorado Avenue**
- 8. Owner name: **Eleanor E. Busch**
- Owner organization:
- Owner address: **3455 S Corona #544
Englewood, CO 80113**

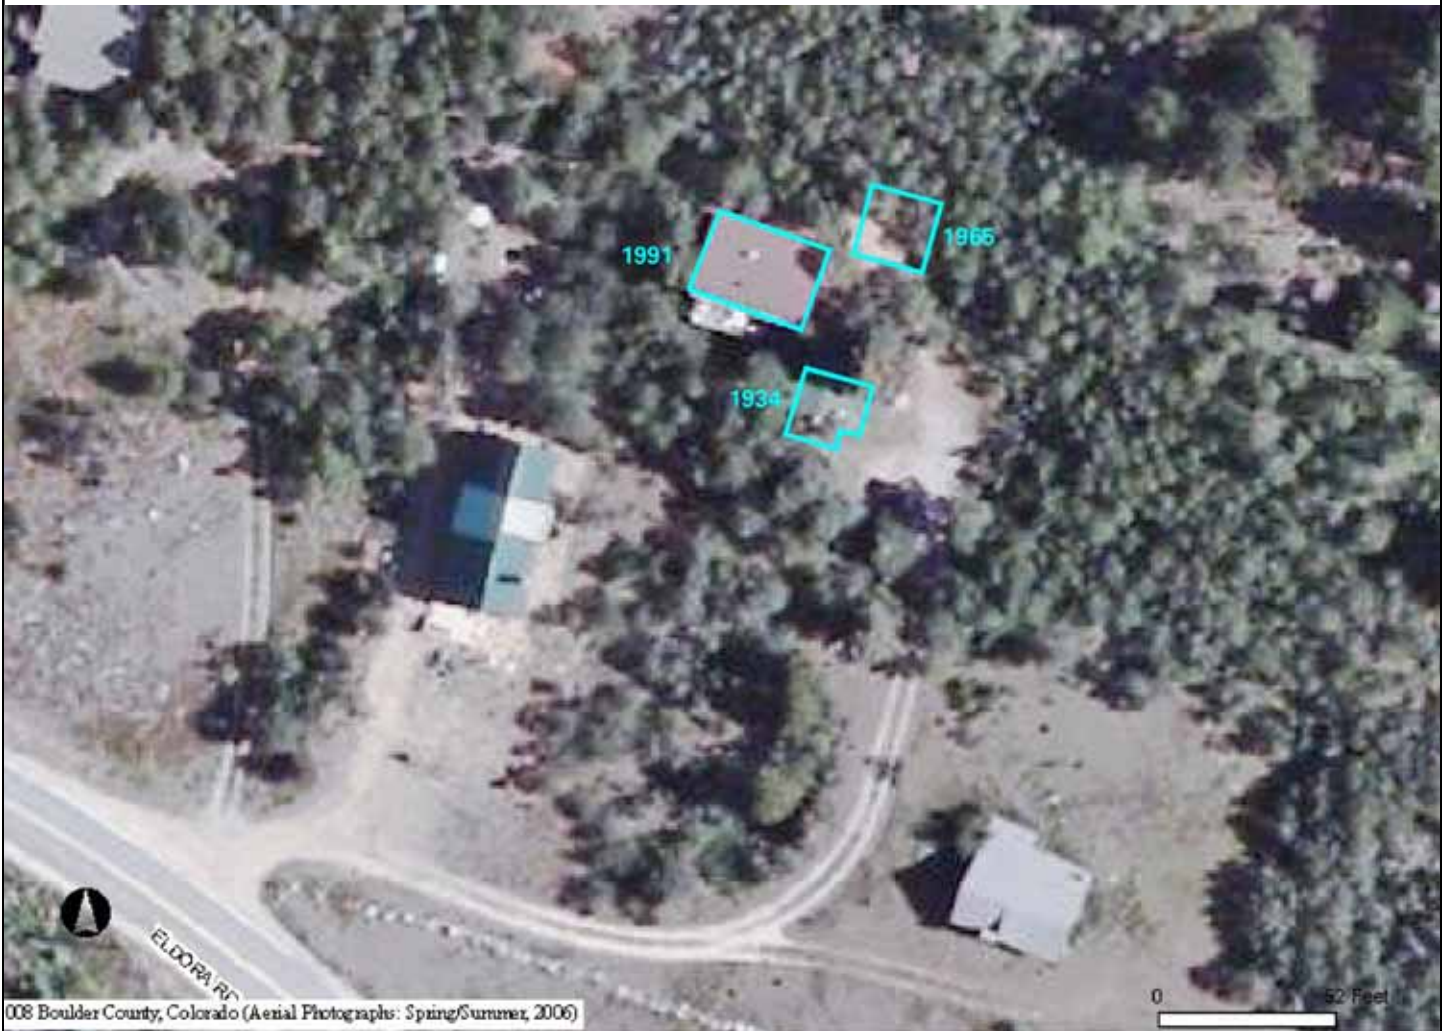
SKETCH MAP

This property is located within a canyon, at the base of the ridge rising to the north, at an elevation of around 8,600 feet above mean sea level. The property rises steeply upward from south to north. This property is situated on Eldorado Avenue, the principal east-west thoroughfare through the village of Eldora. Setbacks vary greatly on Eldorado Avenue, with this property connected to the road via a long, winding driveway. Mature pines and spruces, mixed with young aspens, cover the property, and large spruces line the driveway. The three main buildings on this property are situated close together, joined by a shared deck structure.
